Del Mar Bluffs Geotechnical Study

Part 1: Geotechnical Evaluation
Volume I

DEL MAR BLUFFS GEOTECHNICAL STUDY,
DEL MAR, CALIFORNIA,
PART I - VOLUME NO. 1
GEOTECHNICAL EVALUATION

Project No. 040151-001

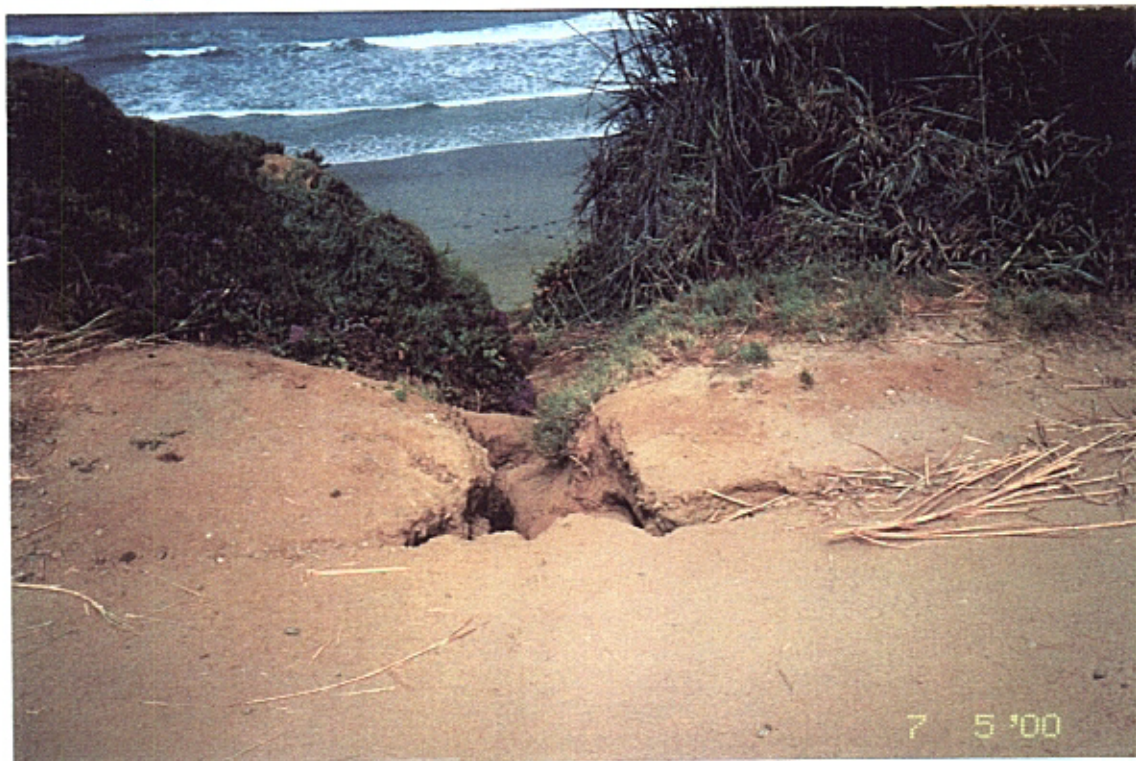
PHOTO NO. 15

Erosion caused by bluff seepage; red sand generated from erosion of terrace deposits.

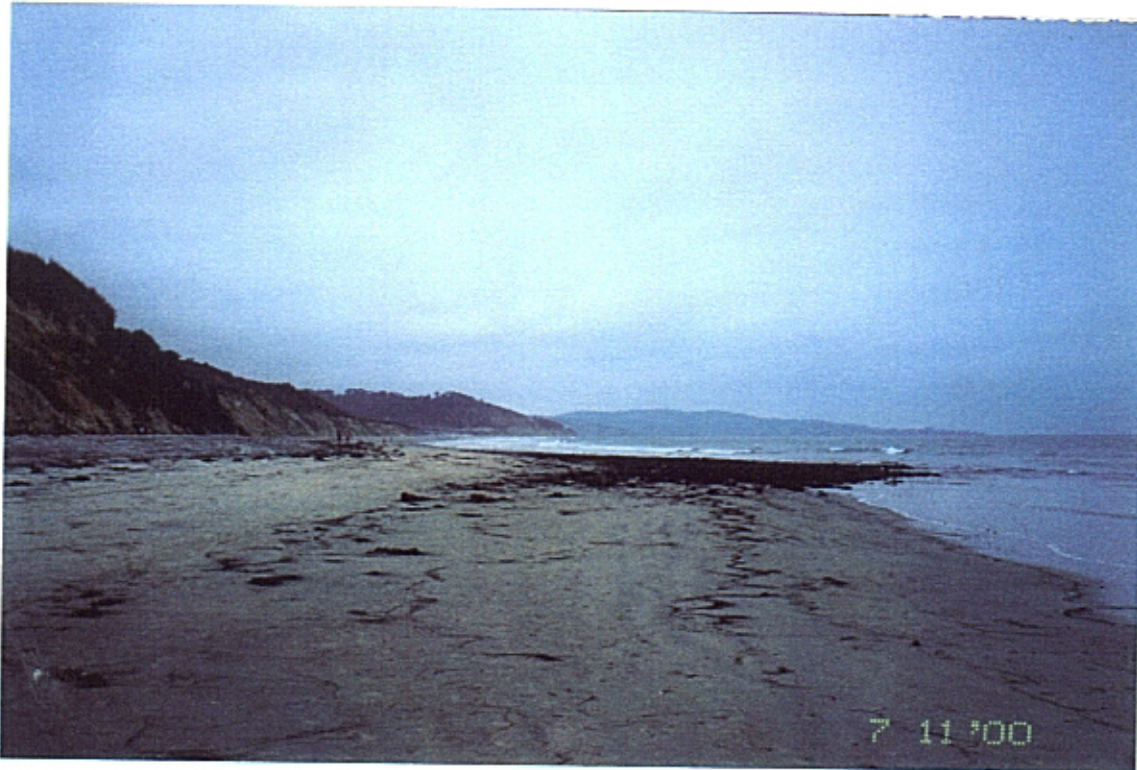
PHOTO NO. 22

View from central section to the south.

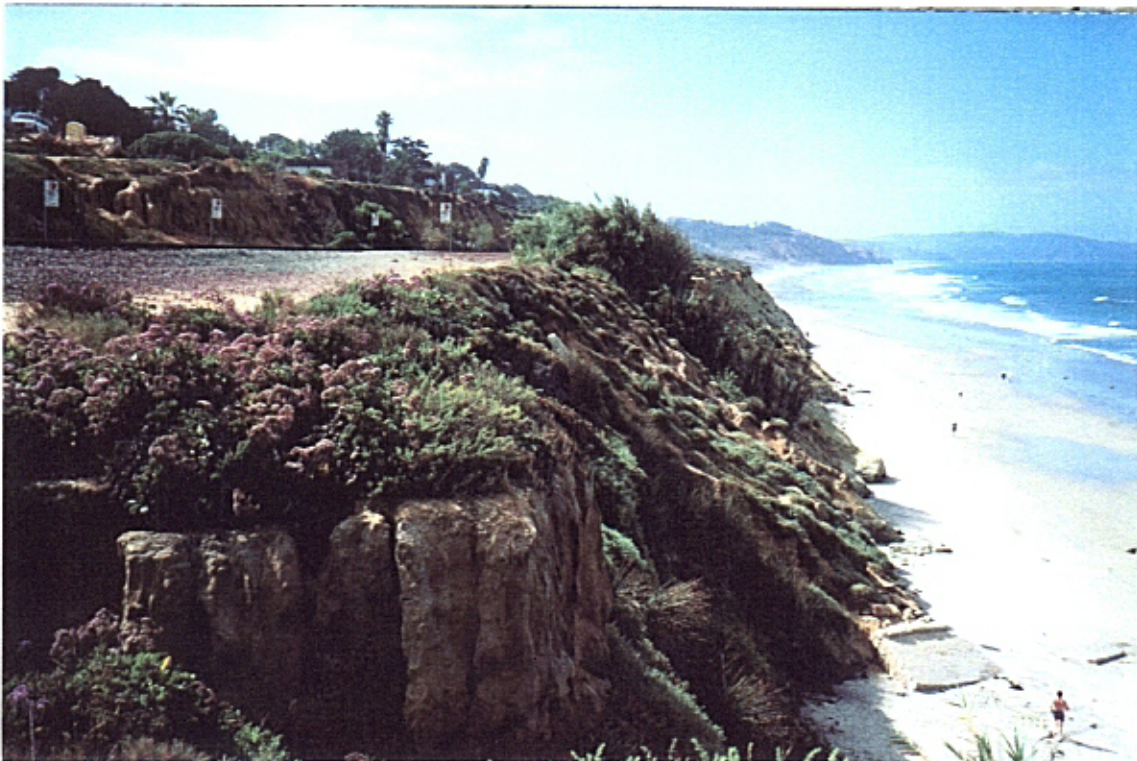
PHOTO NO. 23

Debris resulting from block fall from upper section. Note seepage at base of terrace deposits.

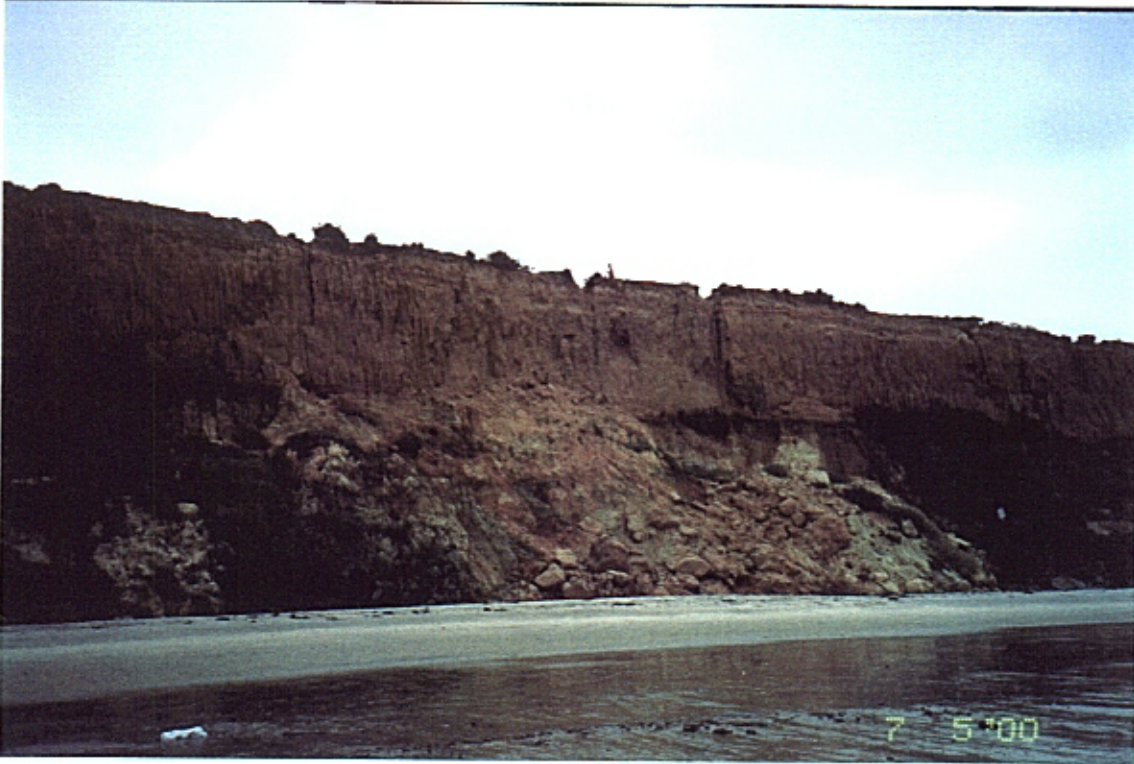
PHOTO NO. 24

View of bluff at southern end of central section. Note lack of vegetation to the south.

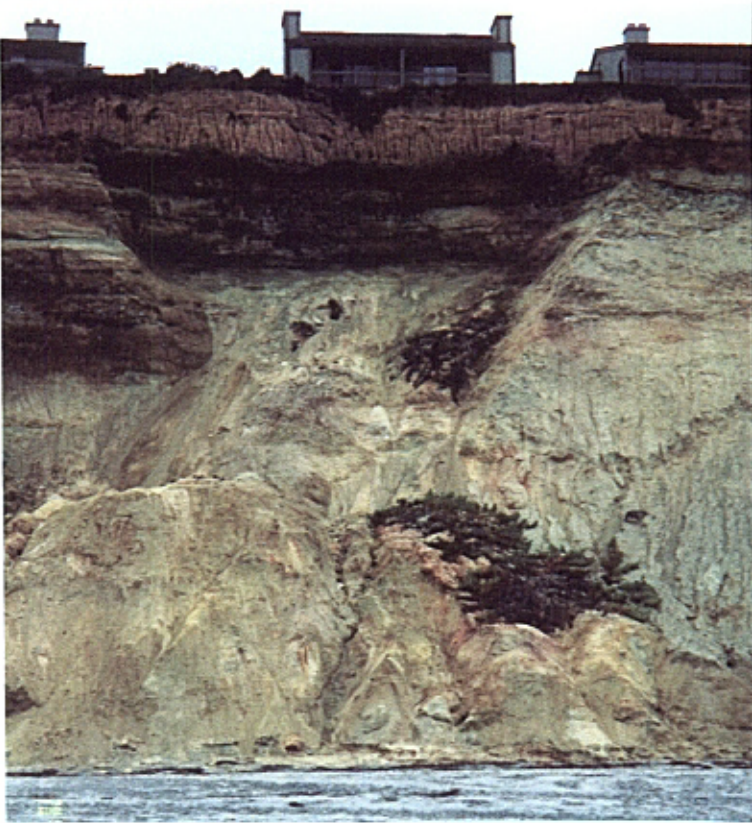
PHOTO NO. 30

Bowl-shaped erosion in southern section, caused by now removed storm drain. Note that erosion stopped at resistant layer that extends across base of bluff.
