Del Mar City Hall/Town Hall
Project
Historic Building Survey of the
City Hall Buildings at
1050 Camino Del Mar
Del Mar, California

Prepared by
RECON Environmental, Inc.
1927 Fifth Avenue
San Diego, CA 92101-2358
P 619.308.9333 F 619.308.9334
RECON Number 7786
July 8, 2015

Report Title: Historic Building Survey of the City Hall Buildings at
1050 Camino Del Mar in the City of Del Mar, California

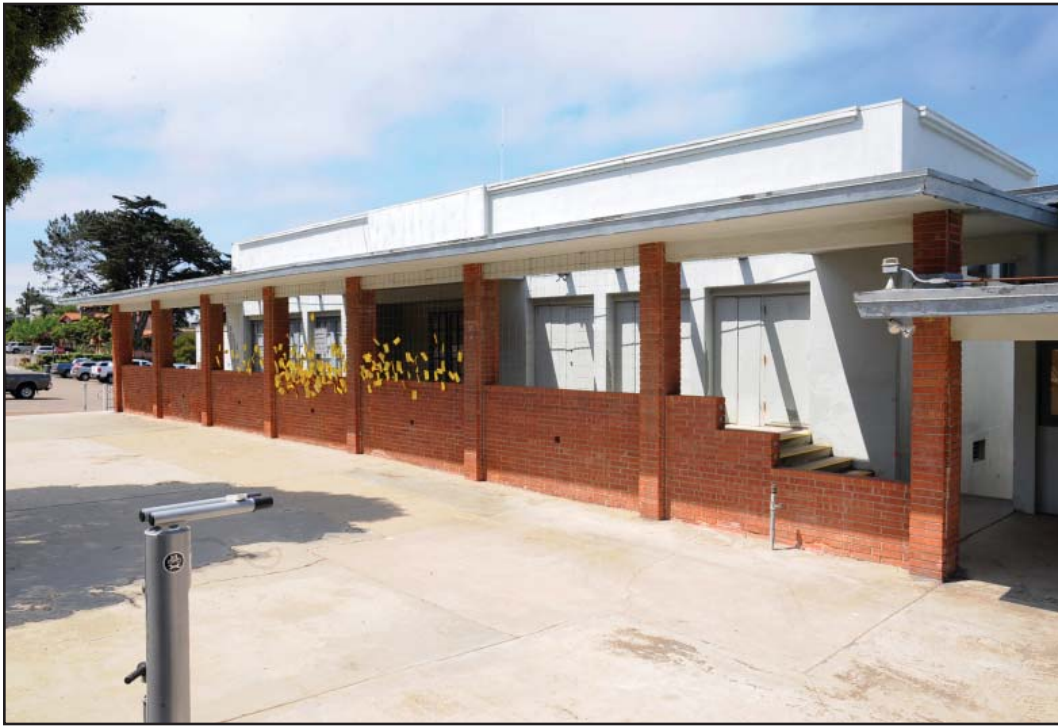
PHOTOGRAPH 1
Building A, Façade Looking Southwest

The façade is symmetrical, with a centrally placed double door and sets of three double doors on each side (Photographs 1 and 2). The double front doors are 10 light wood frame doors with wood casings set in a rectangular recess (Photograph 3). The side doors are slightly recessed and separated by flat mullions. These doors match the front doors in design. The side doors on the right have been boarded up (Photograph 4). A portico extends across the entire façade, extending out approximately 16 feet from the wall. Eight red brick pillars, set approximately 12 feet out from the façade and connected by a low red brick wall, support the roof (Photograph 5). The portico roof is stuccoed, and there is an area of open wood beams above the two side sets of doors. The fascia design and the red brick facing match the style of Building B, and it is possible that the portico was constructed at the same time building B was constructed to tie the two buildings together.

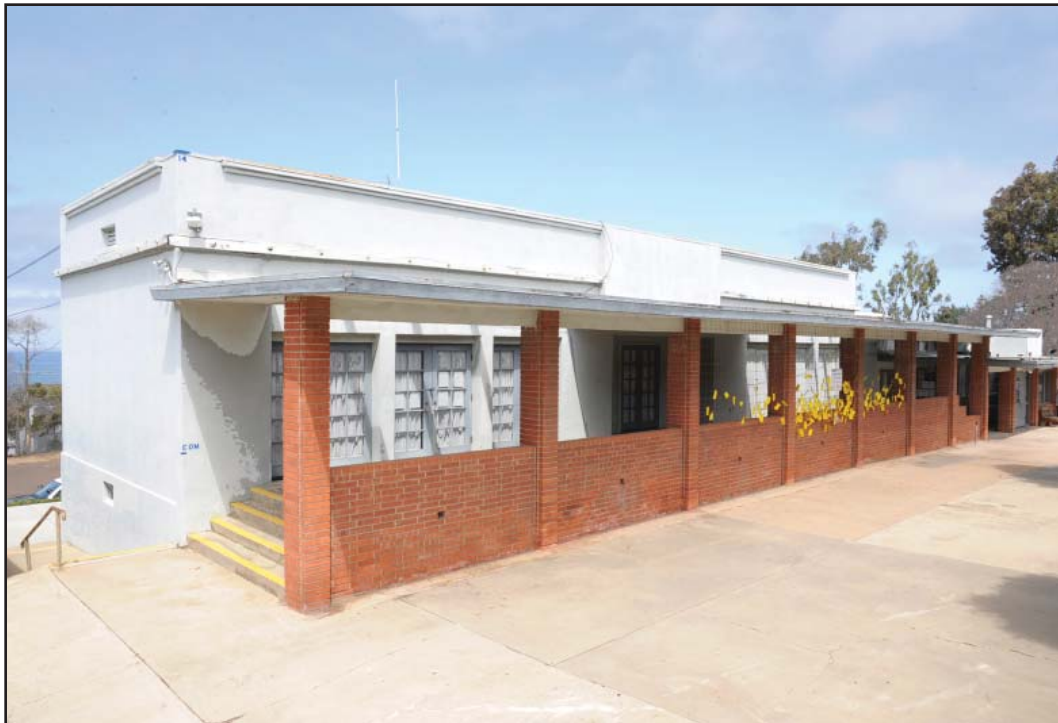
PHOTOGRAPH 2
Building A, Façade Looking Northwest

The south side of the building has no windows or doors and is completely plain except for the roof coping and wood beam (see Photograph 2). The north side of the building has three single light, wood frame windows set high up on the wall, just below the wood beam (Photograph 6).

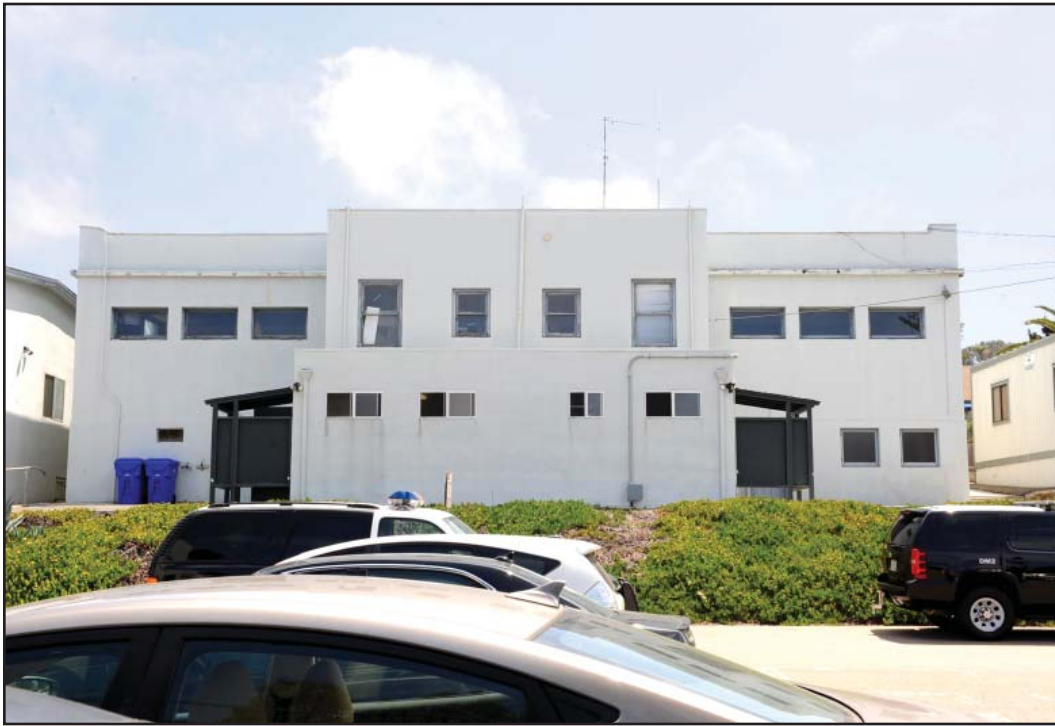
PHOTOGRAPH 7
Building A, Looking East at West Wall

As noted above, the west side of the building is two story, with the central portion extending out approximately 10 feet (creating the T-shaped ground plan). There are ten evenly spaced windows on the second floor, four on the extended portion and three each on either side (Photograph 7). The windows on the sides are hopper style, with wood frames and single lights. The central portion windows are one over one double-hung style with wood frames. The windows near the corners are larger than the inner windows. There are two windows on the first floor, both casement styles with wood frames. Both windows are on the right-hand side. There is a single door on each side, set next to the extension. Both are solid panel wood

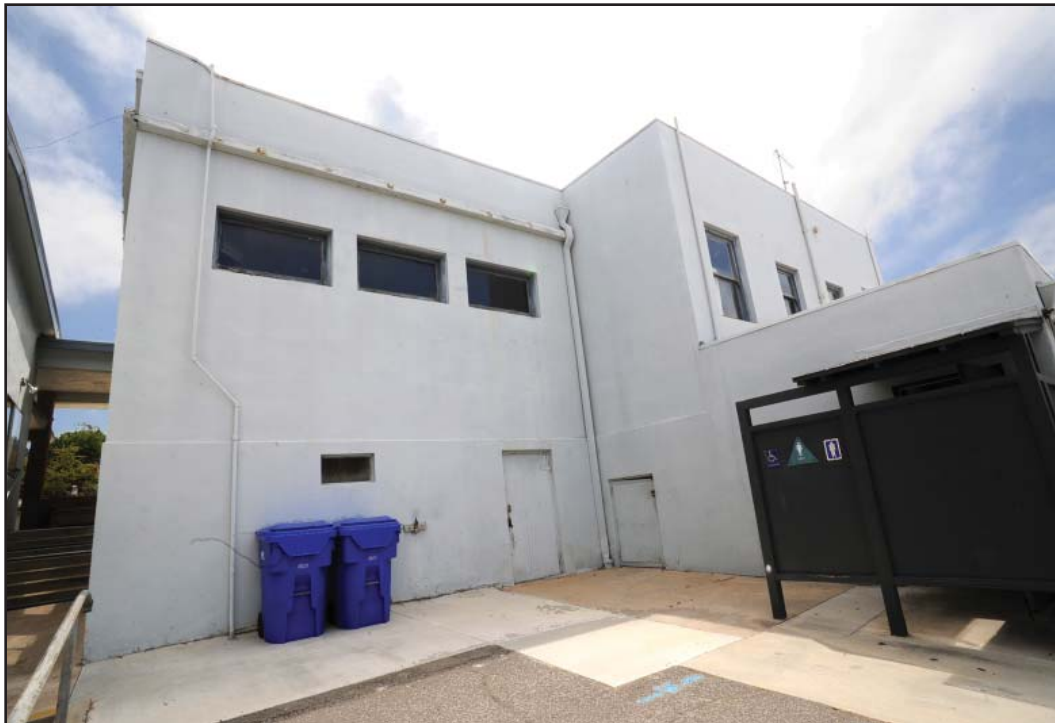
PHOTOGRAPH 8
Building A, North Side of West Wall Showing Bathroom
Extension and Small Lip above First Floor Doors

doors with wood casings. The first floor protrudes out about 1.5 inches, forming a narrow lip above the doors and windows (Photograph 8).

There is a single-story bathroom attached to the extended portion of the west side, approximately 10 feet deep. This appears to be a later addition; a slight joint can be seen on the south side where it attaches to the two-story portion of the building. The small lip near the top of the first floor disappears at the joint between the two-story portion of the building and the one-story bathroom. Also, the windows on the bathroom are small aluminum-framed sliding windows that do not match any other windows on the building.

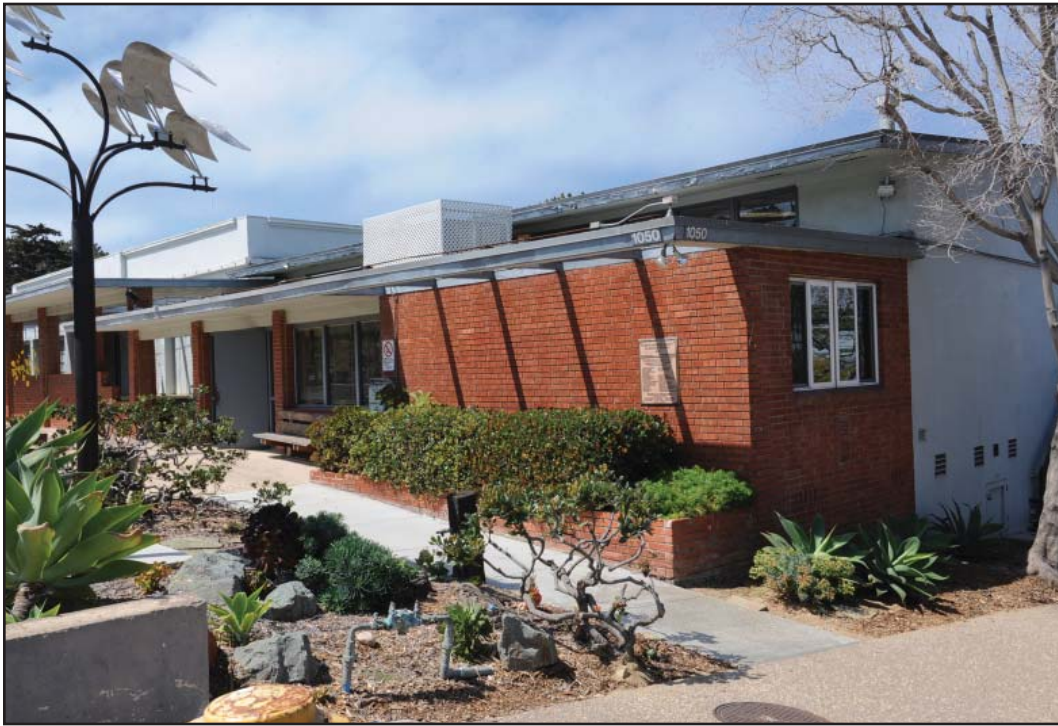
PHOTOGRAPH 9
Building B Looking Southwest

Building B is also constructed on a west-facing slope and consequently is single story on the eastern half and two story on the western half. The ground plan is a rectangle measuring 57 feet north-south by 45 feet east-west. A low front office/reception area is attached to the front (eastern) side of the building measuring 42 feet north-south by 14 feet east-west. The roof is a side gable style with a very low pitch. The eaves overhang approximately 30 inches on the east and west sides and only about 10 inches on the north and south sides. There is a wood fascia board and enclosed rafters with a stuccoed soffit. The basic cladding is stucco, with red brick details on the façade and north wall (Photograph 9).

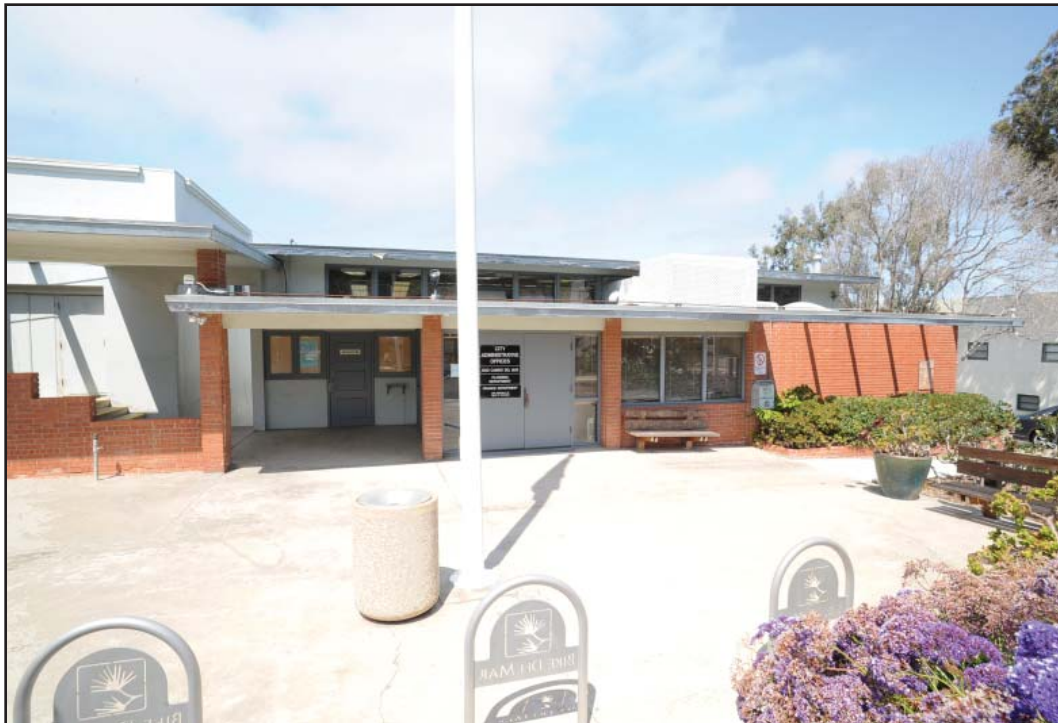
PHOTOGRAPH 10
Building B Façade, Looking West

The façade, facing east, is asymmetrical in layout. A low entrance office/reception area is offset to the right (north) of the main building and extends out approximately 14 feet from the main building (Photograph 10). This office area is divided into three roughly equal parts, with the double-door entrance set at the left (southern) end. The doors are centered between two red brick pillars, with sidelights consisting of two large fixed panes with wood frames (Photograph 11). Three large, single light fixed windows with narrow wood mullions occupy the central portion of the office area, with the wall area below the windows faced in red brick. The left (north) end of the office is a blank red brick faced wall (see Photograph 9). The south wall of the office area is glass, consisting of six fixed lights, the three upper being larger than the three lower, separated by narrow wood mullions.

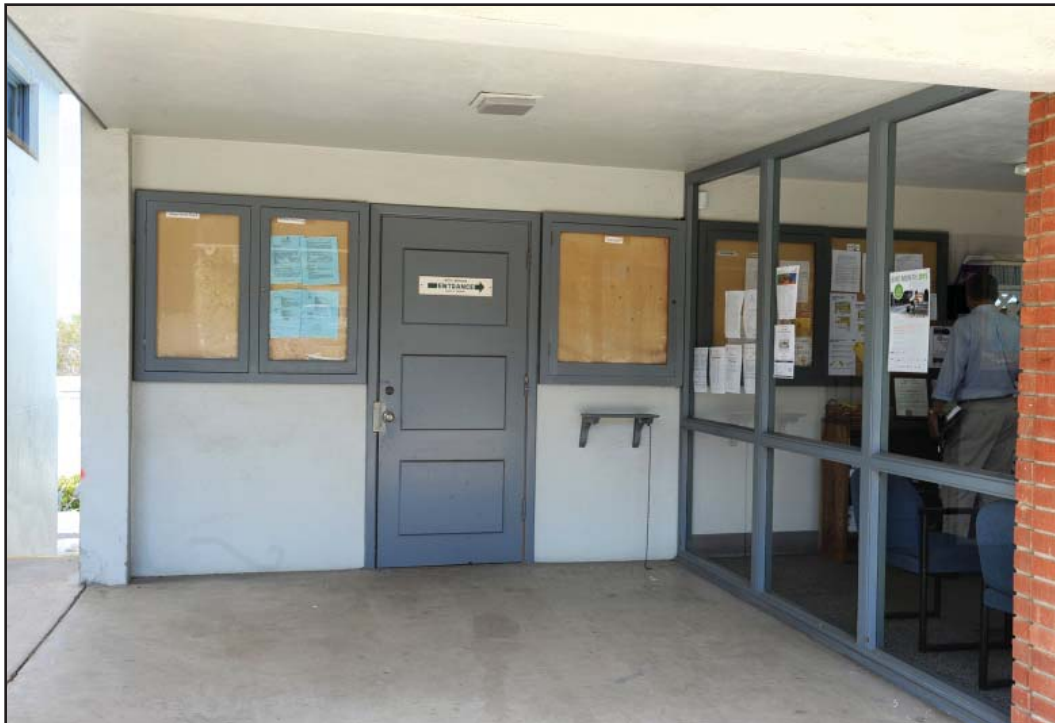
PHOTOGRAPH 12
Building B, South End of Façade

Approximately three feet of the main building façade is visible above the roof of the office area. The majority of this is occupied by 12 single light windows with wood frames. They may be hopper- or awning-style sashes, but this could not be determined as none were open. The left end of the main building is visible, set in a recess created by the office area. A door offset to the right is flanked on the right by a wood framed bulletin board and on the left by two similar bulletin boards set side by side (Photograph 12).

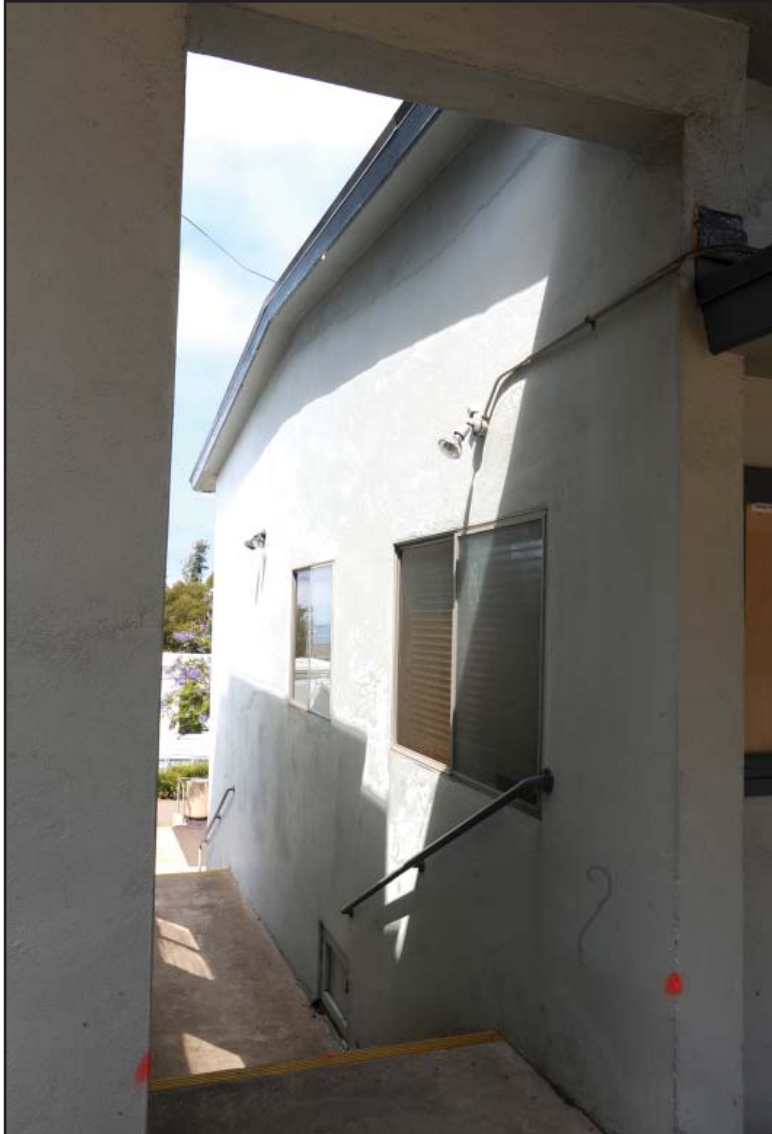
PHOTOGRAPH 13
South Wall of Building B Showing Windows

The south side of the building has two windows offset to the east of center (Photograph 13). Both are aluminum-framed single light sliding windows.

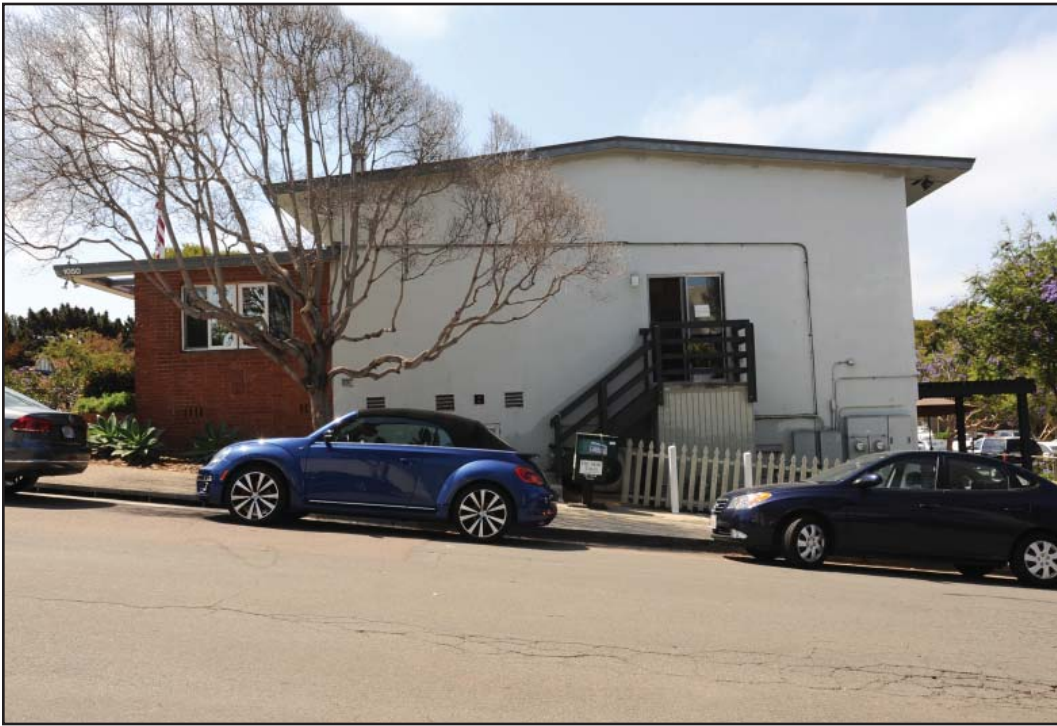
PHOTOGRAPH 14
North Wall of Building B

The north wall has a single glass sliding door set just right of center at the second-floor level, in the main building (Photograph 14). A pair of metal frame single light sliding windows are set side by side in the middle of the office/reception area north wall.

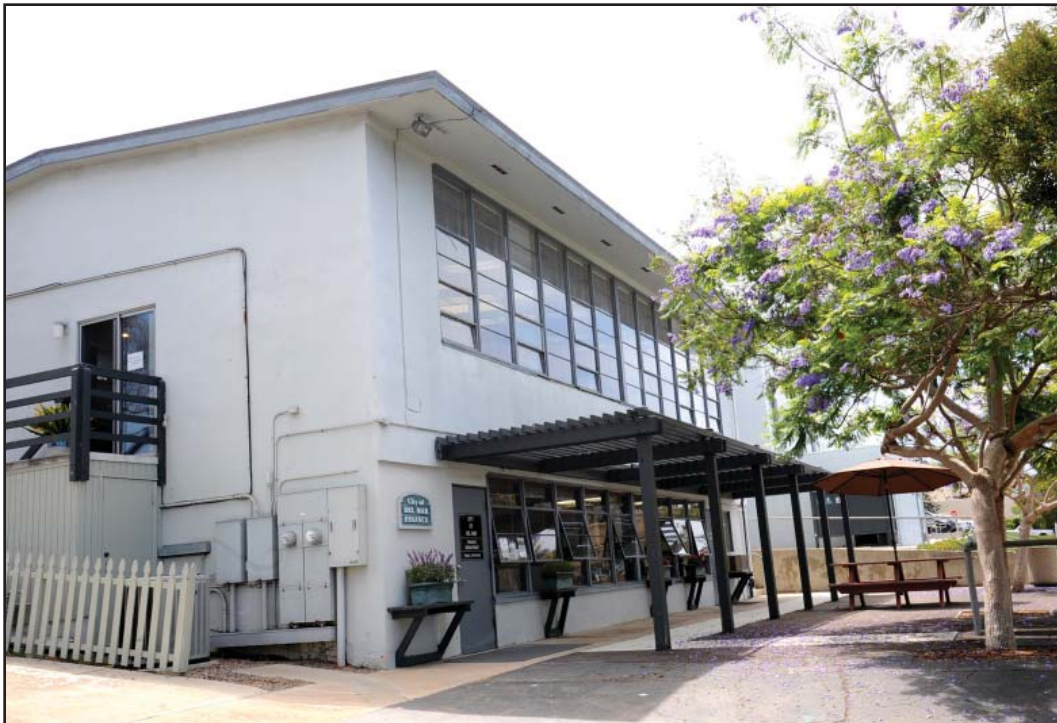
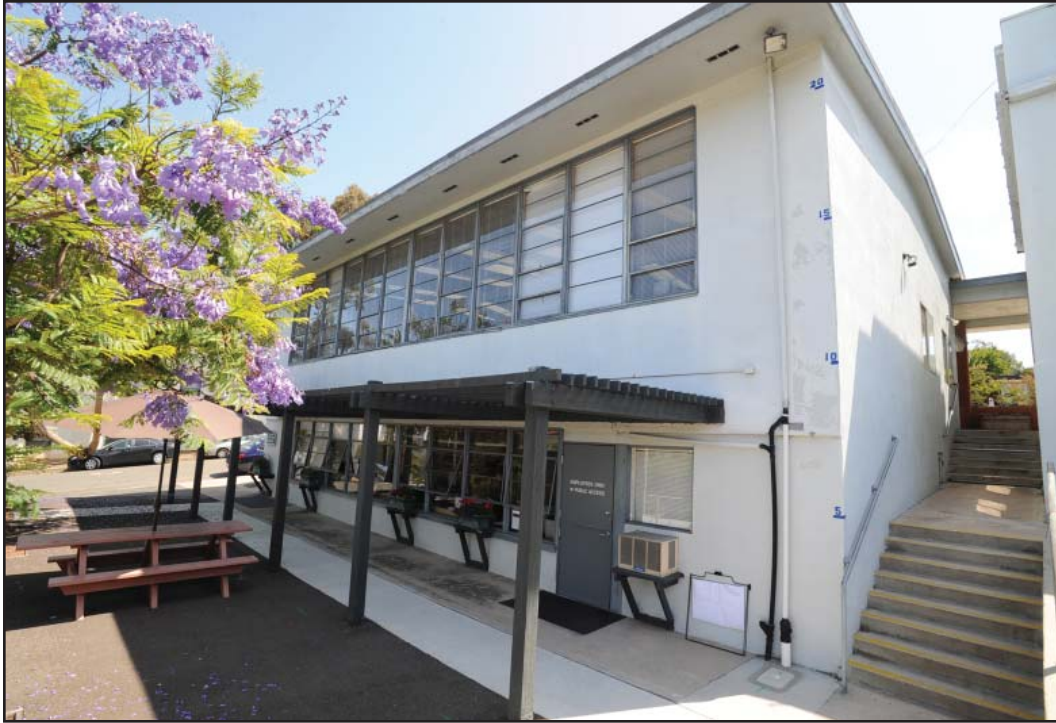
As noted above, the west side of the building is two stories (Photographs 15 and 16). The top floor wall is composed almost completely by a bank of 12 sets of metal-framed windows set side by side with narrow wood sash and casings. Each set is composed of six lights in groups of two, separated from the adjacent set by a narrow wood mullion. The second, fourth, sixth, seventh, ninth, and eleventh banks have fixed lights. The first, third, fifth, eighth, tenth, and twelfth banks have a combination of fixed and moveable lights. The top pair is fixed, the middle two comprise an awning style-sash, and the bottom light is a hopper-style sash. The windows do not extend all the way to the floor. The first floor has a bank of nine windows, offset slightly to the left (north). Each window is composed of four lights; in metal sashes with narrow mullions. The top and bottom light are fixed and the middle two are set in an awning-style sash. This bank of windows also has a wood sash and narrow wood casings. On each side of the windows is a single panel wood door. On the right (south) side, there is a single light fixed window south of the door. A wood shade structure, attached to the west side of the building, extends out approximately 10 feet and covers a concrete patio.

PHOTOGRAPH 15
West Wall of Building B, Looking Southeast

PHOTOGRAPH 16
West Wall of Building B, Looking Northeast
