Del Mar Bluffs Geotechnical Study

Part 1: Geotechnical Evaluation
Volume I

DEL MAR BLUFFS GEOTECHNICAL STUDY,
DEL MAR, CALIFORNIA,
PART I - VOLUME NO. 1
GEOTECHNICAL EVALUATION

Project No. 040151-001

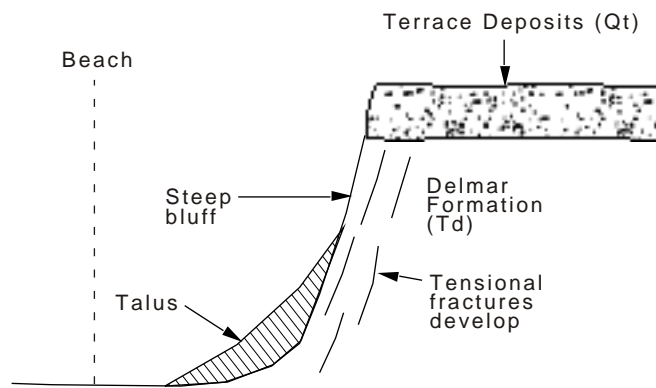
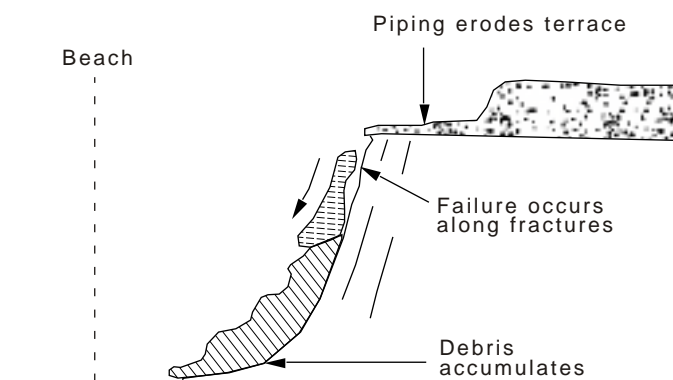
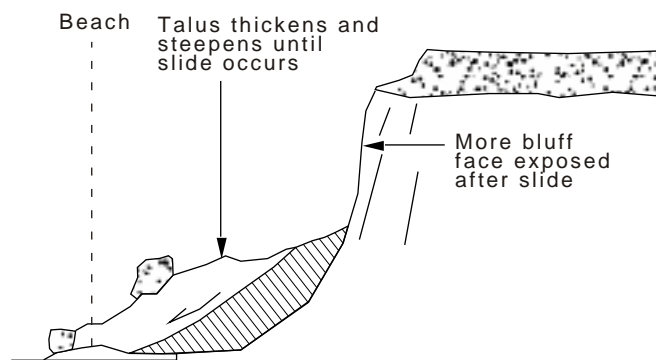
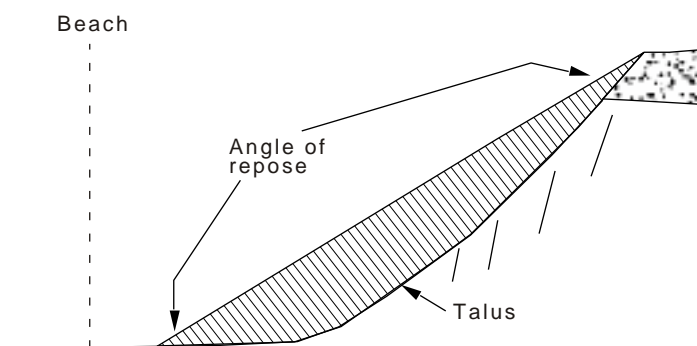
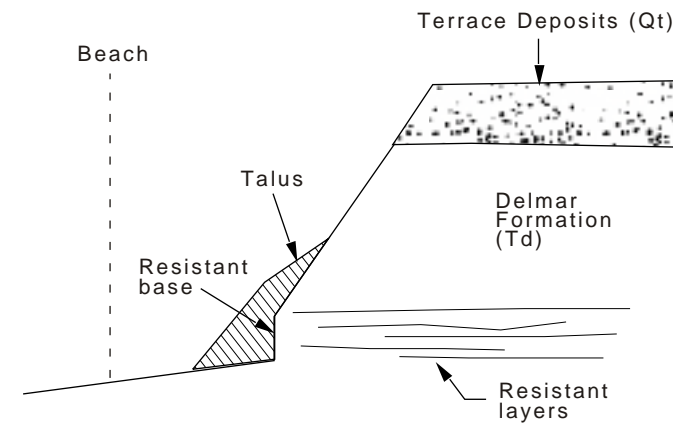
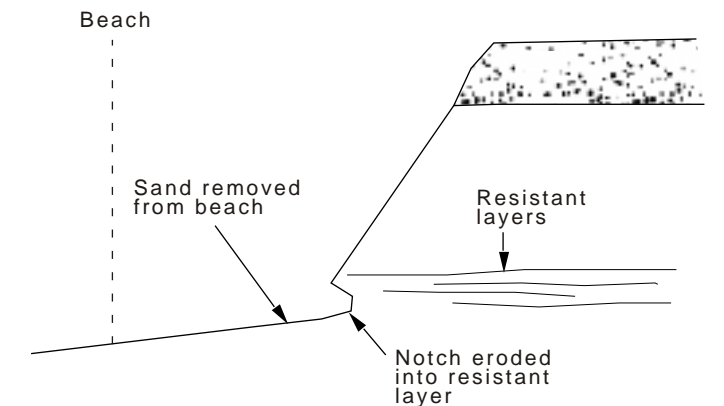
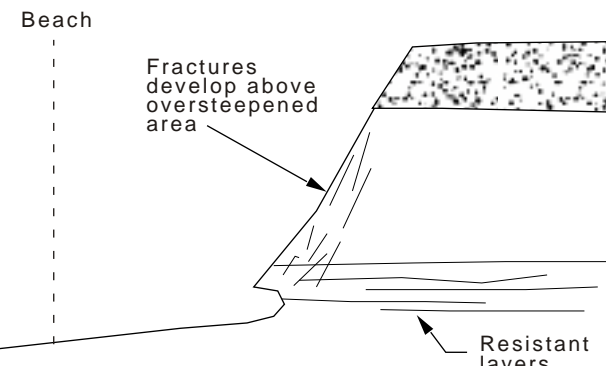
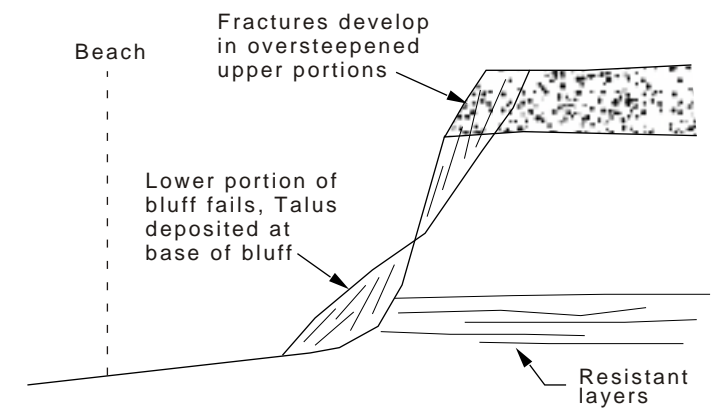
Figure No. 8

In general, a bluff will lay back and flatten over time until a characteristic slope is achieved. The generalized stages of bluff retreat by erosion of less resistant materials on the bluff face are illustrated in Figure 8.

Visual examination of the bluff toe indicates that the conditions vary from dense resistant bedrock to areas of soft and loose talus and debris. The condition of the bluff toe is somewhat variable depending on which stage of bluff retreat the individual location is experiencing in Figure No. 8. The stage of bluff retreat, the condition of the toe, and the nature of the exposed soils will vary over time. Where not protected by a wall or other protective device, the areas of soft or loose debris will rapidly erode during periods of heavy surf. The toe of the bluff has been plotted on the geotechnical maps as the interpreted base of the dense bedrock. Thus, in many locations, the actual bluff toe is buried by surficial debris and loose soil. Further investigation of toe conditions will be required if toe of slope protective devices are desired.

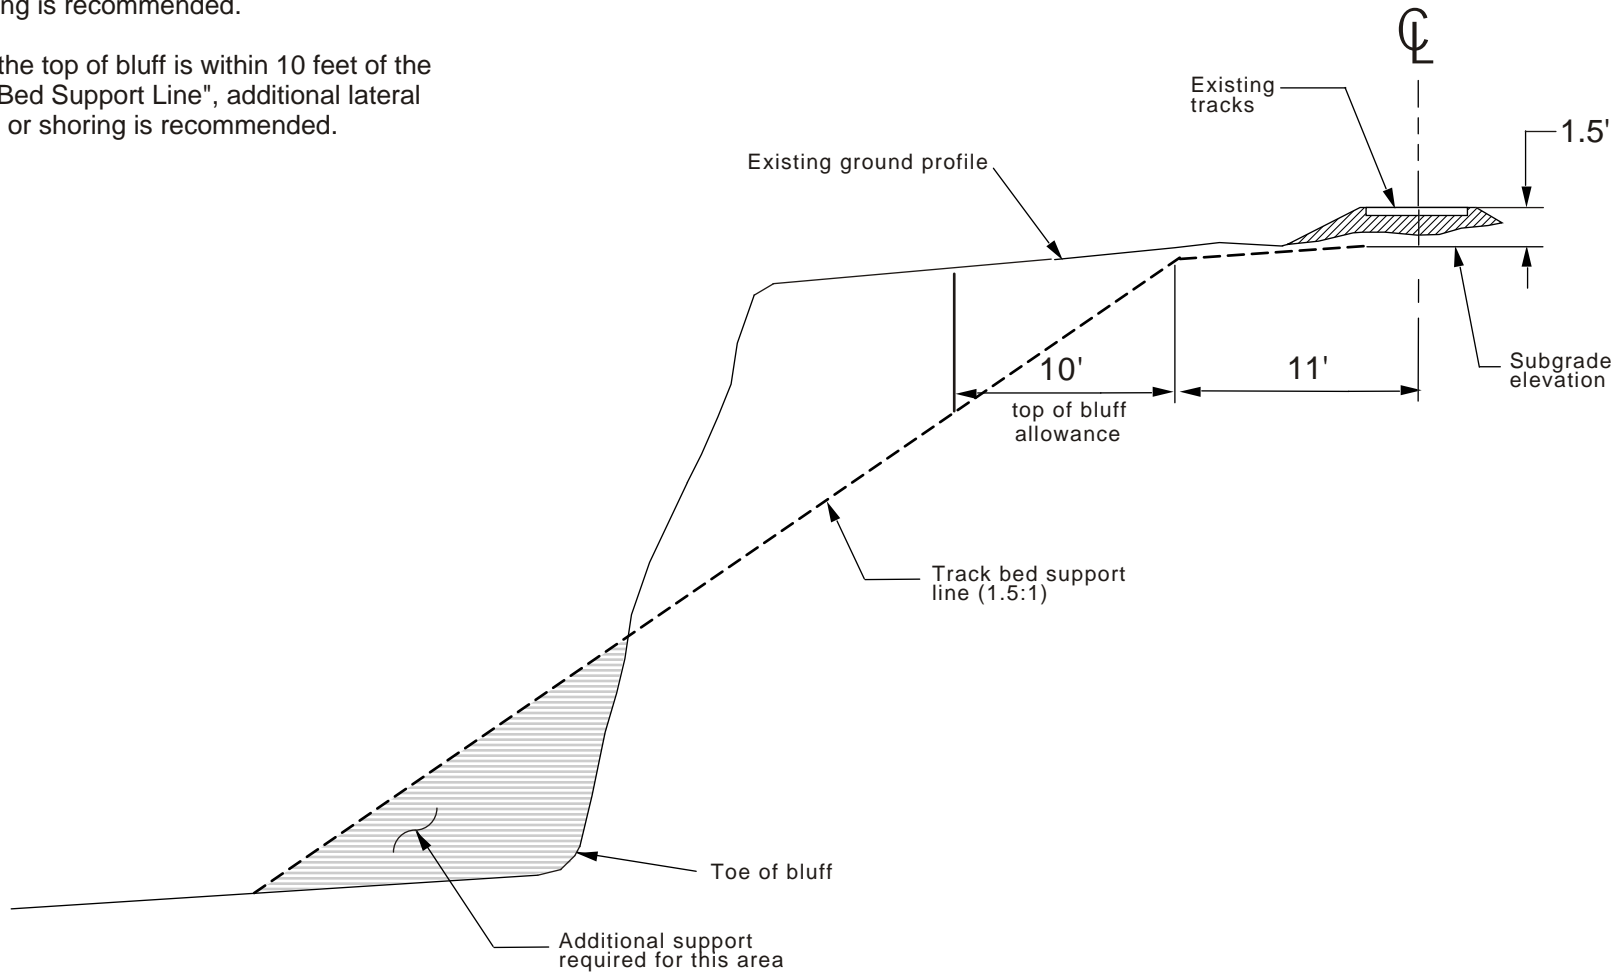
Figure No. 9

The figure shows that the minimum track bed support is defined with a line that extends 11 feet from the centerline of the rails and then outward and downward at a gradient of 1.5 to 1 (horizontal to vertical). When existing grades or zones of highly weathered or disturbed material encroach inside of this line, additional lateral support or shoring is needed. Based on our analysis, stability at the top of the bluffs is generally improved where a 10-foot weathering setback is allowed for beyond the projected track bed support line. This top of bluff weathering setback has been added to Figure 9 to illustrate this allowance.

Where the "Track-Bed Support Line" is above toe of bluff, additional lateral support or shoring is recommended.

Where the top of bluff is within 10 feet of the "Track-Bed Support Line", additional lateral support or shoring is recommended.

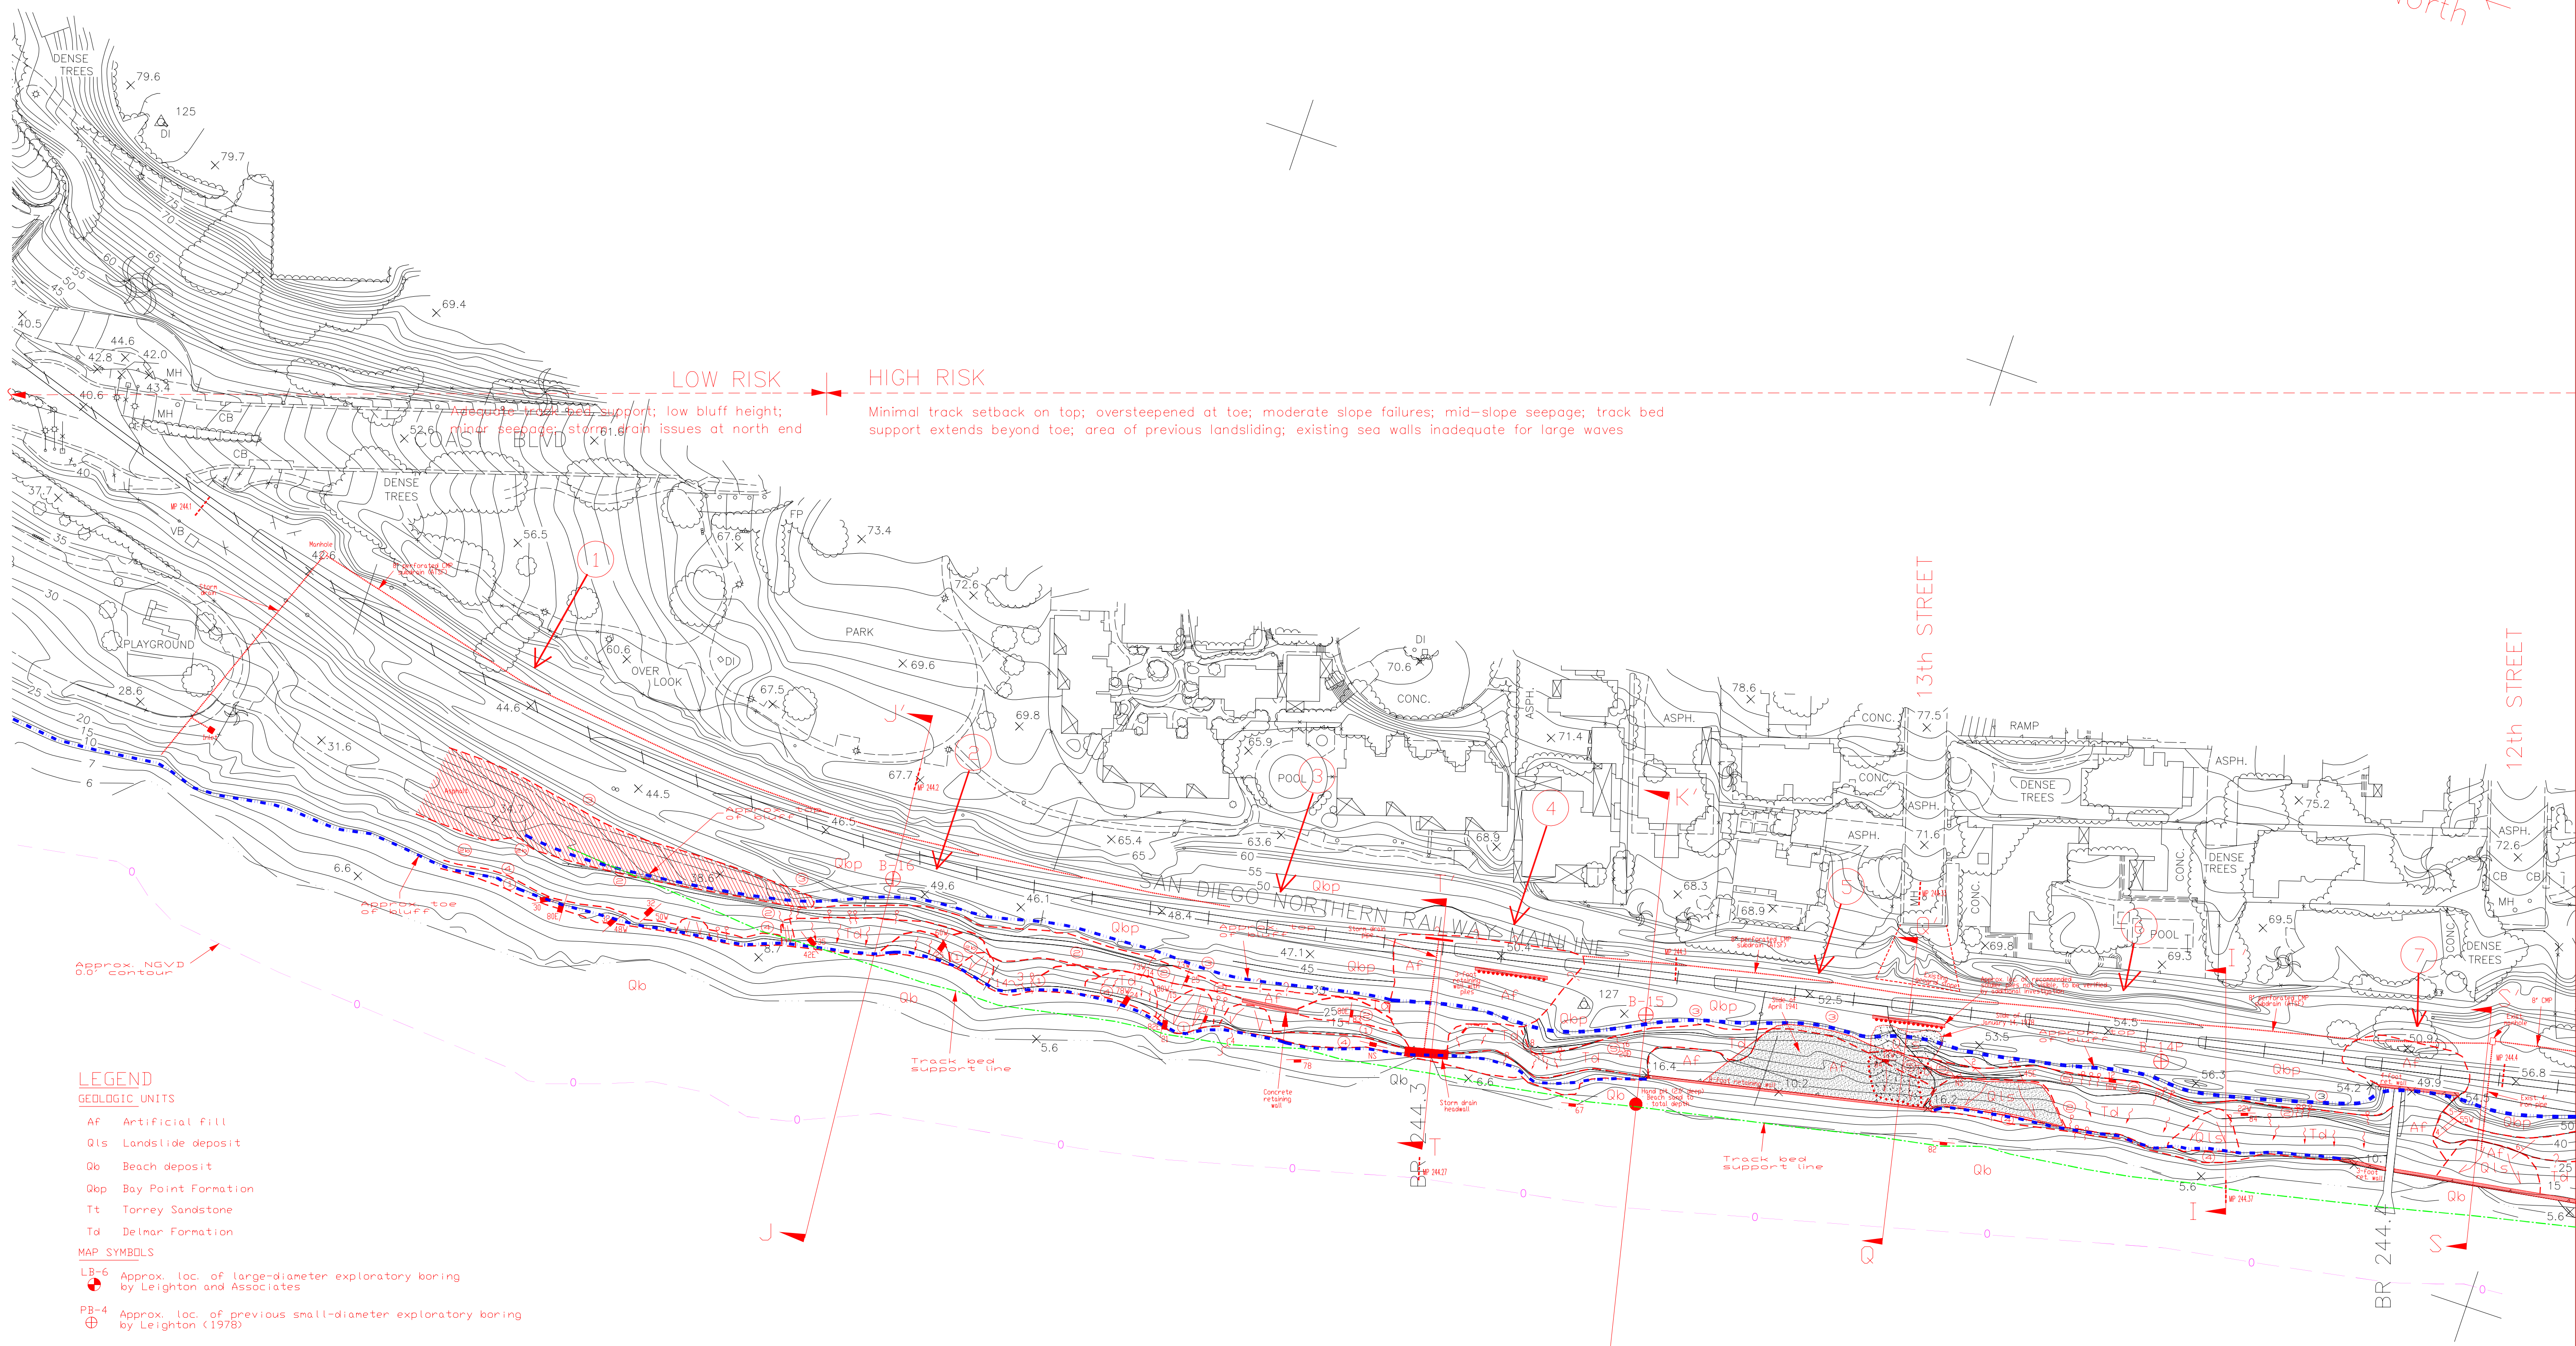
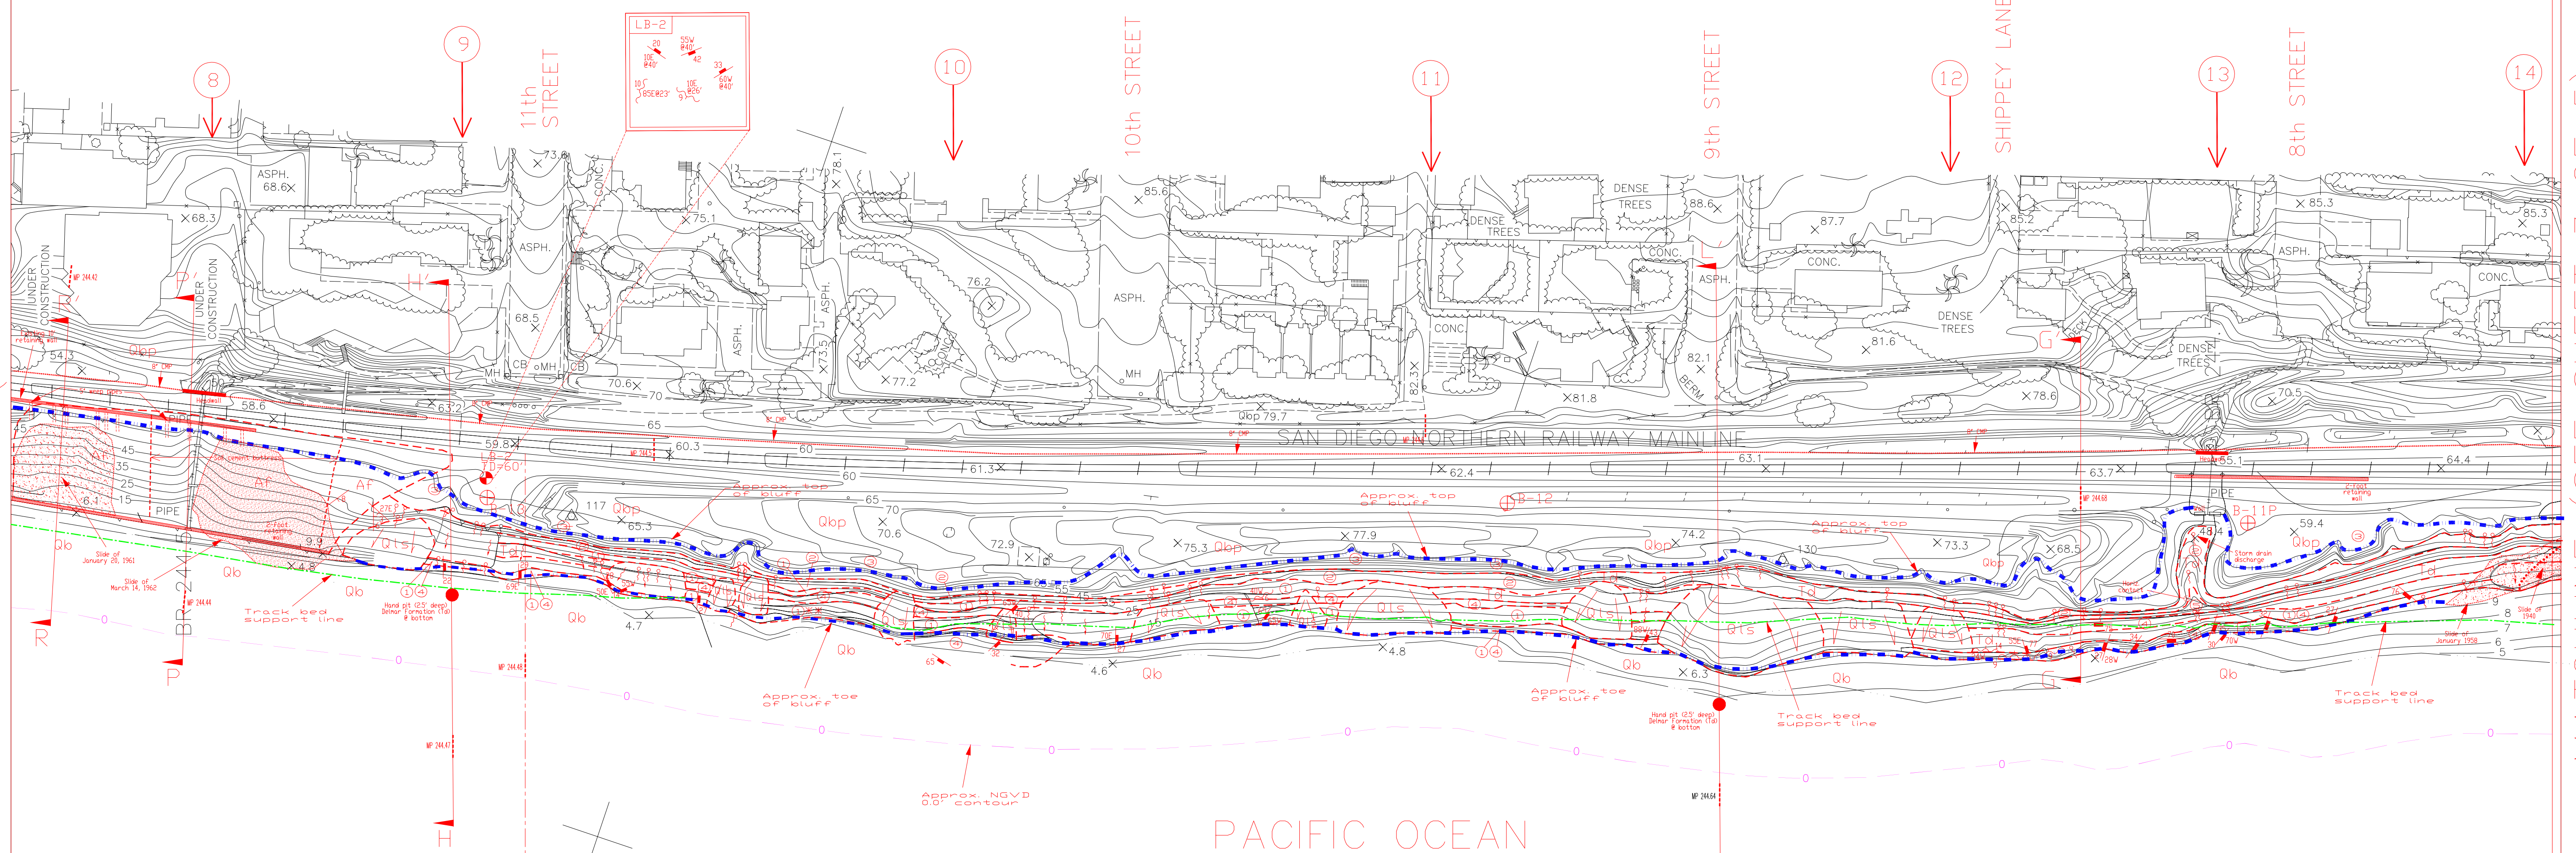
<p>SITE PLAN AND GEOLOGICAL MAP (MP 244.4 to MP 244.75)</p>	040151-001
		PLATE NO. 2
<p>DELMAR BLUFFS GEOTECHNICAL INVESTIGATION</p>		<p>SCALE 1" = 40'</p>
		January 2001

Major oversteepened area; heavy seepage; high foot traffic; major ex. failures; track bed support line extends beyond toe

Moderate seepage; minor failures; moderate oversteepening; some ponding along tracks; adequate track setback to top of bluff; adequate lateral support at toe; high cliffs

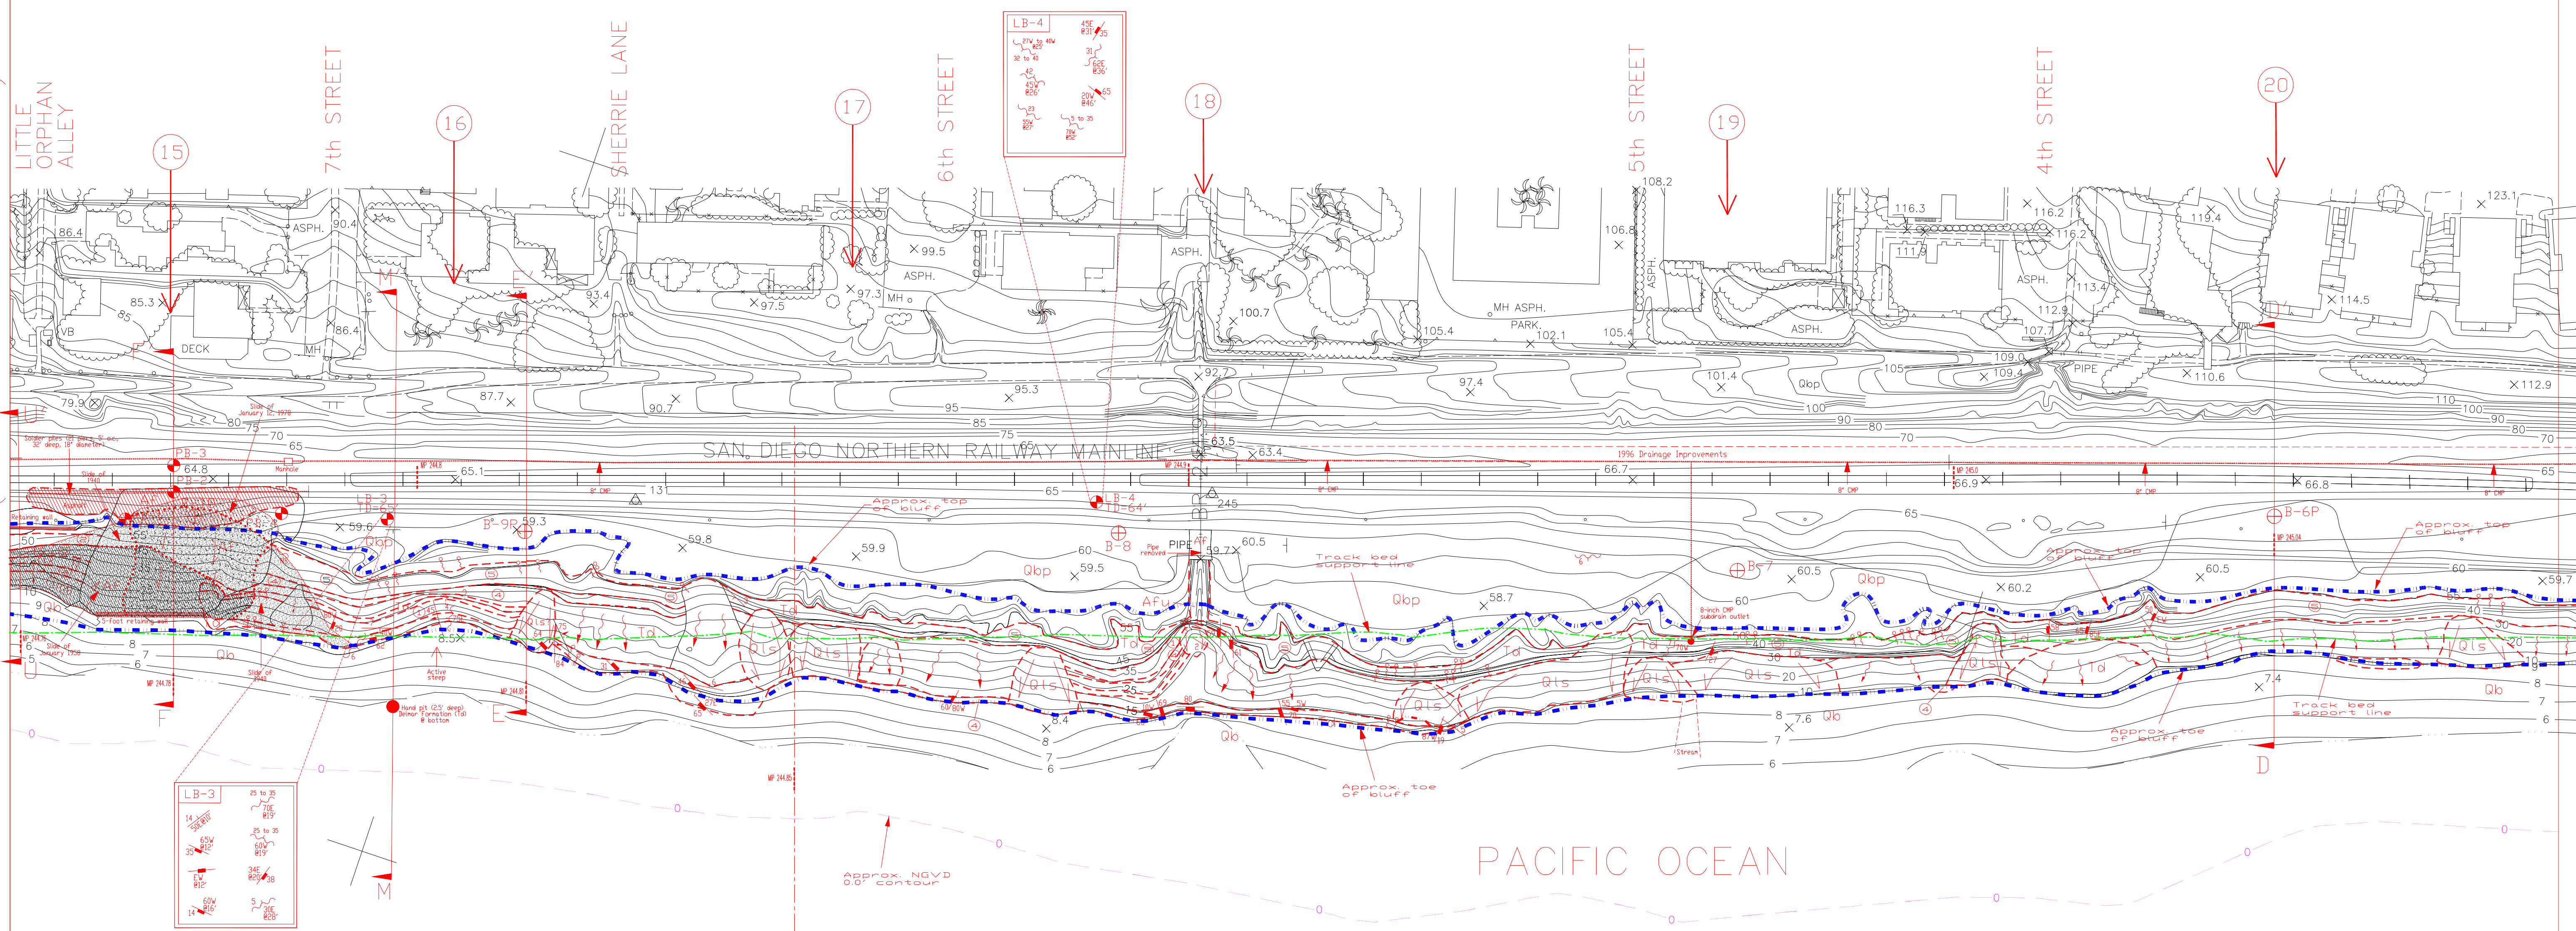
<p>SITE PLAN AND GEOLOGIC MAP (MP 244.75 to MP 245.06)</p>	<p>040151-001 PLATE NO. 3</p>
				<p>SCALE 1" = 40'</p>
<p>DELMAR BLUFFS GEOTECHNICAL INVESTIGATION</p>				<p>January 2001</p>

Minimal track setback in north; existing soldier piles in north; adequate setback in the south; track bed support line at or well behind toe; localized seepage; existing failures in the south

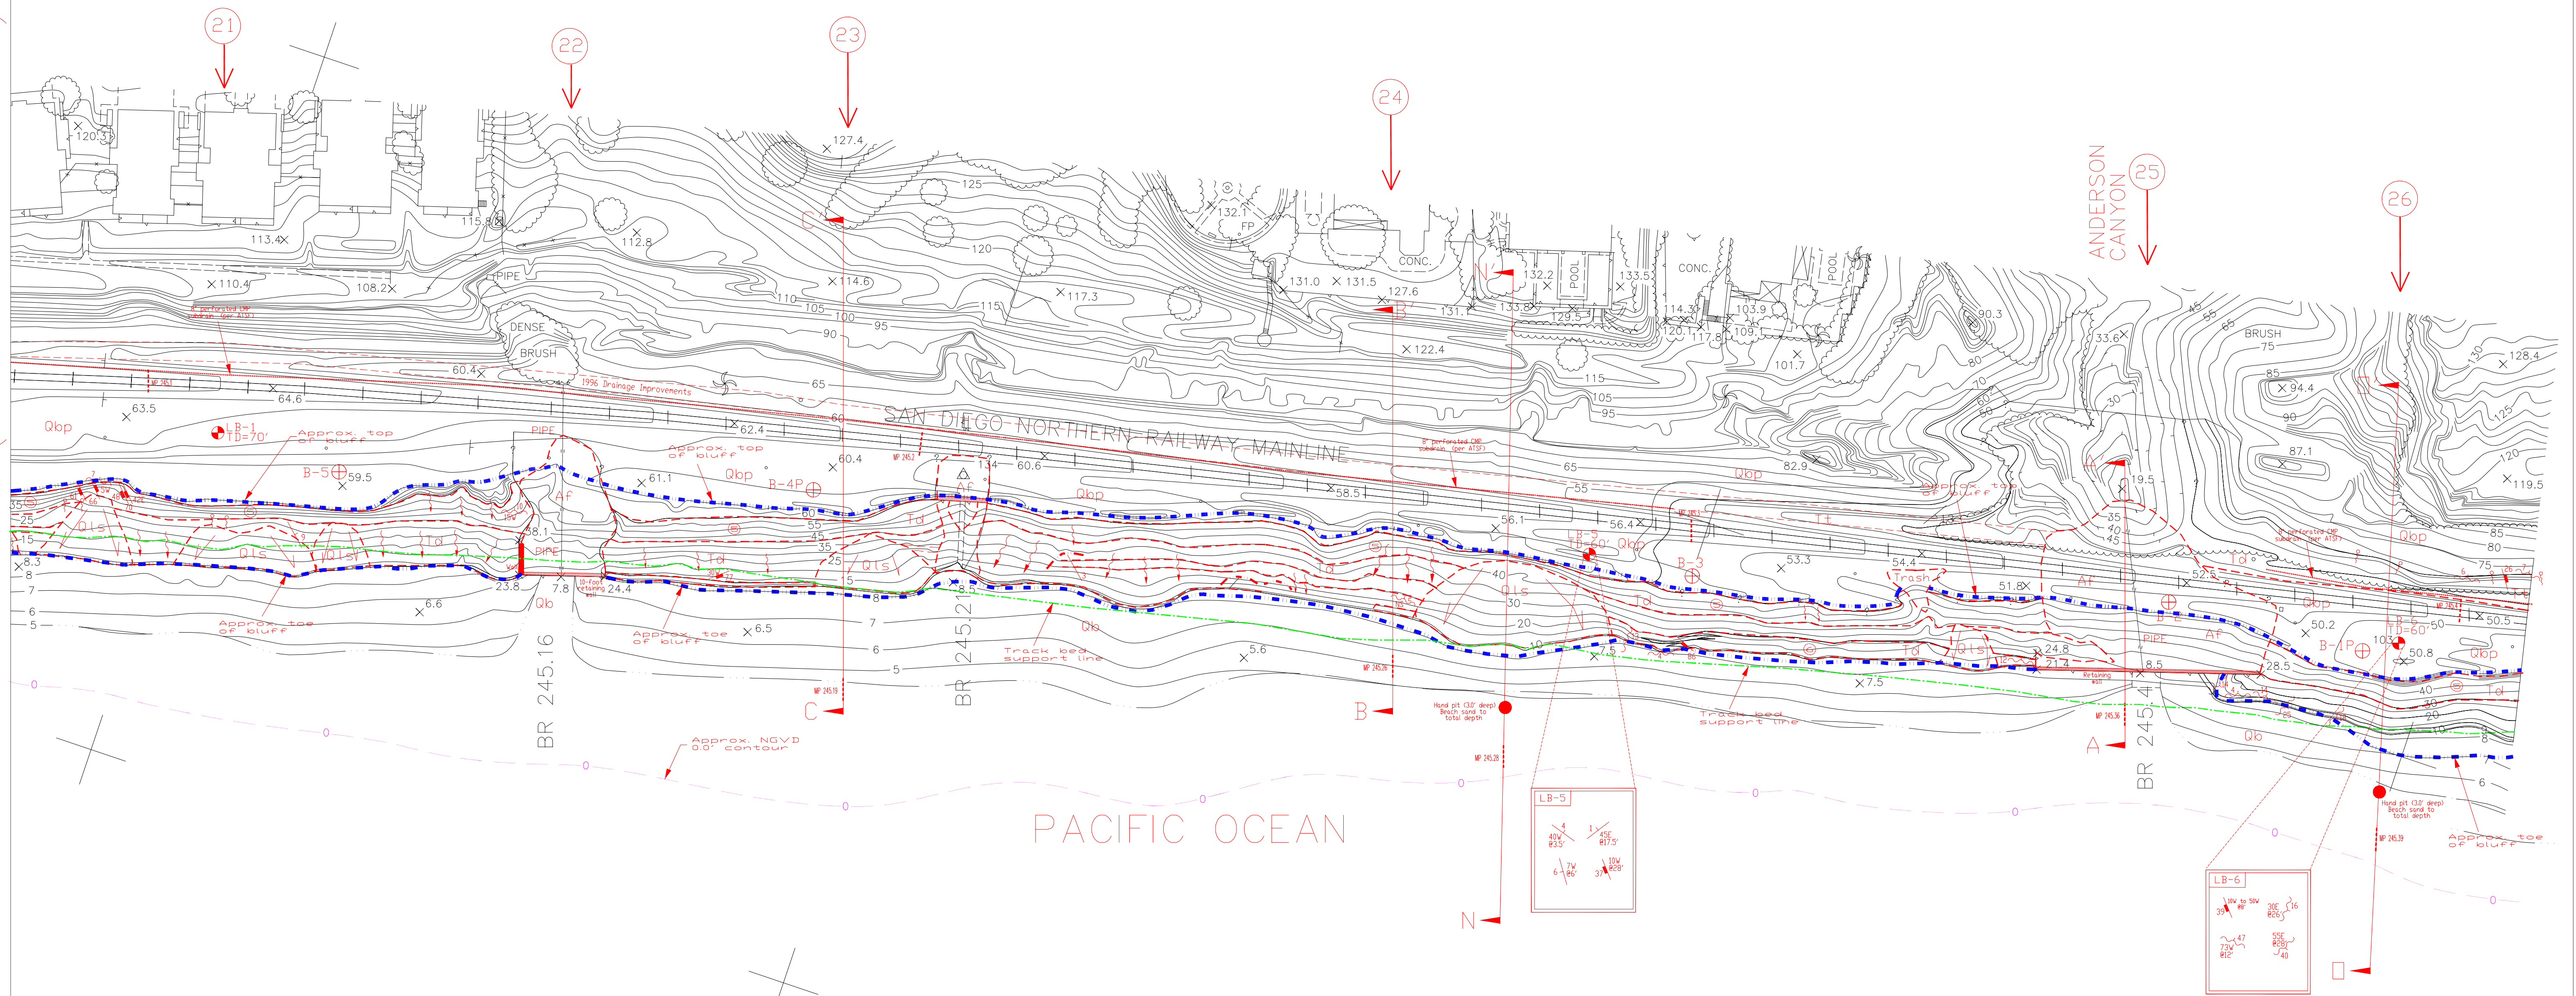
MEDIUM RISK
 Adequate setback at top; track bed support line well behind toe; no foot traffic; minor seepage; moderate oversteepening; minor existing failures

LOW RISK
 Adequate setback at top; lateral support line generally behind toe; minor oversteepening; no seepage; no foot traffic

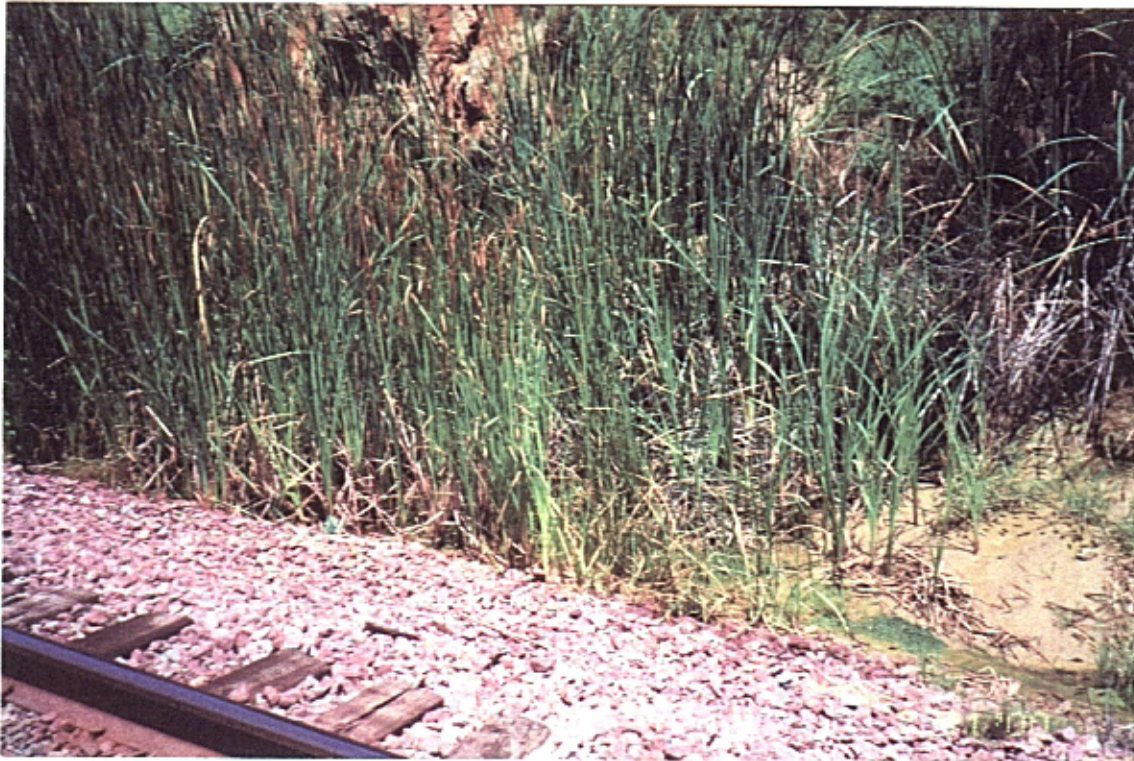
PHOTO NO. 3

Erosional gulley near tracks, northern section.

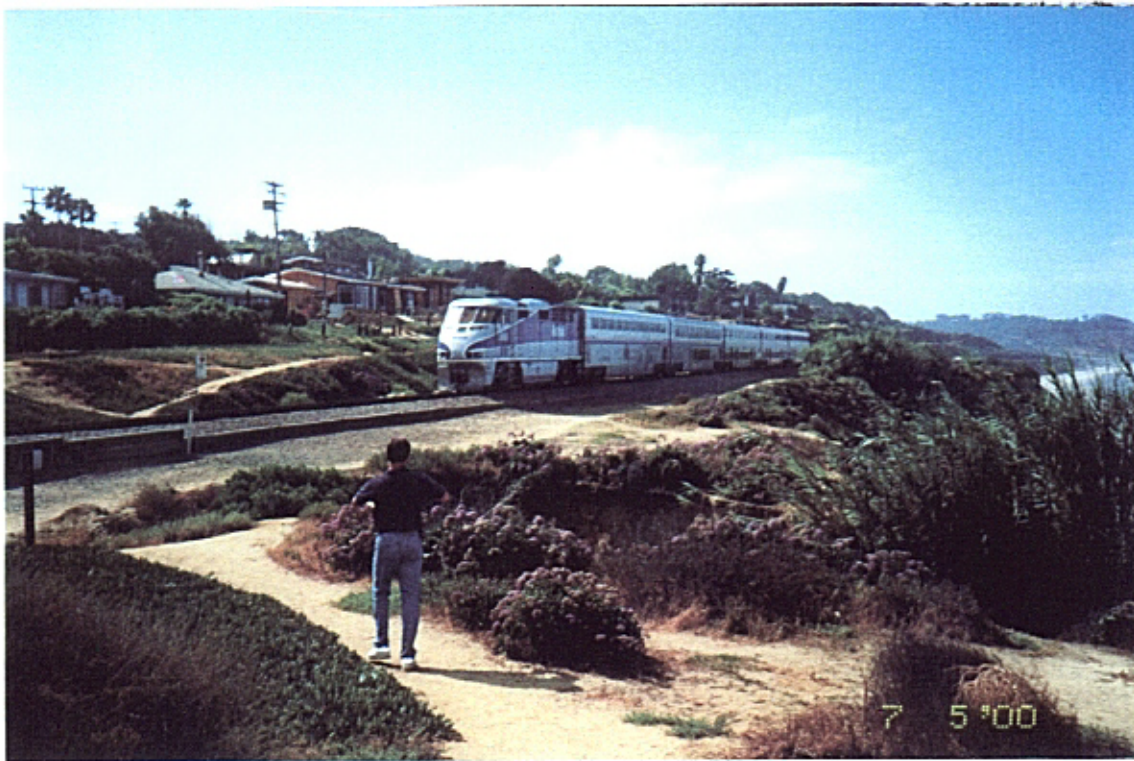
PHOTO NO. 4

View north from the central section. Note wide beach, soil cement buttress, and areas of dense vegetation.

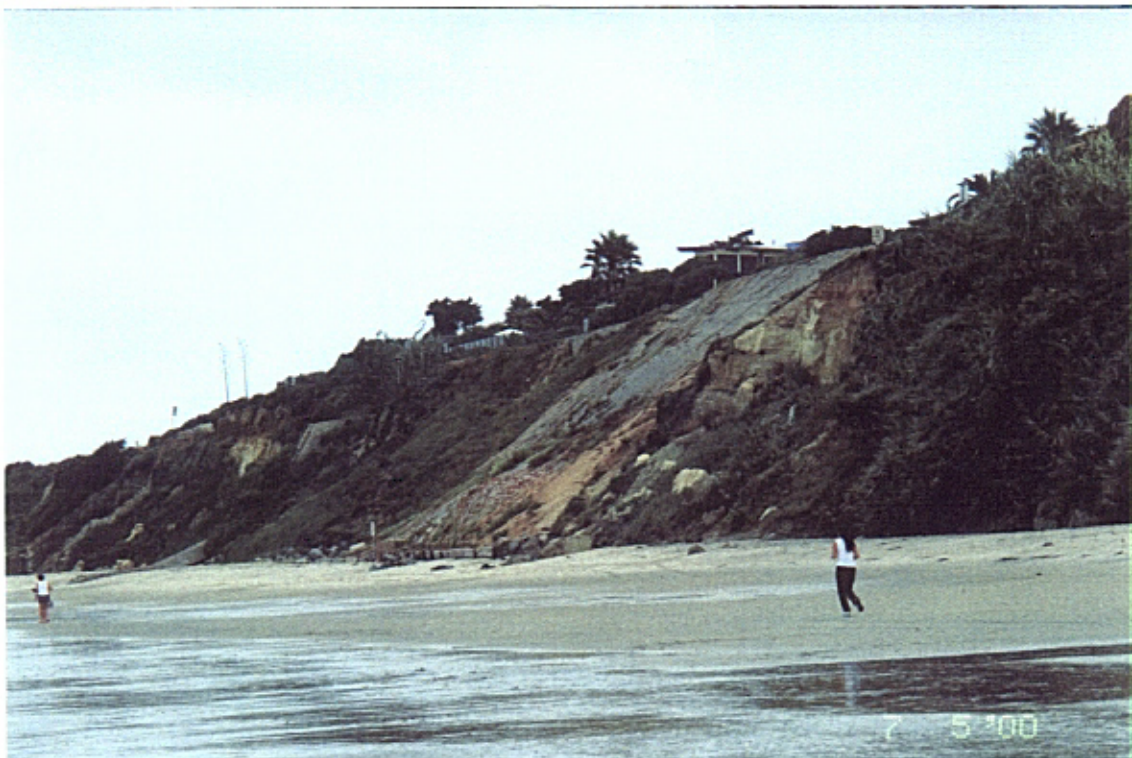
PHOTO NO. 5

Close proximity of tracks to bluff top, northern section.

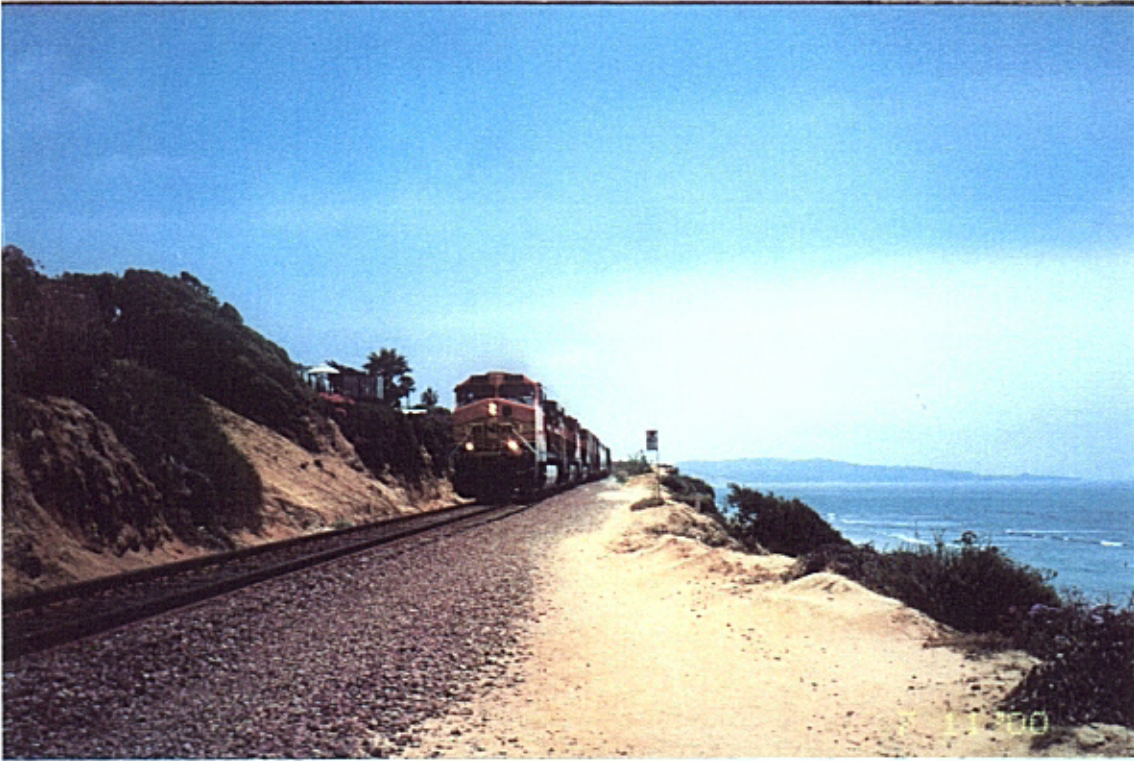
PHOTO NO. 6

Wall supporting tracks, northern section.

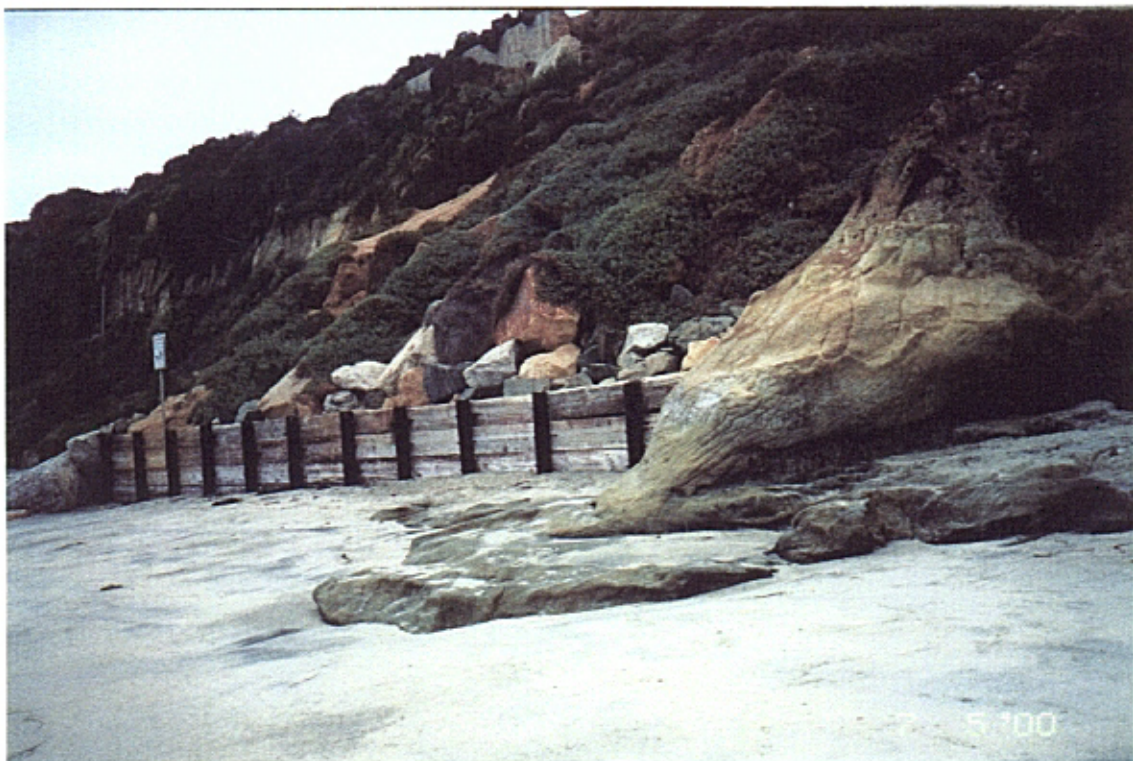
PHOTO NO. 9

Dense vegetation on bluff. Note resistant basal layer in foreground.

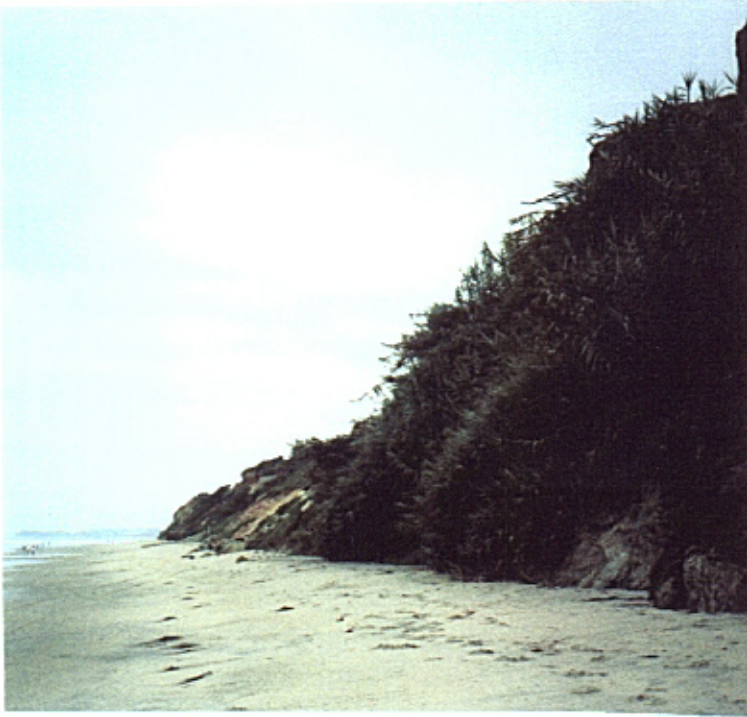
PHOTO NO. 10

Resistant unit at base of bluff, dense vegetation above.

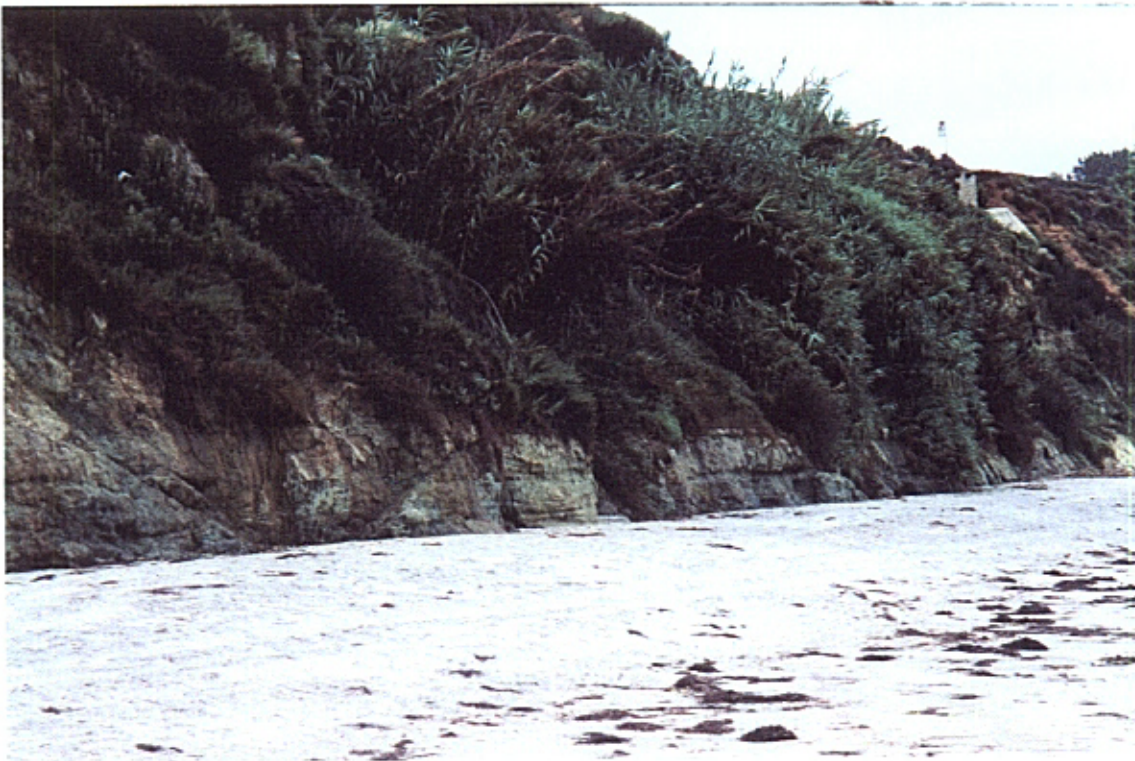
PHOTO NO. 11

The shore platform adjacent to the central section of the bluff is slightly higher than adjacent areas to both the north and the south and can easily be observed at low tide and in review of aerial photographs. This beach platform is essentially flat and exhibits very little evidence of downwearing. In the central portion of the bluff, wooden pilings can be observed that are remnants of the 1885 "Natatorium" which was essentially a walled in swimming area along the beach (see Photo Nos. 11 and 12, Appendix B). Review of historical photos of this structure shows beach widths and bluff configurations similar to those that can be observed today (see Figure 5). In addition, resistant beds can be observed on the bluff at nearly identical locations to those observed today. When reviewing this photo, it is important to note that railroad construction removed a majority of the Bay Point Formation terrace deposits in the northern section. Marine erosion in this section of the bluff consists of relatively minor and infrequent wave action against the base of the bluff. Wave energy is quickly dissipated by the relatively high shore platform that forces most waves to break farther offshore. In addition, the majority of the year there is a sand berm against the resistant bluff base. This sand tends to migrate seasonally with a larger sand berm present in the summer months. While some waves do reach the base of the bluff, these waves have deposited most of their energy in the offshore zone. As such, the majority of the waves to reach the base of the bluff typically lack energy and generally only wash against the base of the bluff. Therefore, the only waves to actually reach the base of the bluff with significant energy to cause serious erosion will be large storm waves that would be coupled with a high tide during periods where low sand levels are present on the beach. This combination of events significantly reduces the frequency of wave attack at the base of the bluff. As

View of flat shore platform in central bluff section.

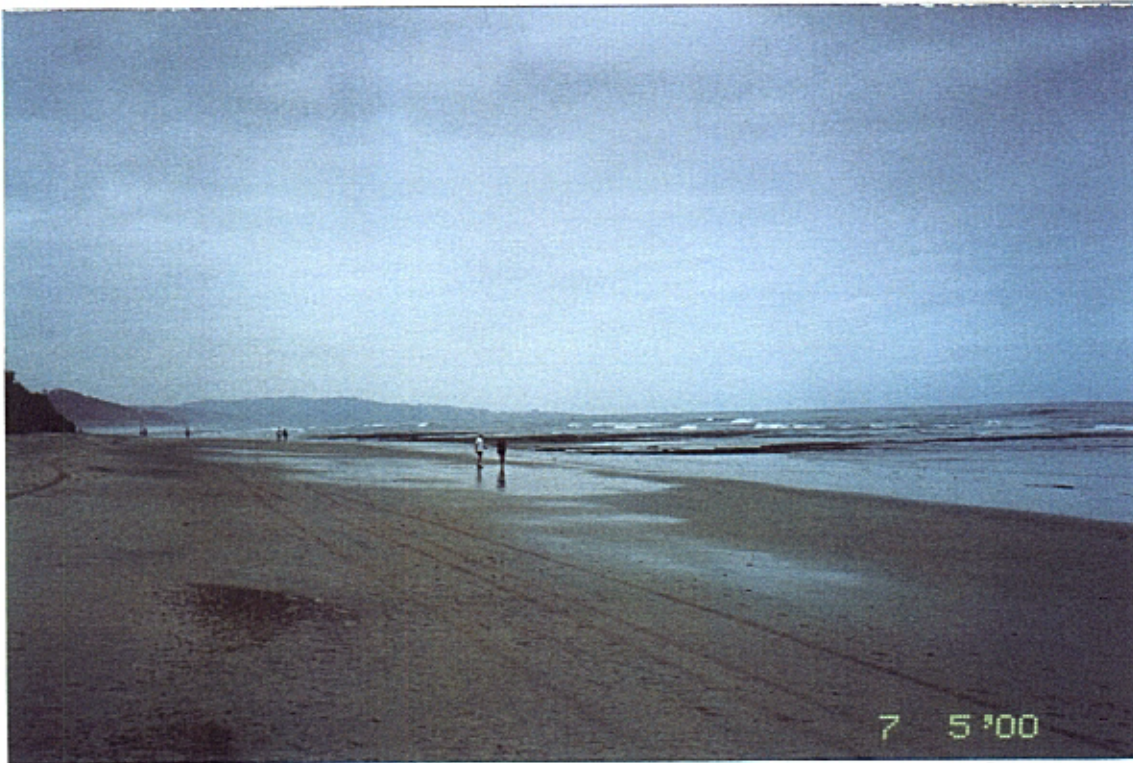
PHOTO NO. 12

Horizontal shore platform in central bluff section. Note wooden pilings from 1885 "Natatorium".
