Del Mar Bluffs Geotechnical Study

Part 1: Geotechnical Evaluation
Volume I

DEL MAR BLUFFS GEOTECHNICAL STUDY,
DEL MAR, CALIFORNIA,
PART I - VOLUME NO. 1
GEOTECHNICAL EVALUATION

Project No. 040151-001

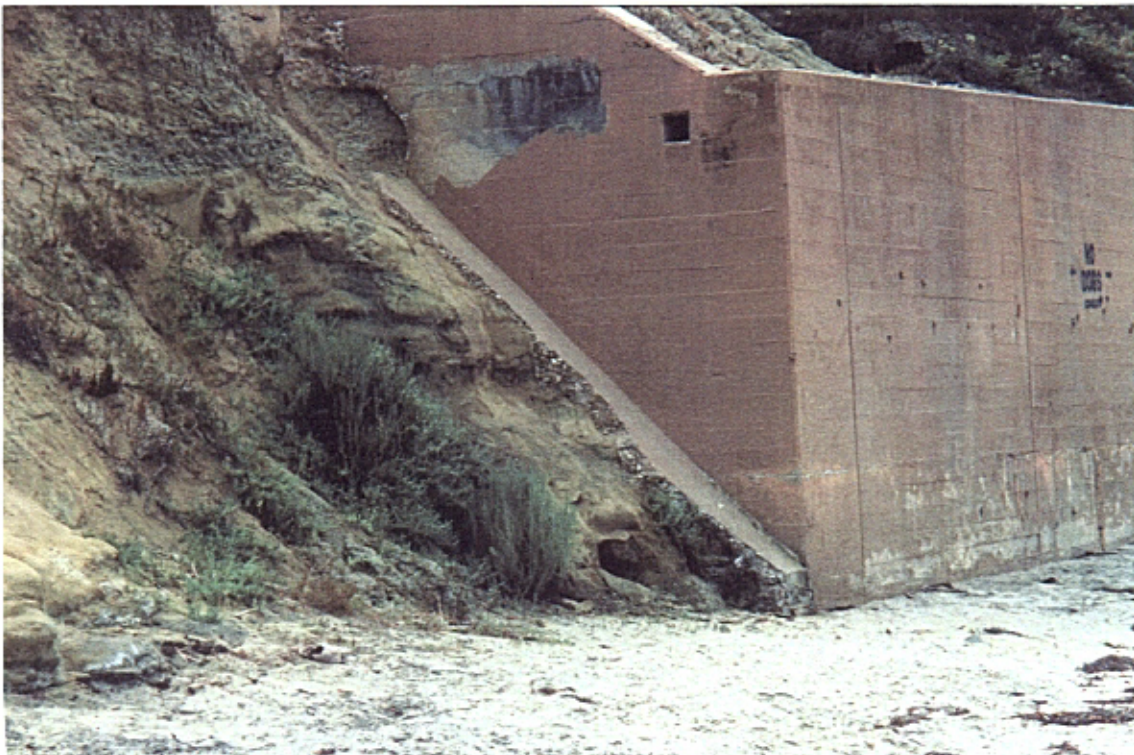
PHOTO NO. 19

As evidenced in Photo Nos. 19 and 21, in Appendix B, this section of bluff forms somewhat of an embayment with a slightly wider beach. Most noticeable in this section is the lack of significant vegetation on the bluff face (Photo No. 24). Two factors appear to influence the lack of vegetation in this area. The first and probably the most significant is the noticeable reduction in seepage through the bluff face. The second is likely the result of a slight increase in erosion rates for this area. The shore platform that is so noticeable to the north is slightly deeper for this area. While the shore platform cannot be observed directly or from aerial photographs, it can be identified by diving in the surf zones. Based on our rough measurements, the shore platform is approximately 3 to 4 feet below the section immediately to the north (see Photo No. 20, Appendix B). The shore platform still appears to be relatively level. Sand width on this section of beach (including sand within the surf zone) is roughly 300 feet.

View of southern section. Note slight embayment.

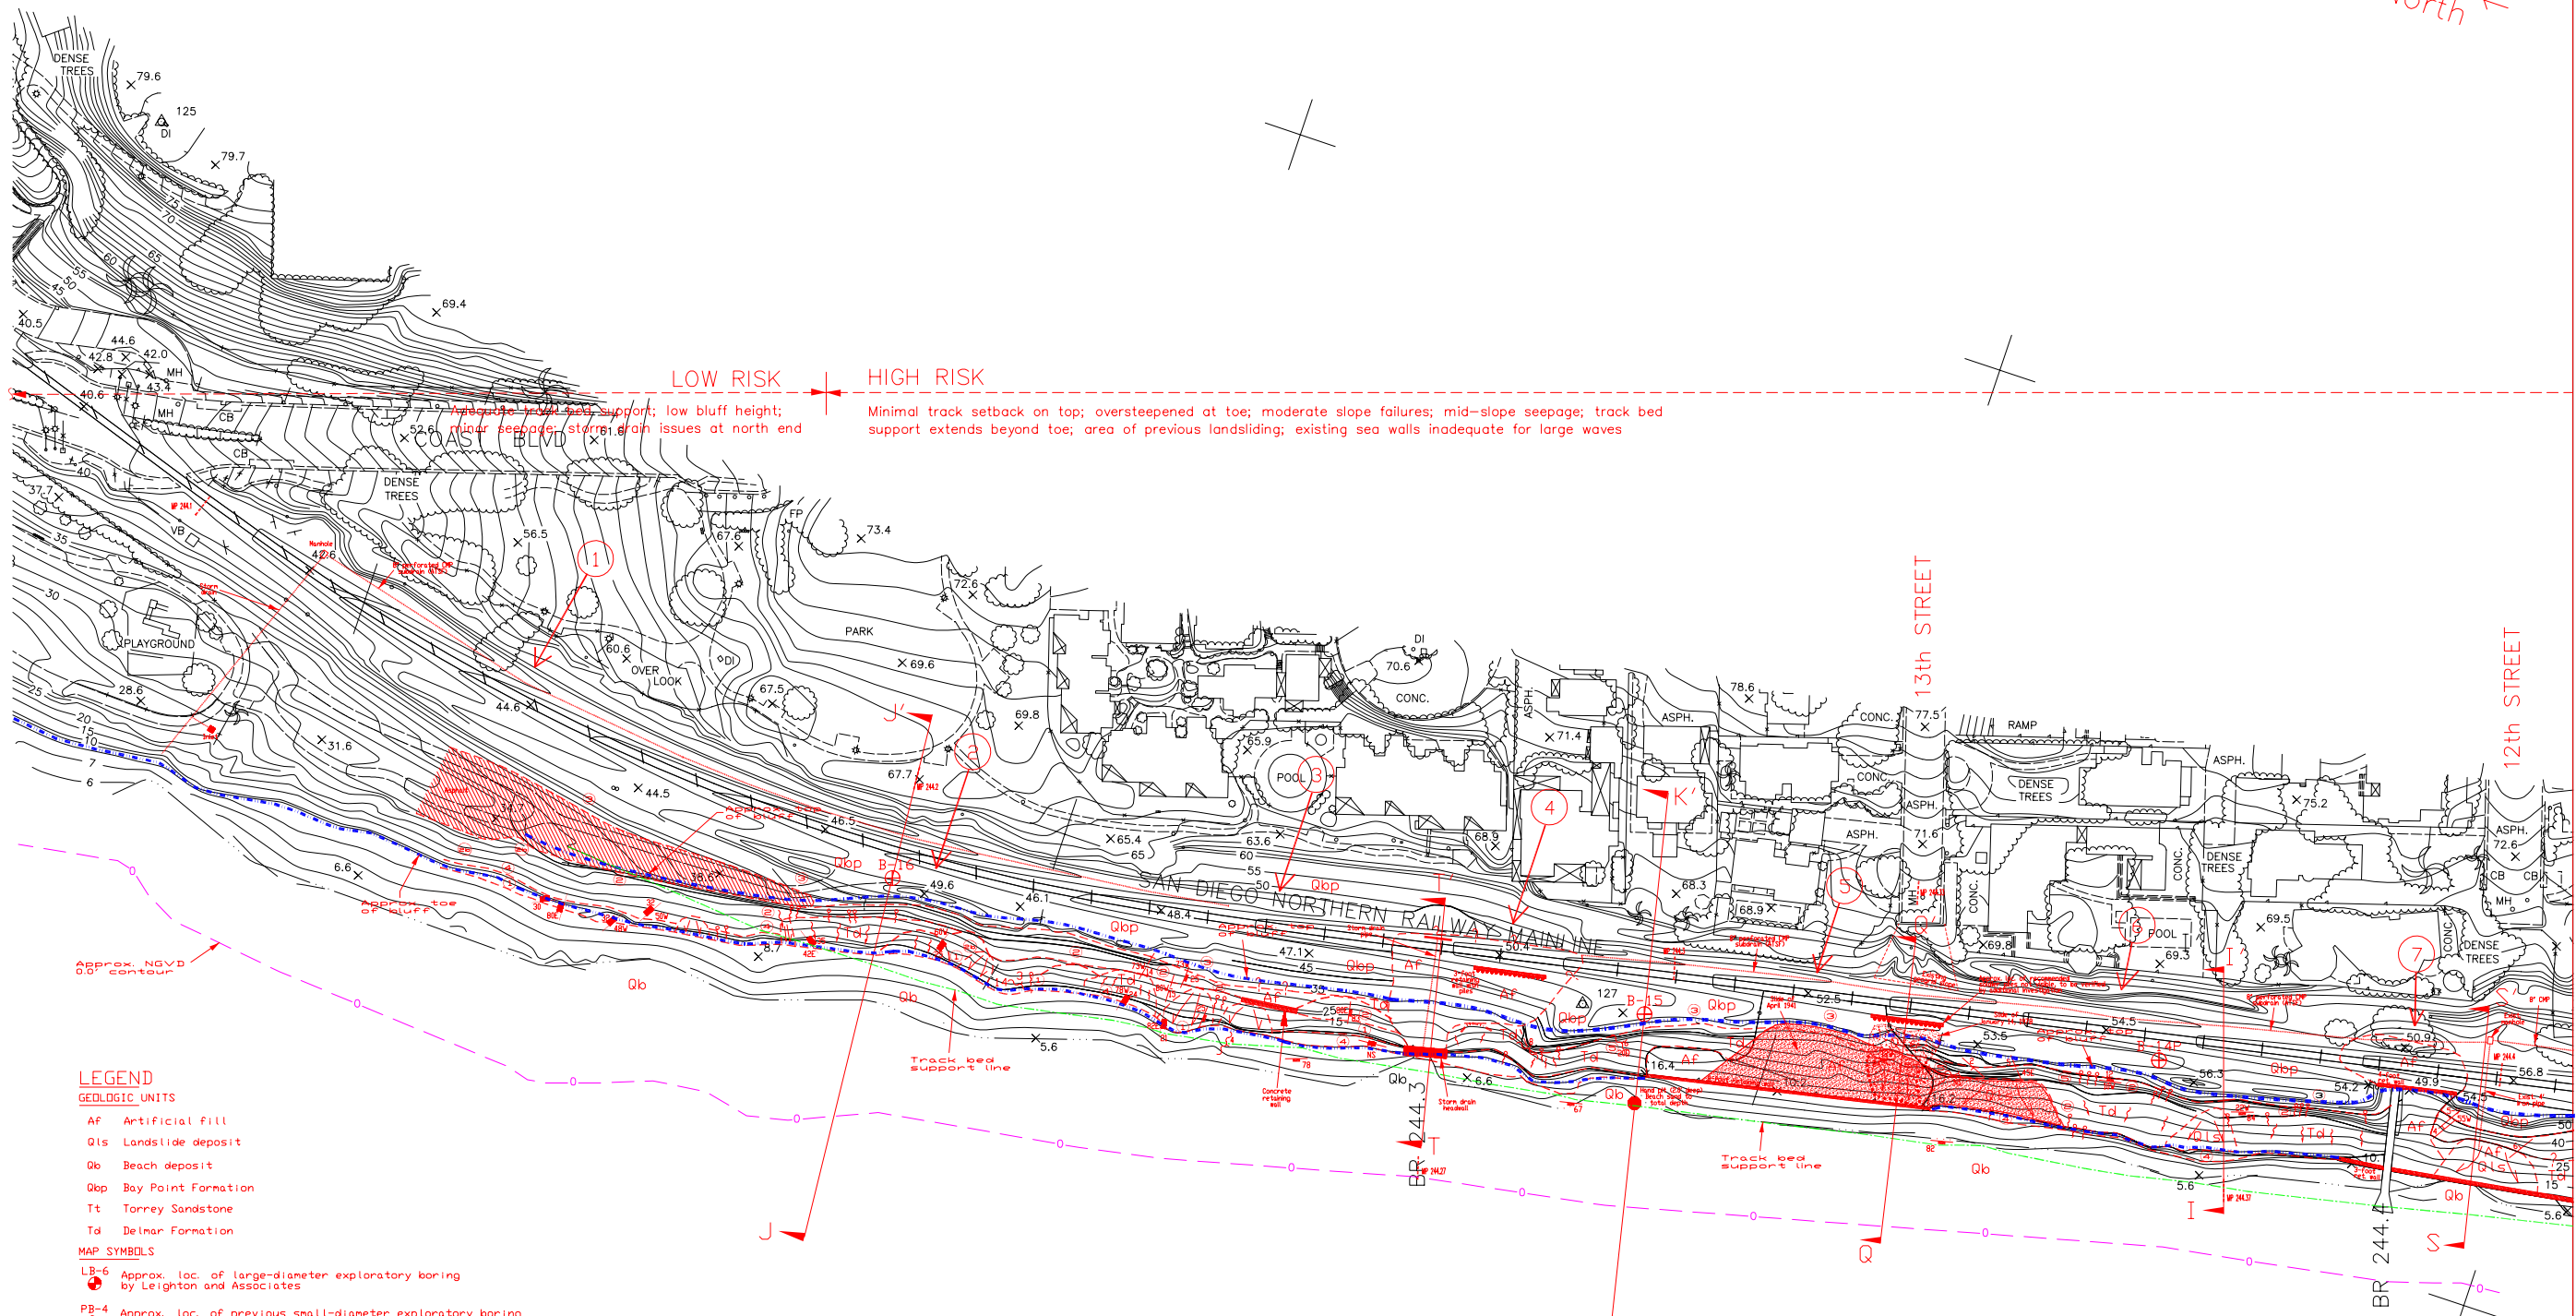
North

Inadequate track bed support; low bluff height; minor seepage; storage drain issues at north end

Minimal track setback on top; oversteepened at toe; moderate slope failures; mid-slope seepage; track bed support extends beyond toe; area of previous landsliding; existing sea walls inadequate for large waves

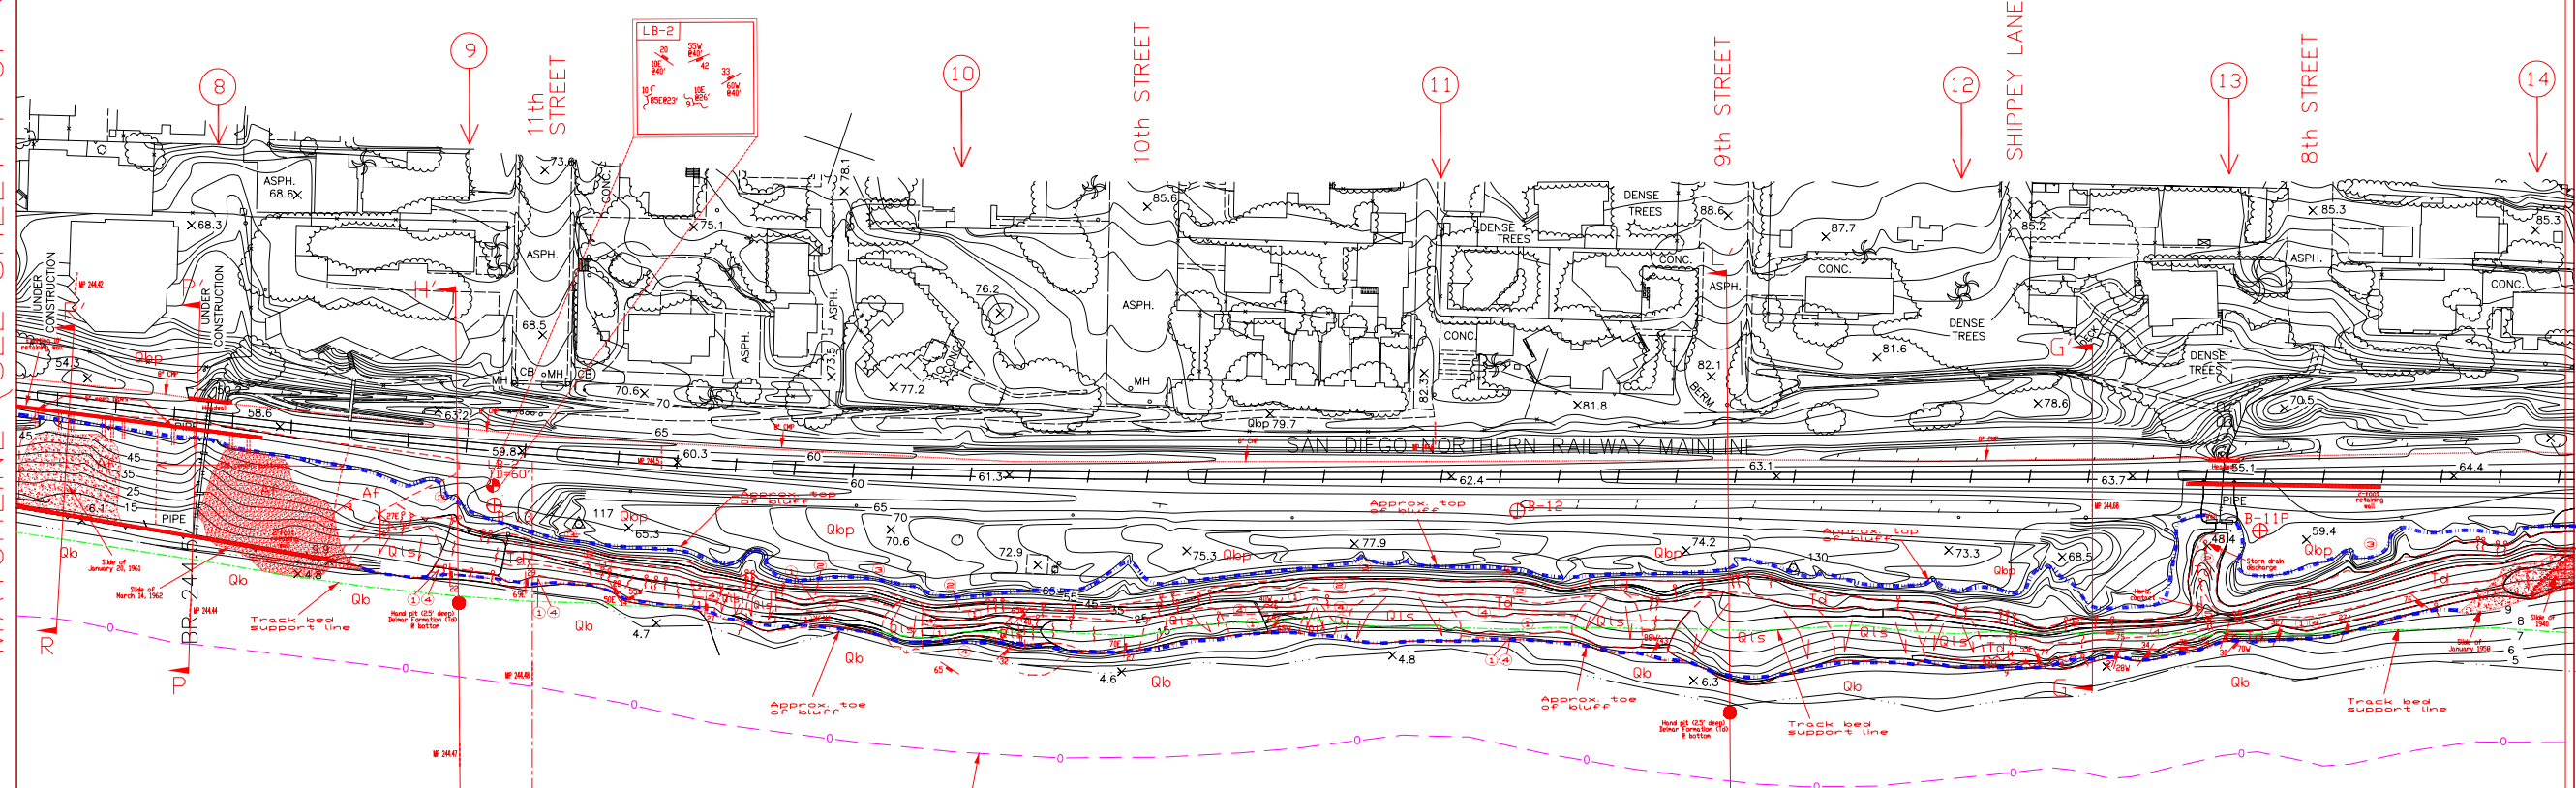
HIGH RISK
Major oversteepened area; heavy seepage; high foot traffic; major ex. failures; track bed support line extends beyond toe

MEDIUM RISK
Moderate seepage; minor failures; moderate oversteepening; some ponding along tracks; adequate track setback to top of bluff; adequate lateral support at toe; high cliffs

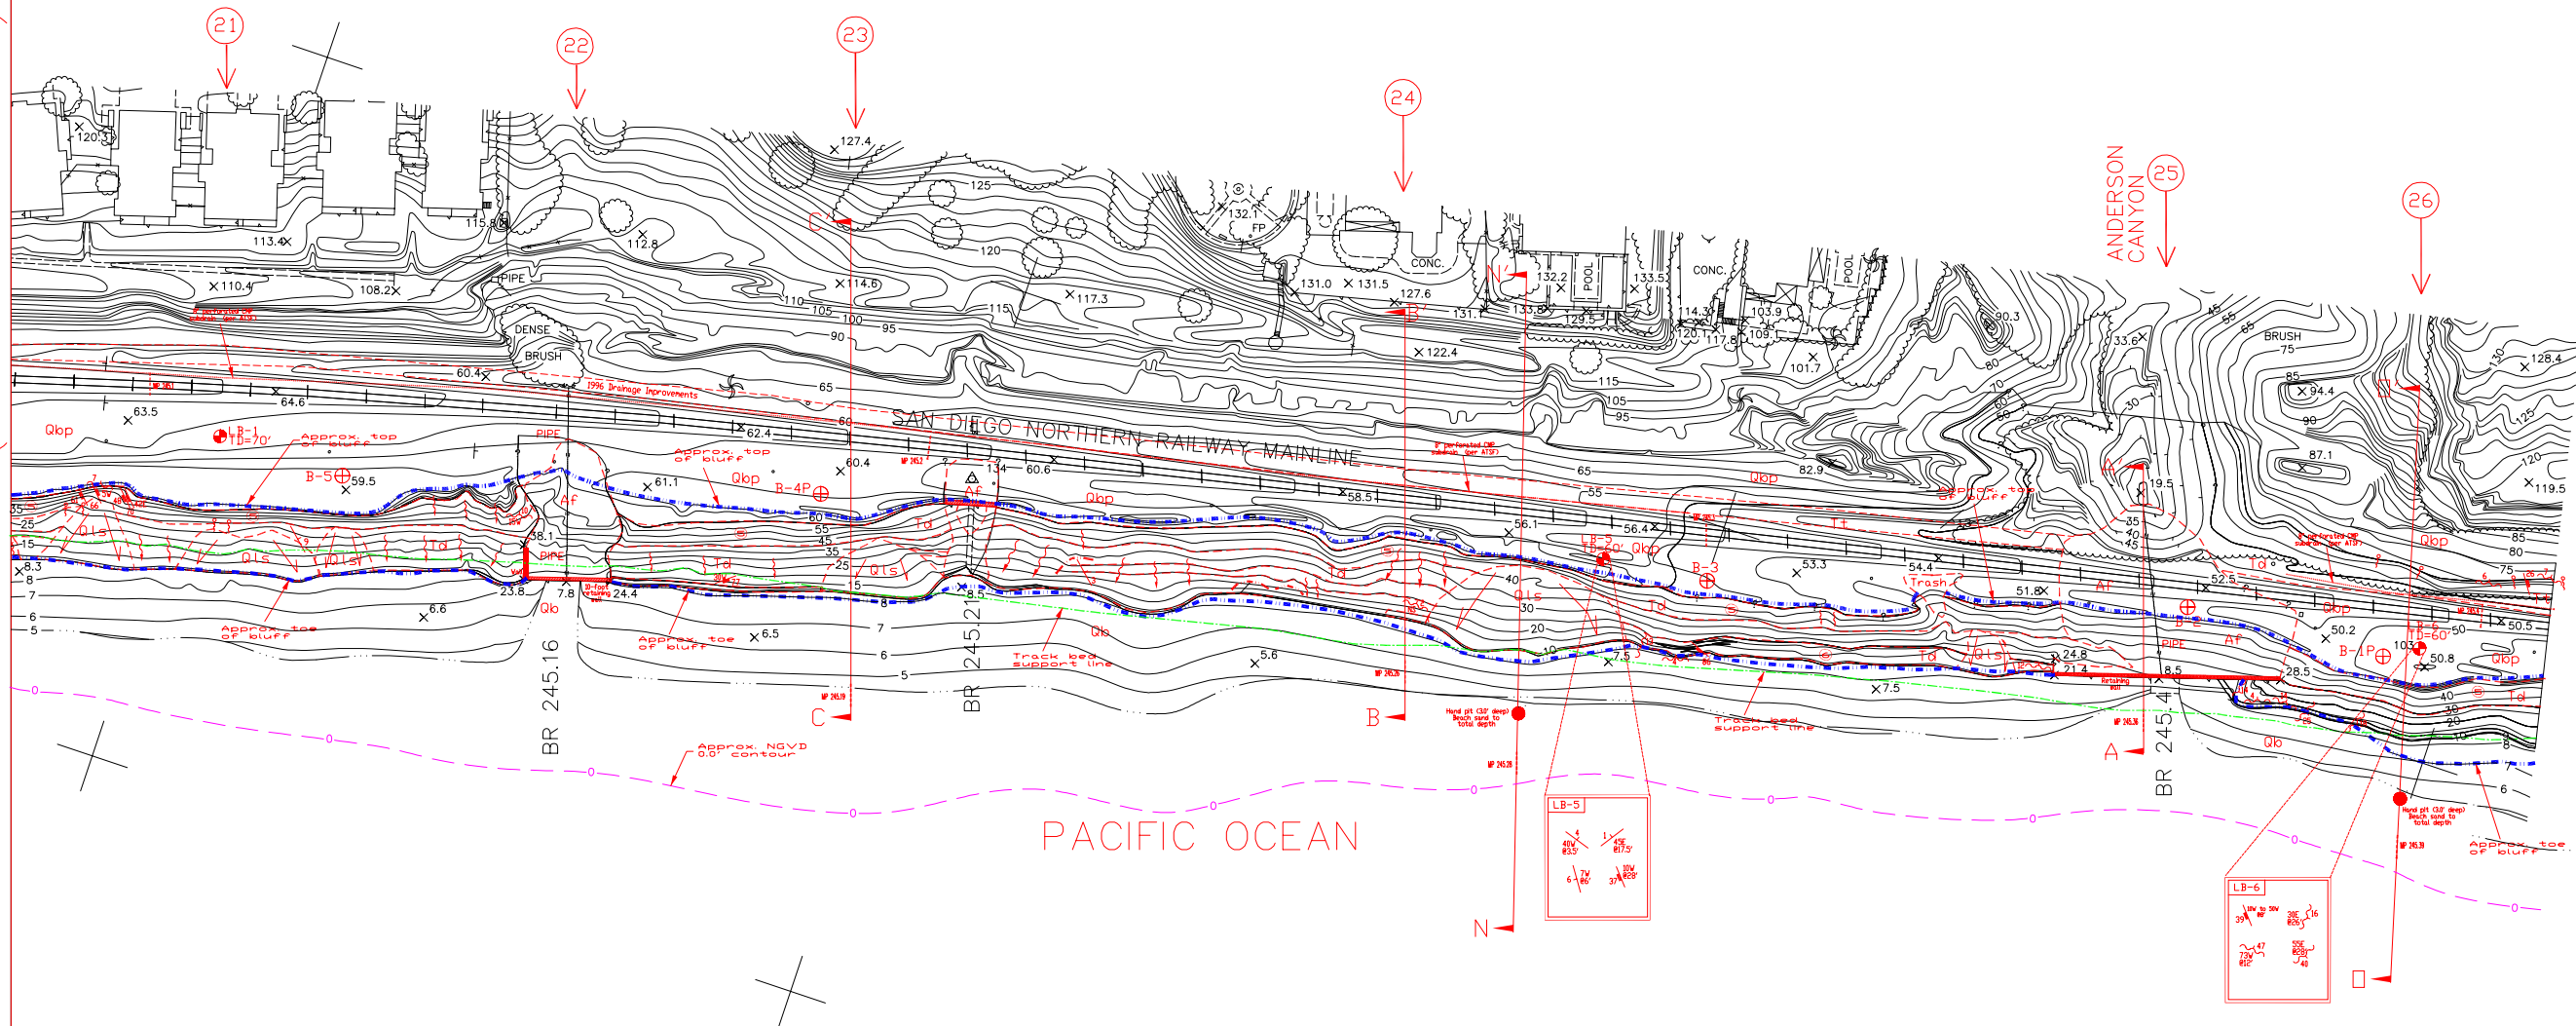
SITE PLAN AND GEOLOGIC MAP
(MP 245.06 to MP 245.4)

Adequate setback at top; track bed support line well behind toe; no foot traffic; minor seepage; moderate oversteepening; minor existing failures

Adequate setback at top; lateral support line generally behind toe; minor oversteepening; no seepage; no foot traffic
