Village Specific Plan  
Visual Impact Assessment

**KTU+A Planning and Landscape Architecture**  
3916 Normal Street  
San Diego, CA 92103

March 13, 2012  
Revised July 5, 2012

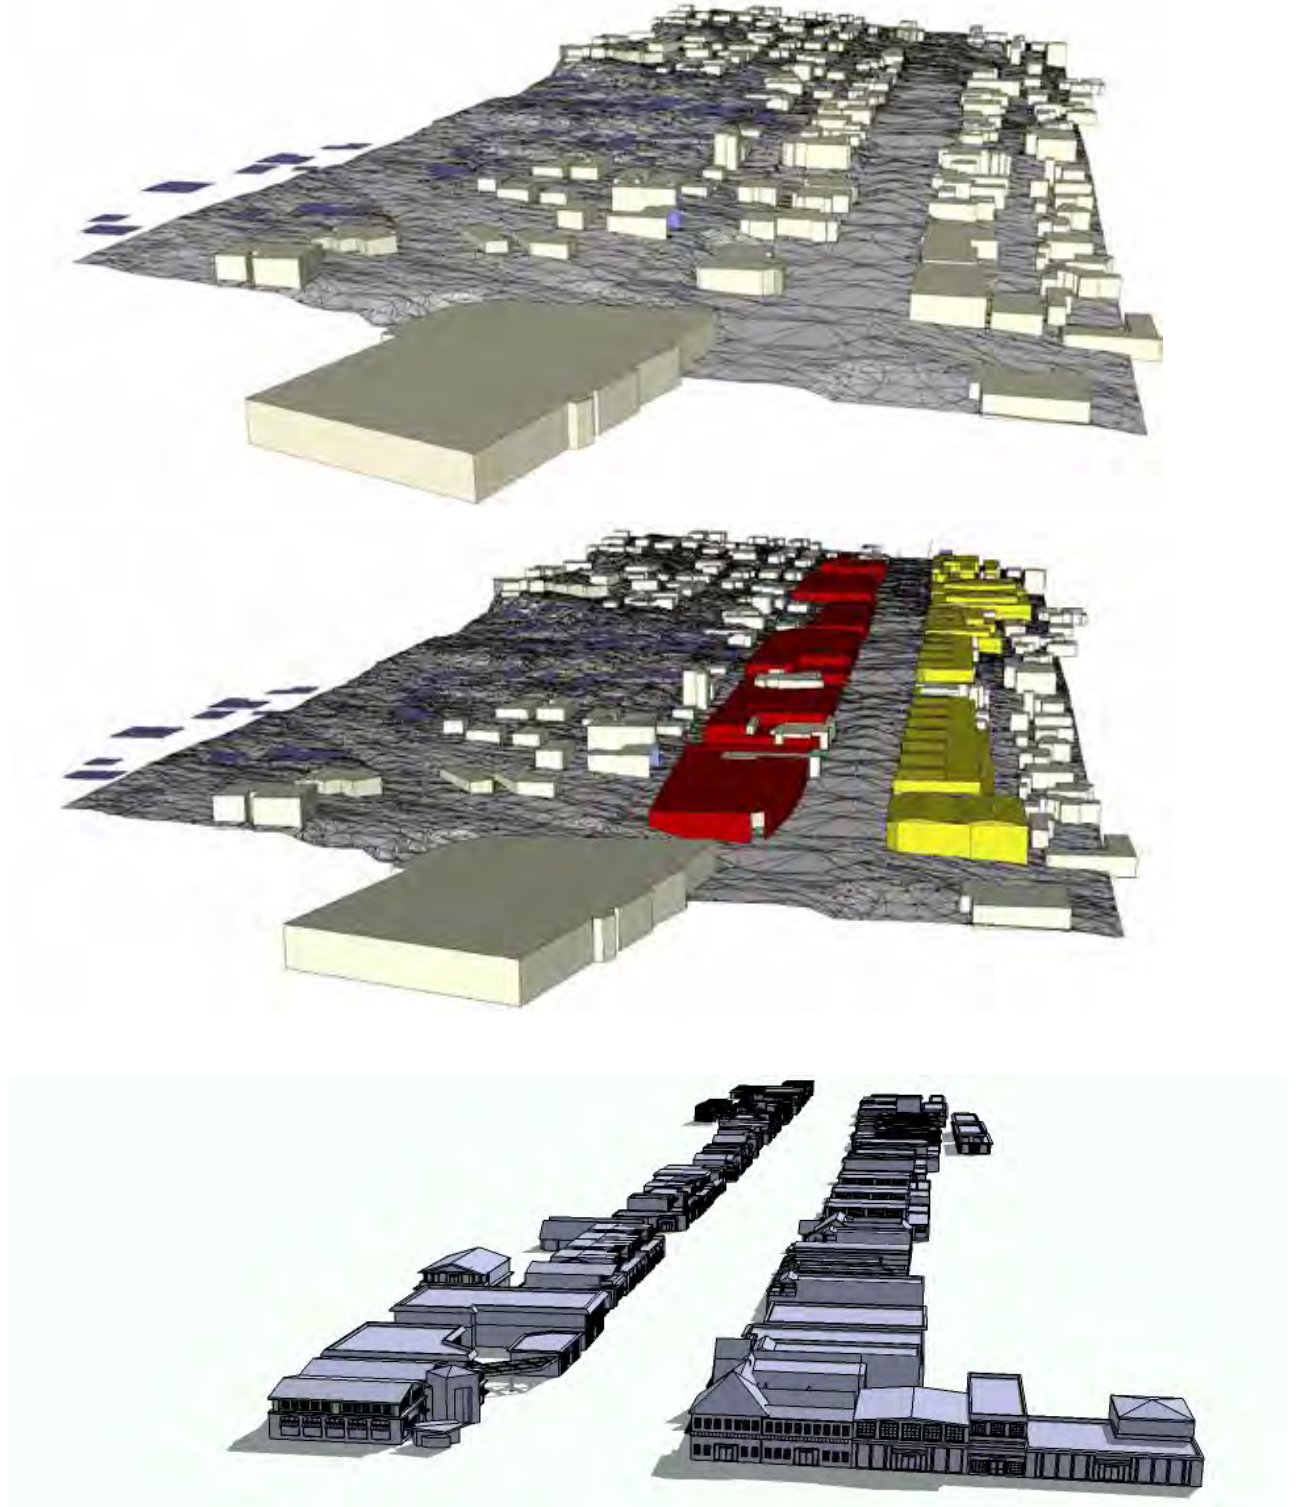
Computer model outputs showing existing buildings (top), maximum building envelopes (middle) and theoretical infill buildings (bottom). These views are looking from the north, by the Del Mar Plaza at 15<sup>th</sup> Street, southward to 9<sup>th</sup> Street.

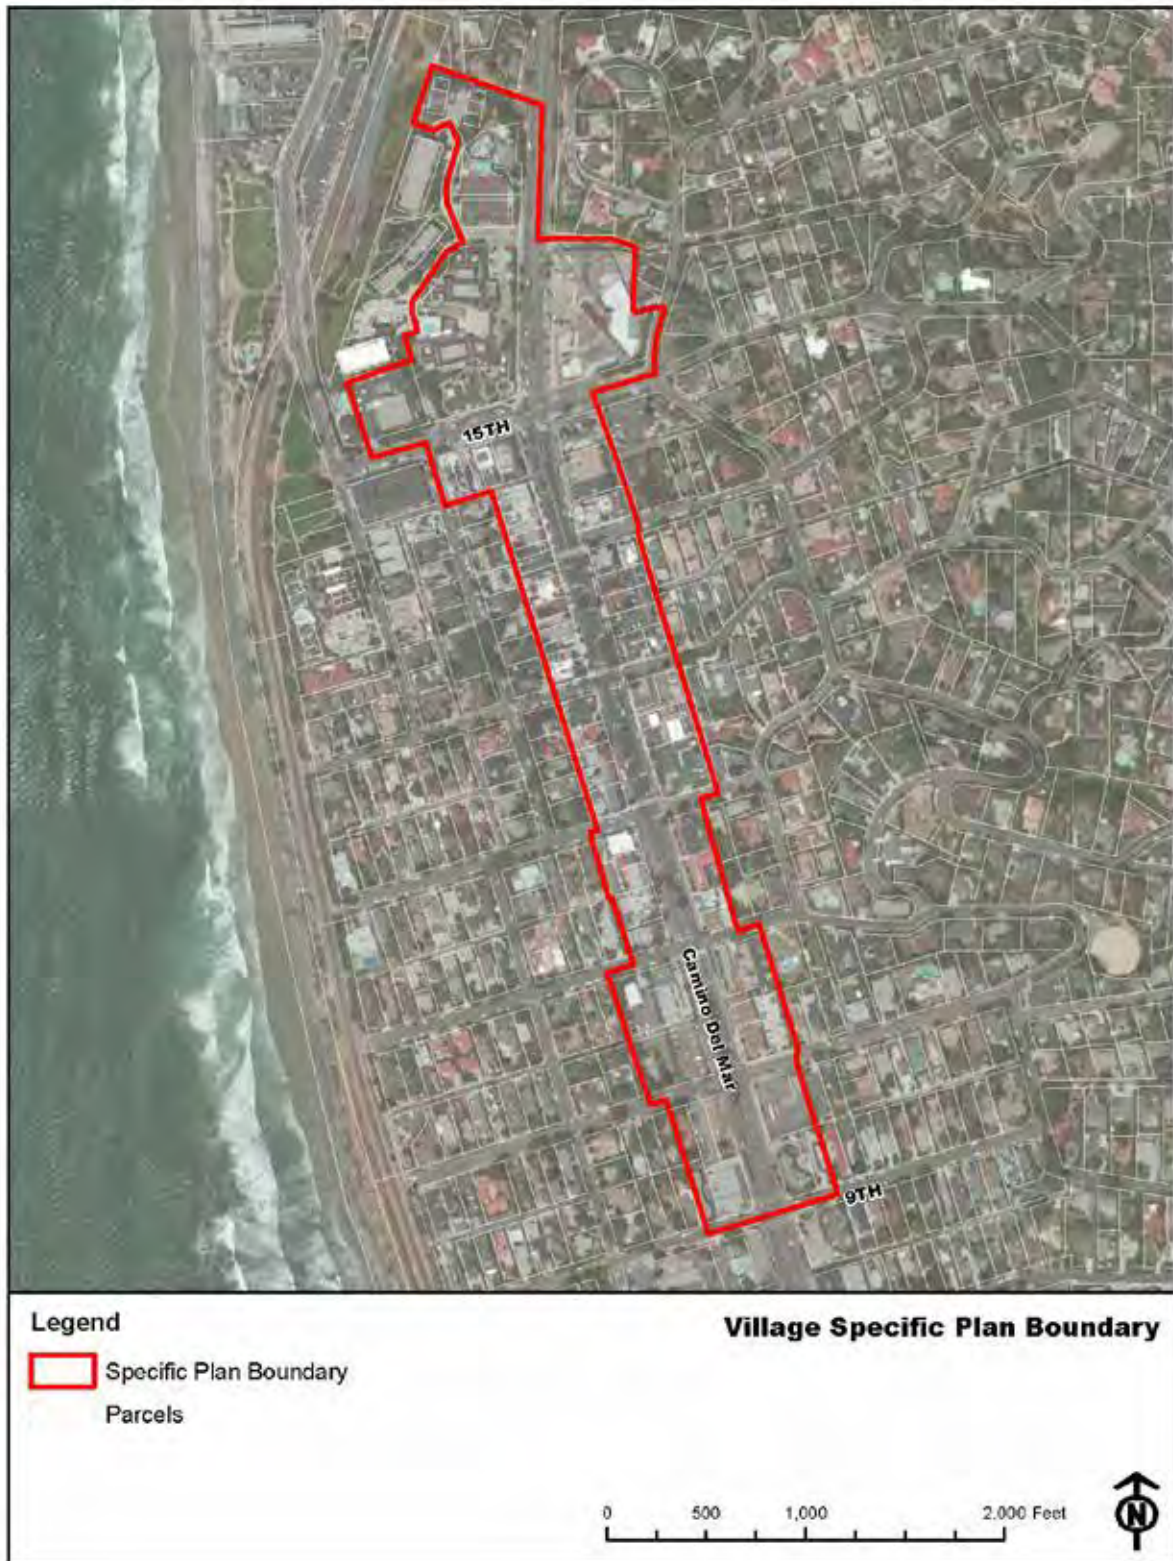
Figure 4-1: Project Location and Village Specific Plan Boundary

The Village Specific Plan boundary is shown in Figure 4-1. The plan occupies approximately 40 acres within the urbanized town center of Del Mar. The Village Specific Plan generally encompasses the central business district corridor that is along Camino del Mar between 9<sup>th</sup> Street and approximately the easterly alignment of 17<sup>th</sup> Street. Additionally, commercial and post office properties along 15<sup>th</sup> Street west to Stratford Court are included.

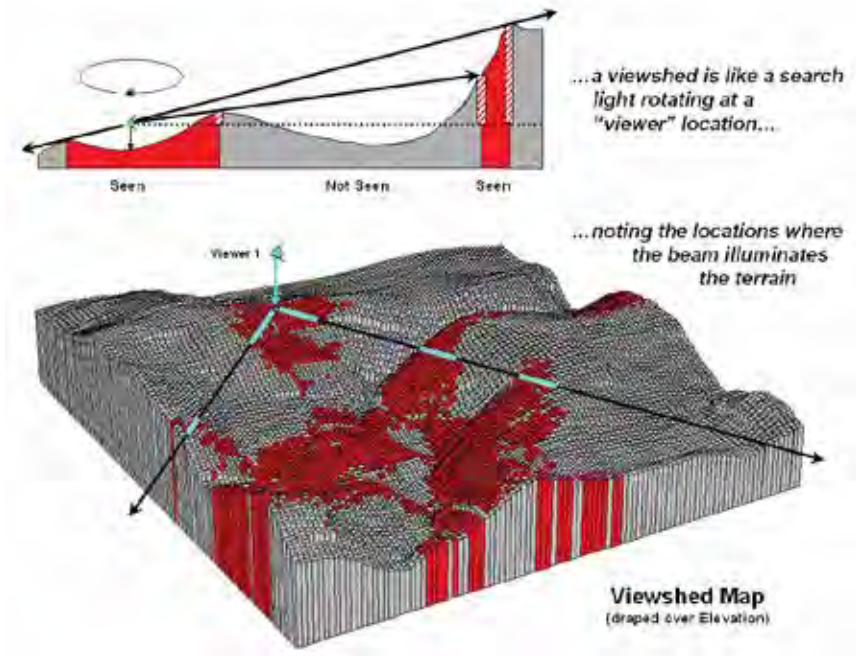
**Figure 4-2: Viewshed and Human Eyesight Dynamics**

How a viewshed works

The dynamics of the Del Mar visual environment requires the development of two distinctively different viewshed types. Views of the Pacific Ocean are an important aspect of living in Del Mar. They affect property values and the quality of life. Though one large body of water, the ocean in visual terms has: a horizon line or background view; an open water view or middle ground view; and a coastal beach / shore view or a foreground view. The proposed buildings on Camino del Mar have the potential of blocking views of the ocean by interceding or piercing the view corridor. A viewshed model was developed first to determine the leading edge of the ocean as seen by all of the residents on the slopes east of Camino del Mar. Then, the leading edge of this view was selected and a viewshed model was developed to show the areas that can see the multiple points along this linear leading edge in the ocean. Interceding buildings along Camino del Mar, as well as other topography in the area, determine what can see this leading edge and what cannot (see Figure 4-4). It should be noted that vegetation and other buildings outside the Specific Plan area are not in the model, so the results should be considered as the worst-case situation. The real viewshed model can be dramatically less than this due to other buildings and vegetation. The computer model was then modified to include increased building heights allowed in the Specific Plan and another viewshed model was calculated (see Figure 4-5). Finally, the difference between the current viewshed and the proposed viewshed based on the building height differences was calculated (see Figure 4-6).

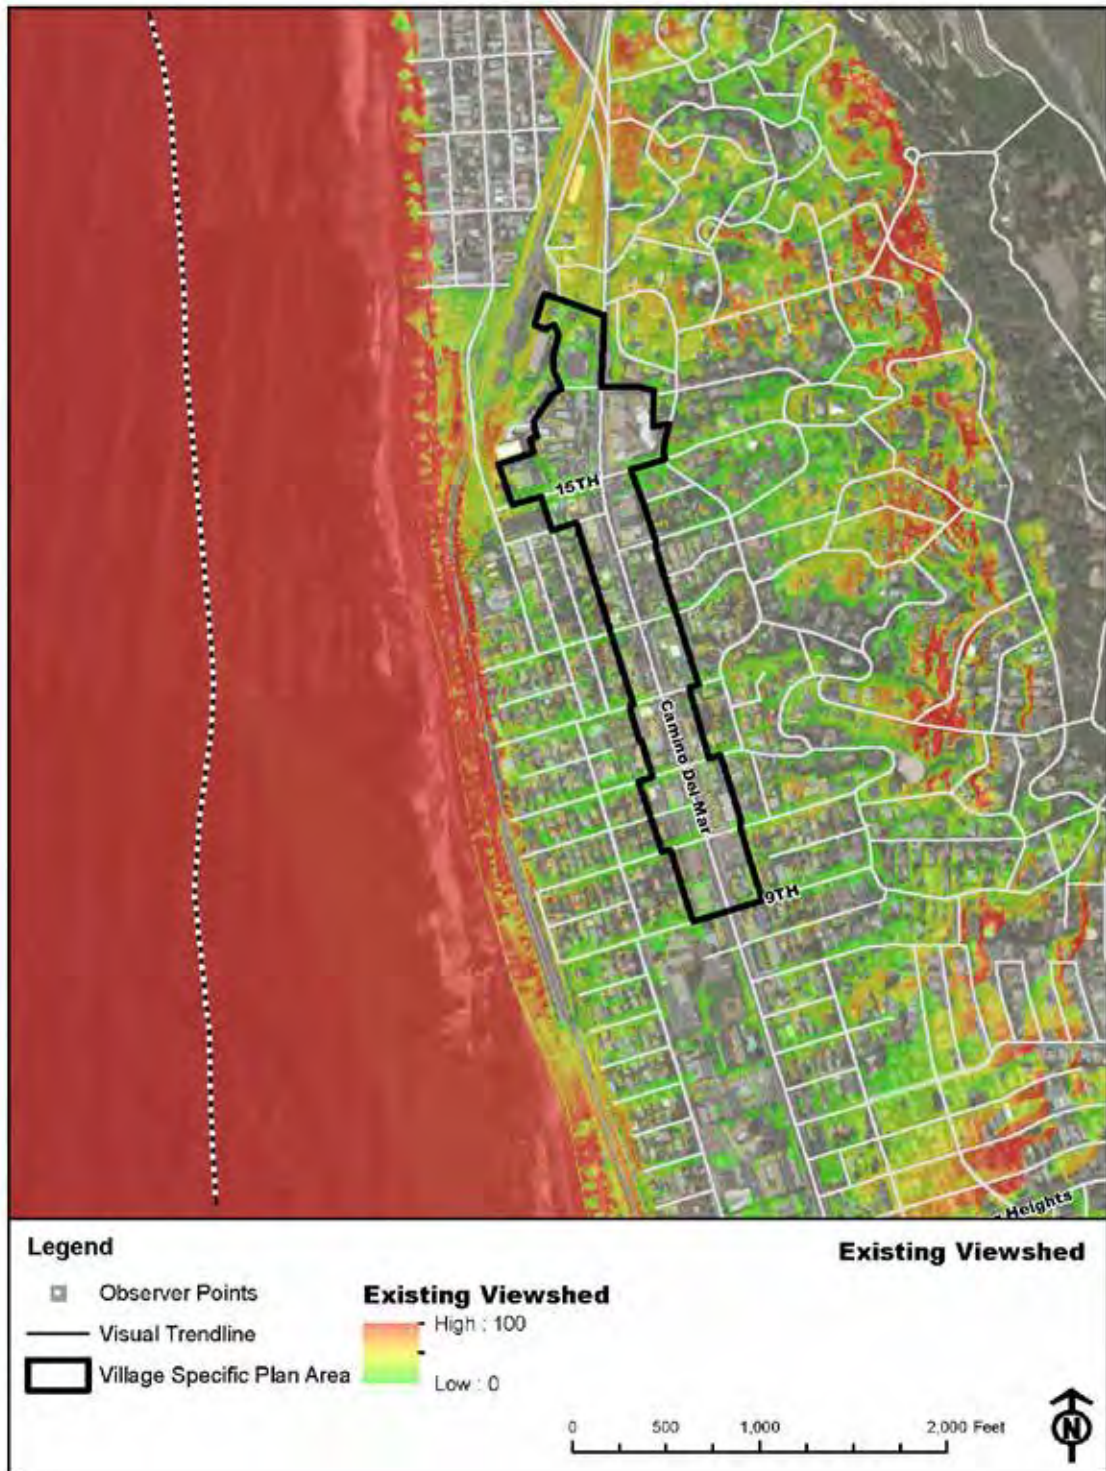
**Figure 4-4: Viewshed Trendline with Existing Buildings along CDM**

Viewshed of the trendline (dashed line) on the ocean determined to be the most visible part of the near ocean that most structures on the slopes east of Camino del Mar can see (given current buildings and landforms that block views).

The lower slopes show in bright yellow on Figure 4-10, are those from approximately one to two blocks east of Camino del Mar. Depending on topography, these roadway segments and private parcels, potentially have a small portion of their views blocked by buildings that are 26' or taller. Several existing buildings currently block views of the lower portions of the ocean, and dozens of mature trees also interrupt these views. In general, a building between 26' and 30' would be part of the viewing scene of the middle-ground from this area, and the near shoreline out past the trend line (shown on Figures 4-3 to 4-6). The horizon line is not likely to be interrupted by buildings up to 30'.

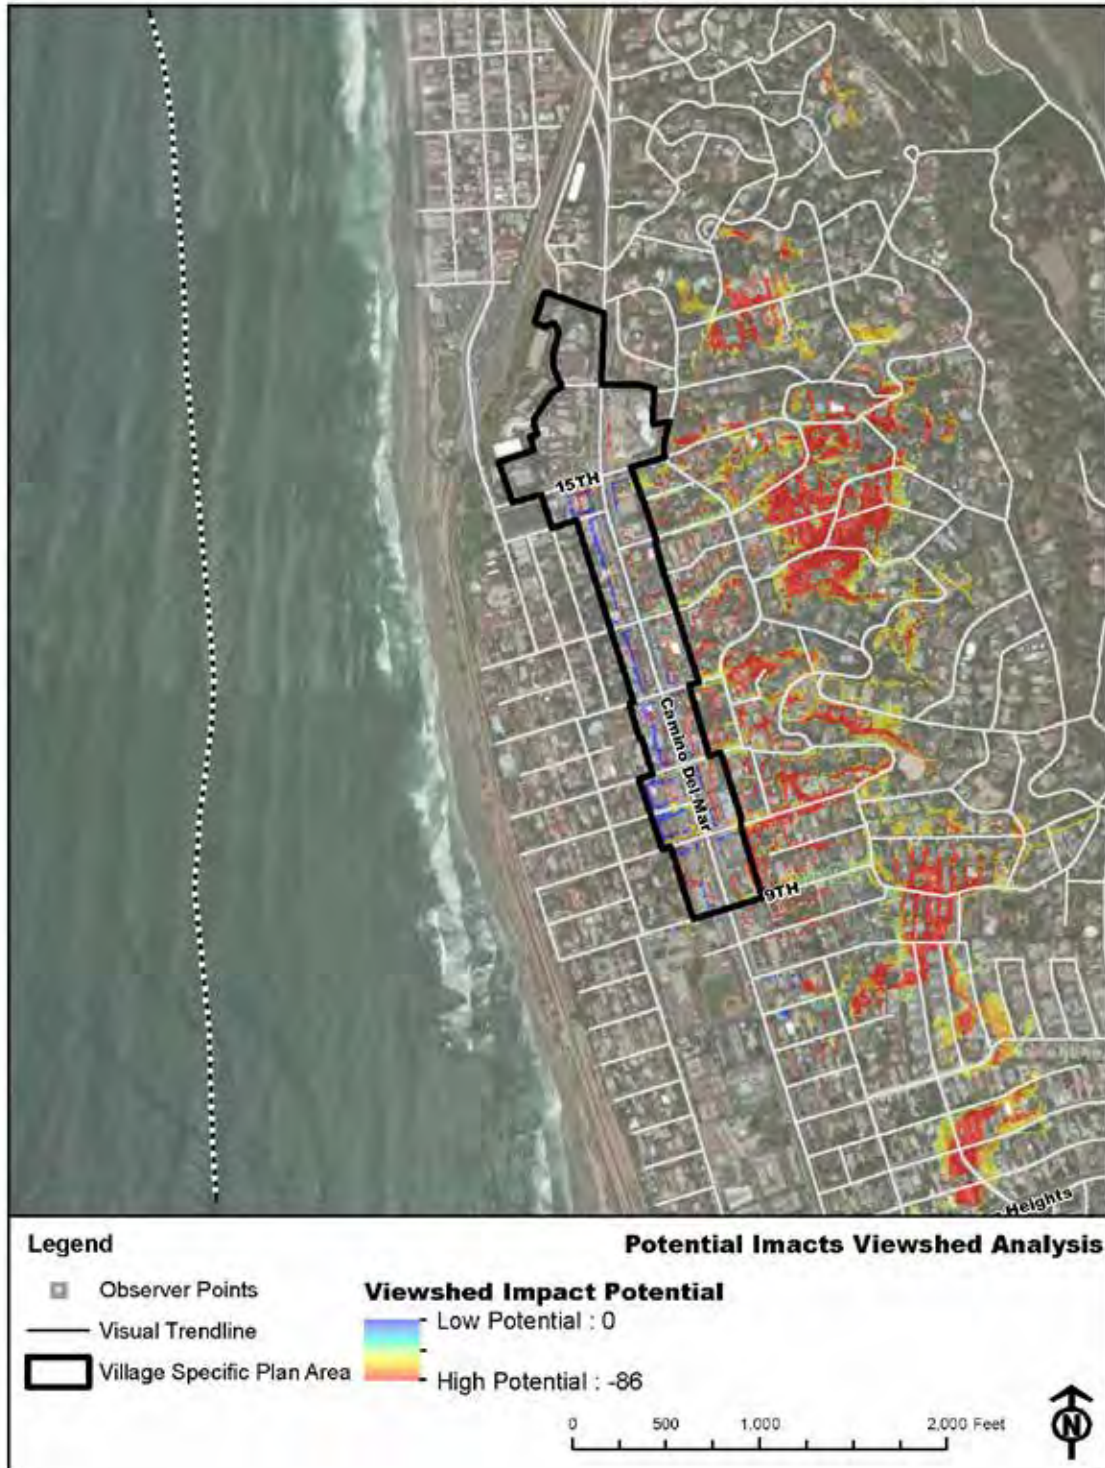
**Figure 4-6: Viewshed Trendline Net Difference**

Net difference of areas where portions of the view of the ocean (trendline) would be partially blocked by building heights along Camino del Mar versus existing building heights.

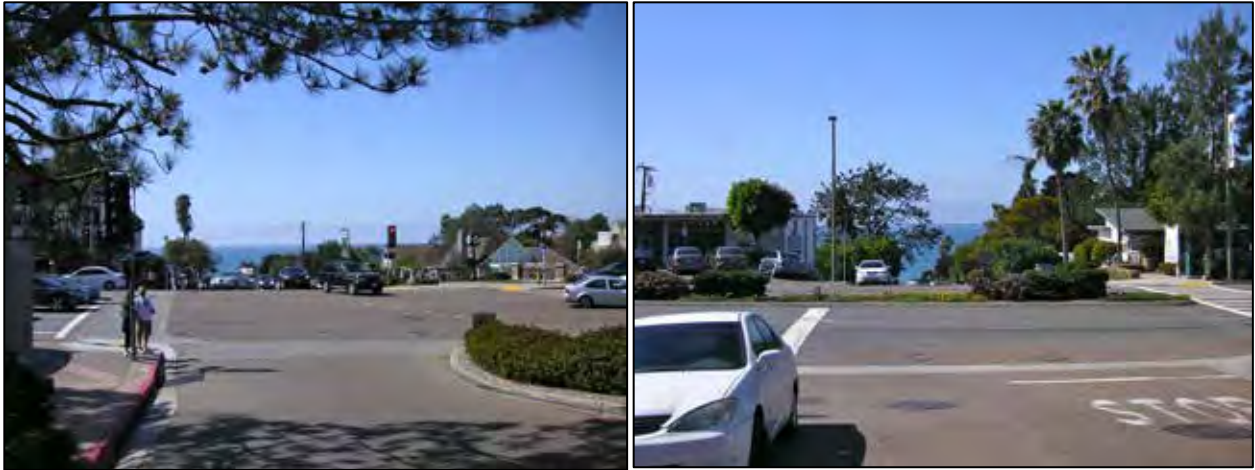
Most of the east to west streets have views of the ocean, but the amount of ocean seen can vary dramatically as you head to the east, where just one block will allow you to see over most buildings.

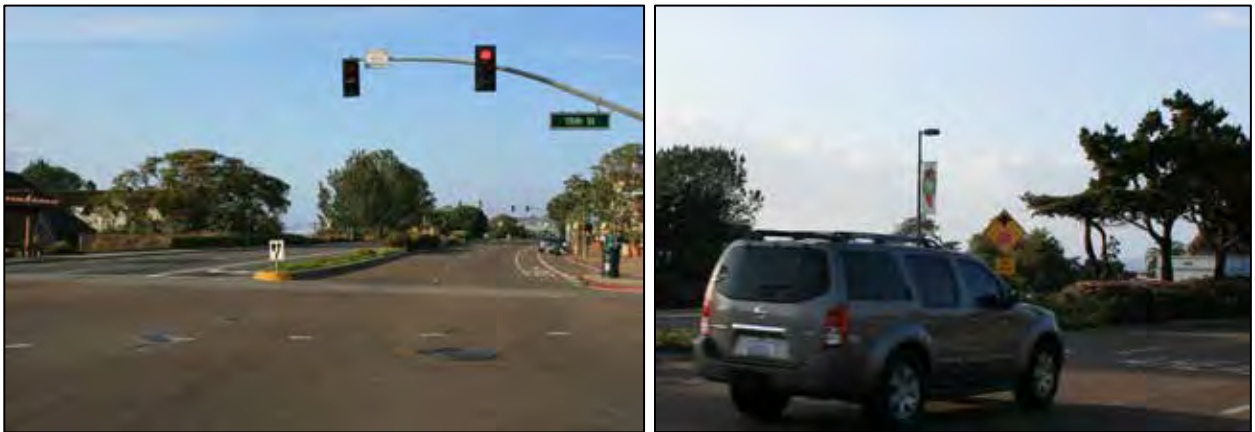
Views heading north or southbound on Camino del Mar are much more limited. Where they do appear, it is the result of a break in building masses and where mature plant material does not exist.

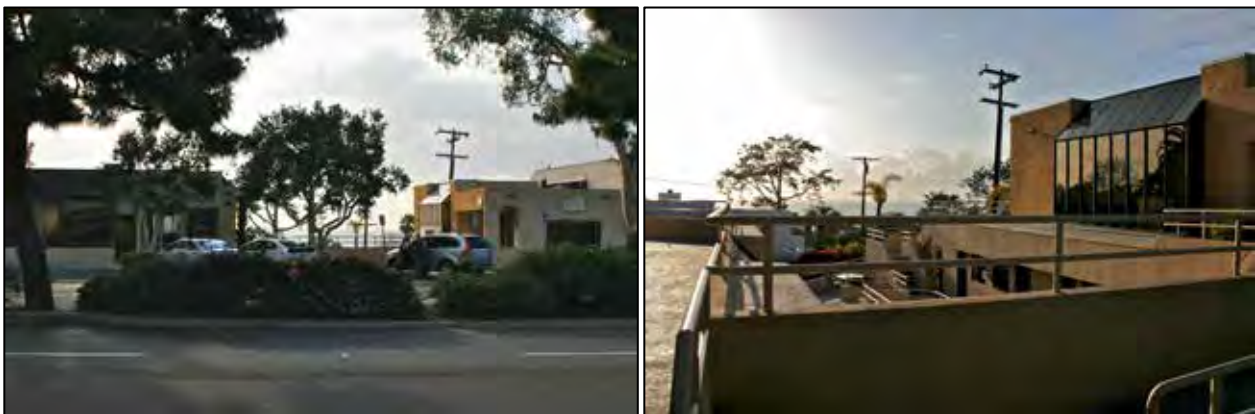
A few midblock views can be seen between buildings. A portion of the ocean can be seen from across from the east side of the street, though more dramatic views can be seen from the west side.

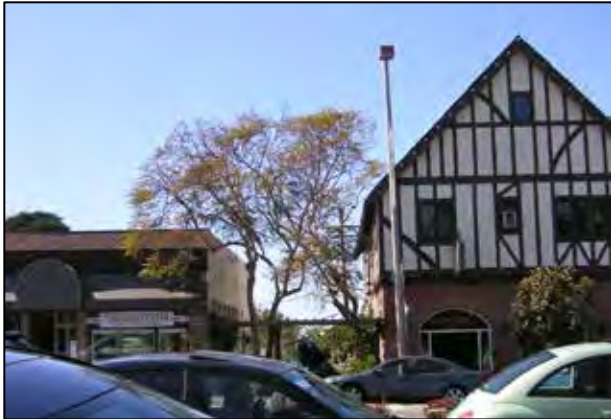
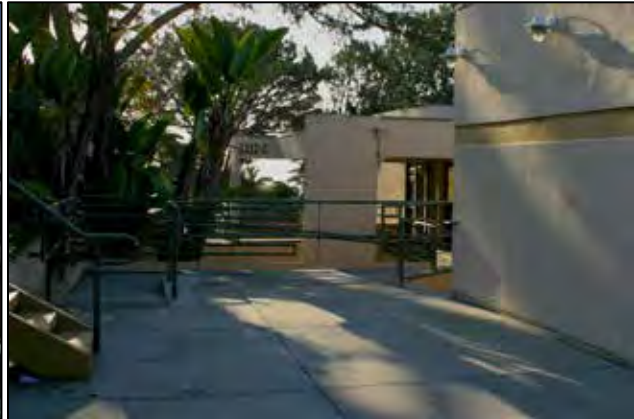
Other openings exist, but contain a large amount of walls or landscaping that blocks most of the view.

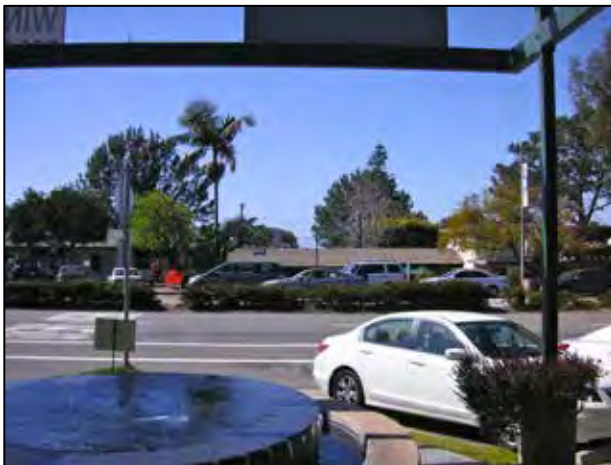
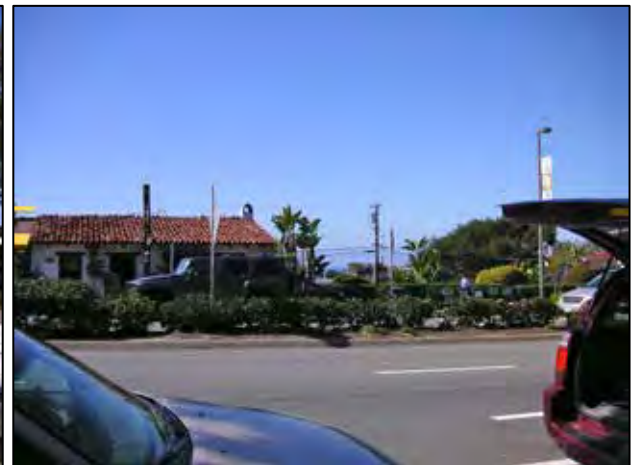
Current buildings block most of the views as seen from the road or sidewalk. Even a depressed 14' building cannot be seen over the top from this side. Where buildings are missing, views do exist.

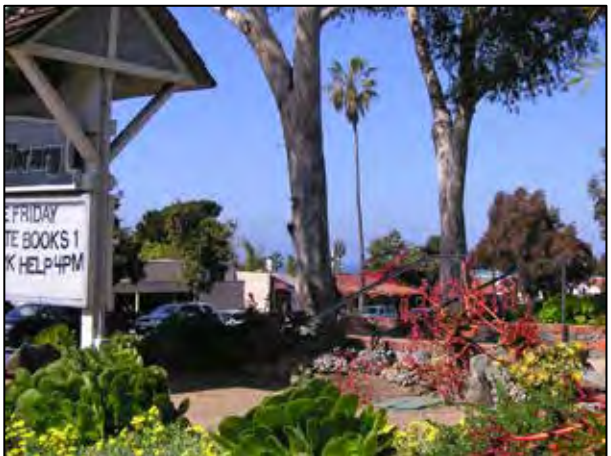
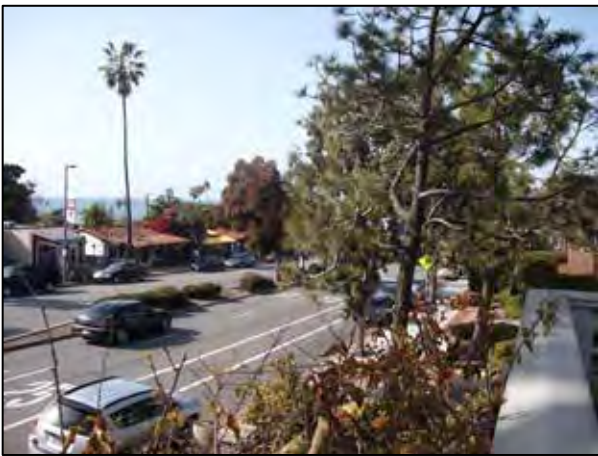
Views over buildings occur once you head east up the streets and gain altitude. Views over the west side buildings from the first half block eastward only occur over the top of 14' buildings. It is likely that buildings at 26' to 30' will not be seen over unless you travel east of the alleyway.

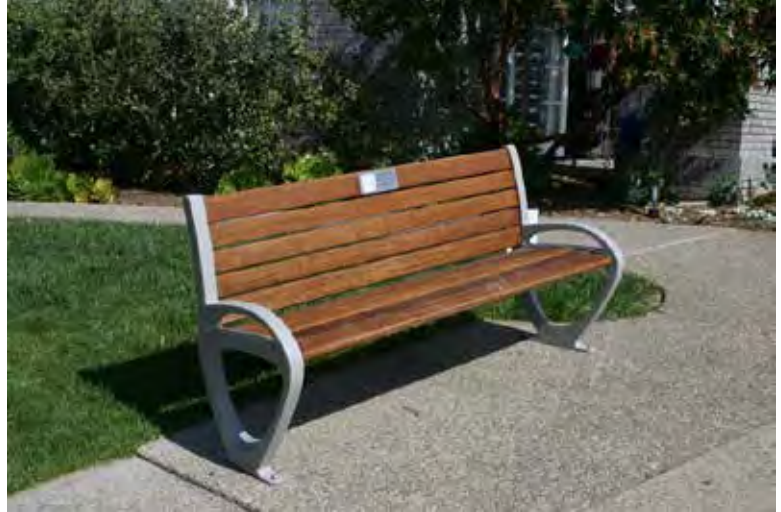
**Benches with City Branding**

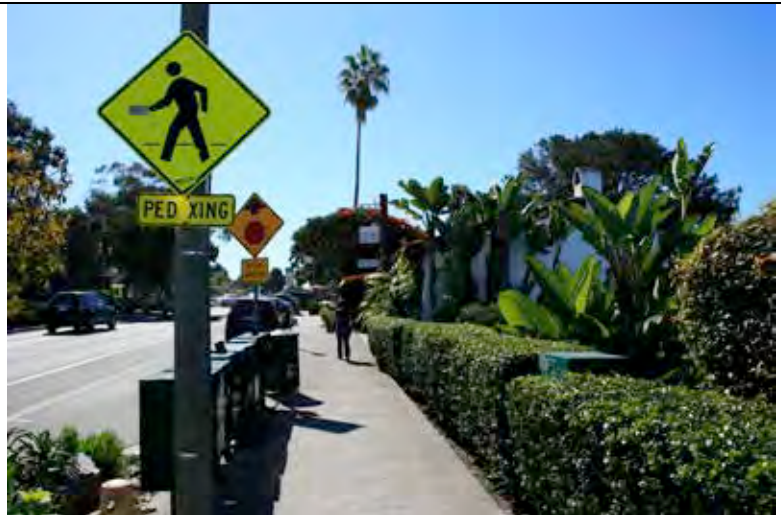
**Sidewalks with a consistent finish and a minimum width throughout the Village**

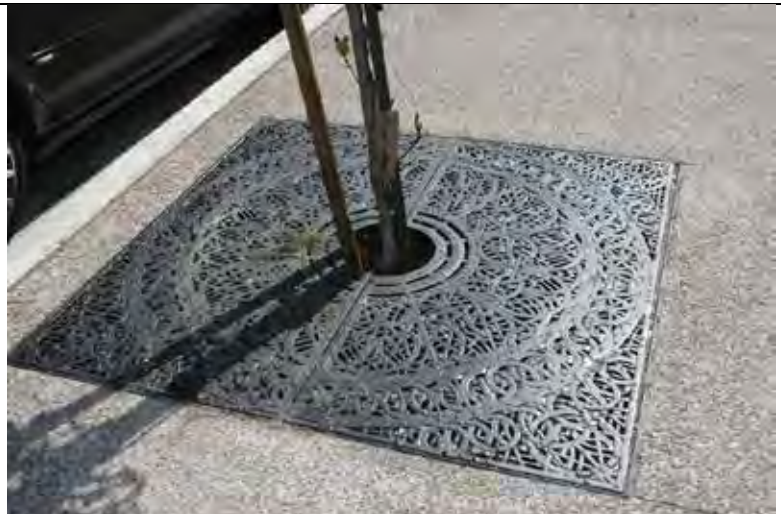
**Tree Grates**

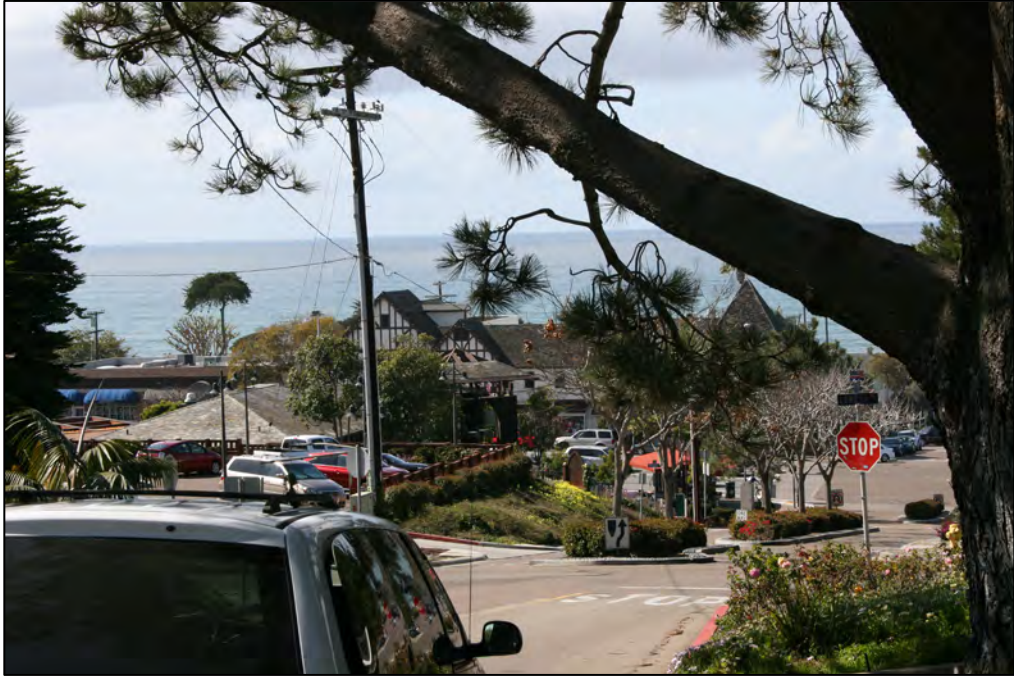
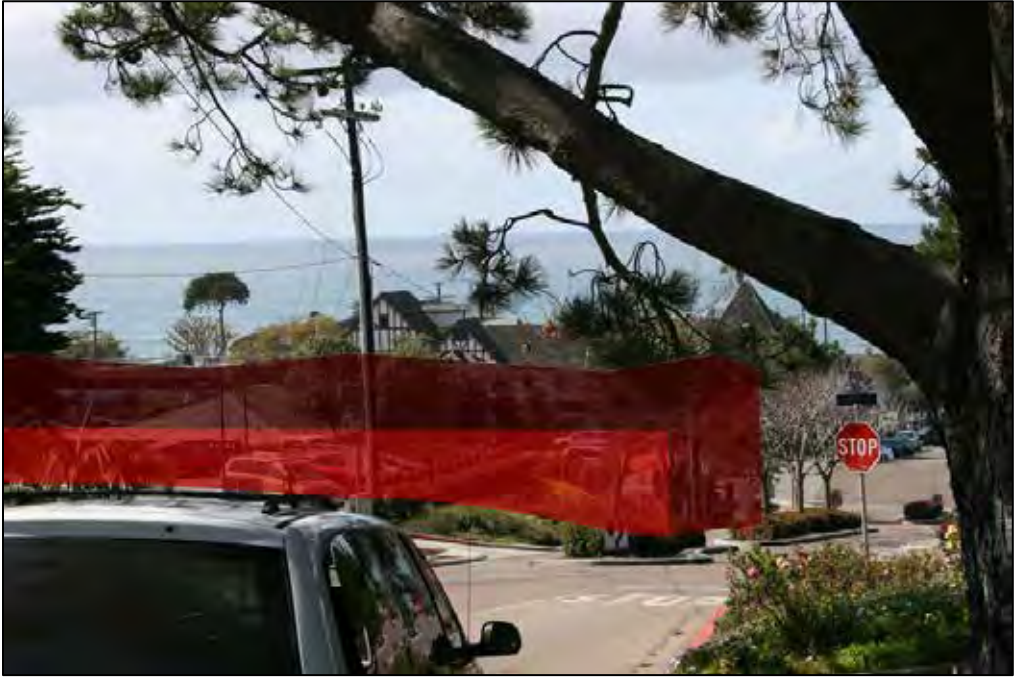
**Candidate Key View #1**

*Candidate Key View #1*

This view looks west from the north side of 15<sup>th</sup> Street at 412 15<sup>th</sup>. This view is not recommended for simulation. This view shows the affect of the 30' maximum height on the ocean view; it does not interrupt the horizon line.

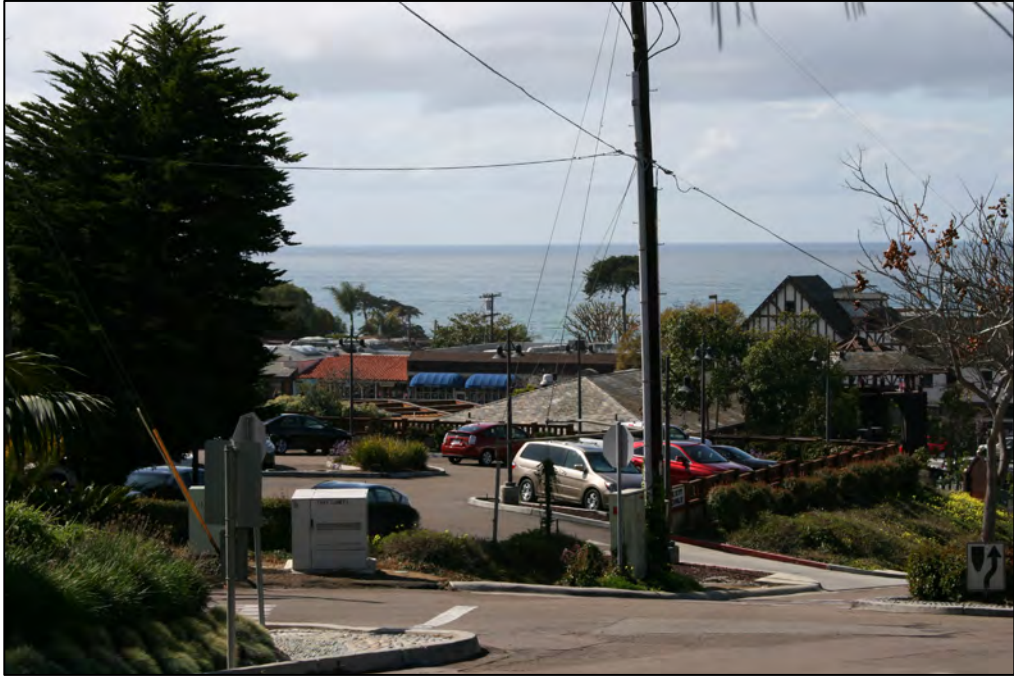
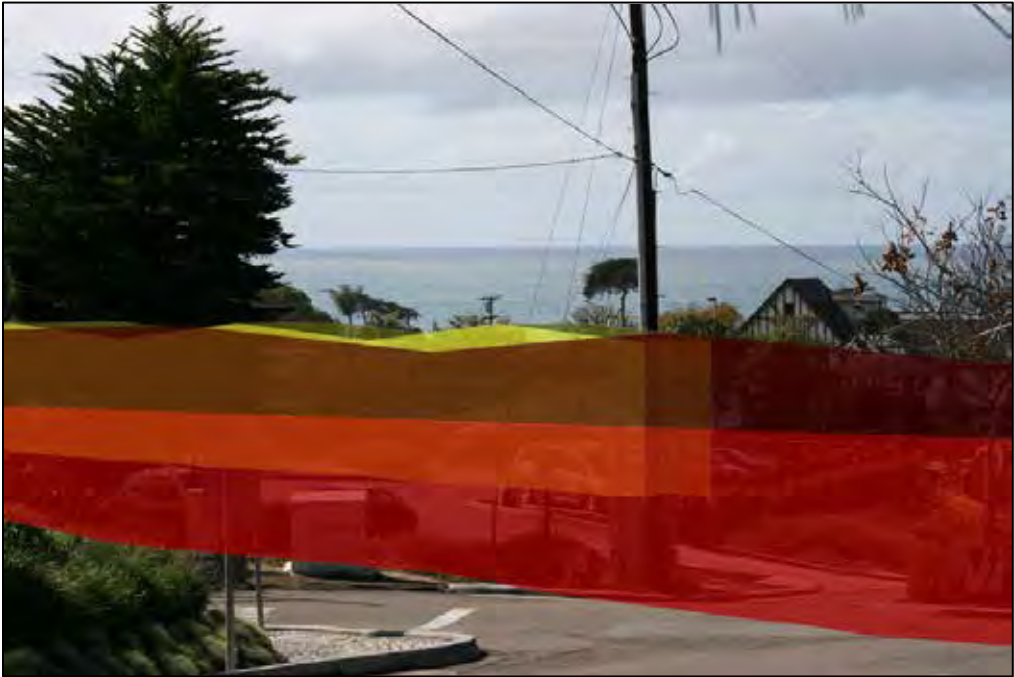
**Candidate Key View #2**

*Candidate Key View #2*

This view looks southwest from the north side of 15<sup>th</sup> Street at 412 15<sup>th</sup>. This view is not recommended for simulation since the proposed changes will not interrupt the horizon line.

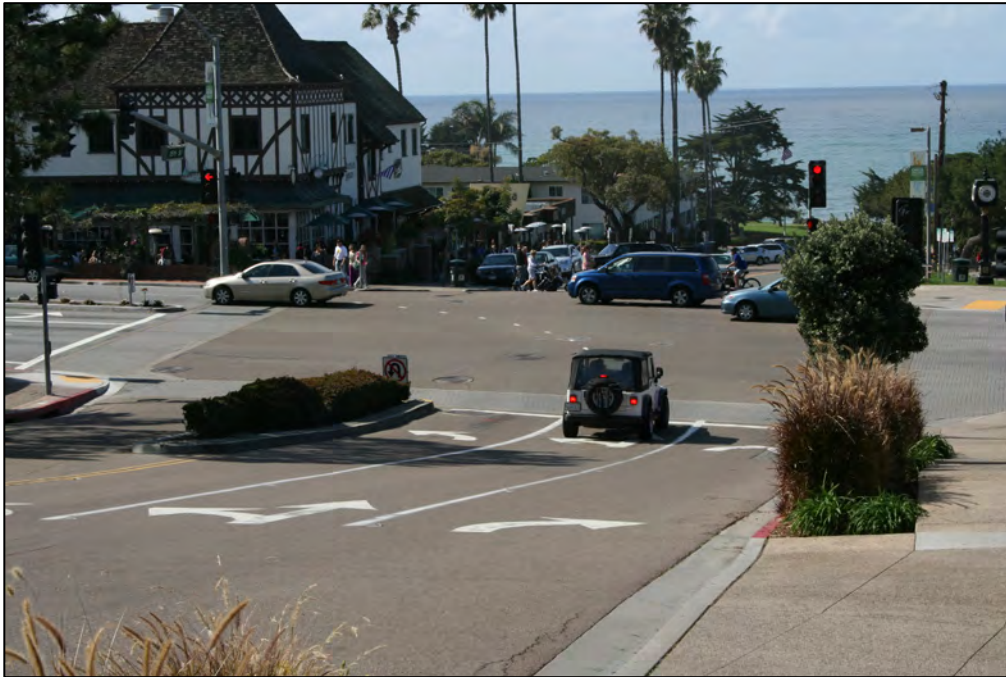
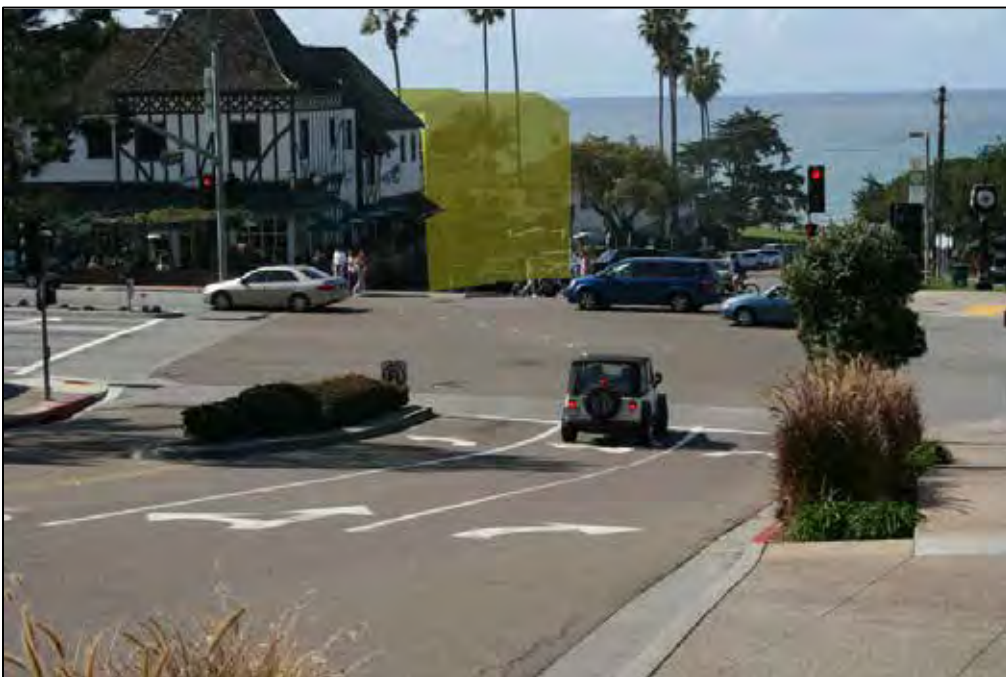
**Candidate Key View #3**

*Candidate Key View #3*

This view looks west from the north side of 15<sup>th</sup> Street at 383 15<sup>th</sup>. This view is not recommended for simulation since potential changes do not fully block the horizon.

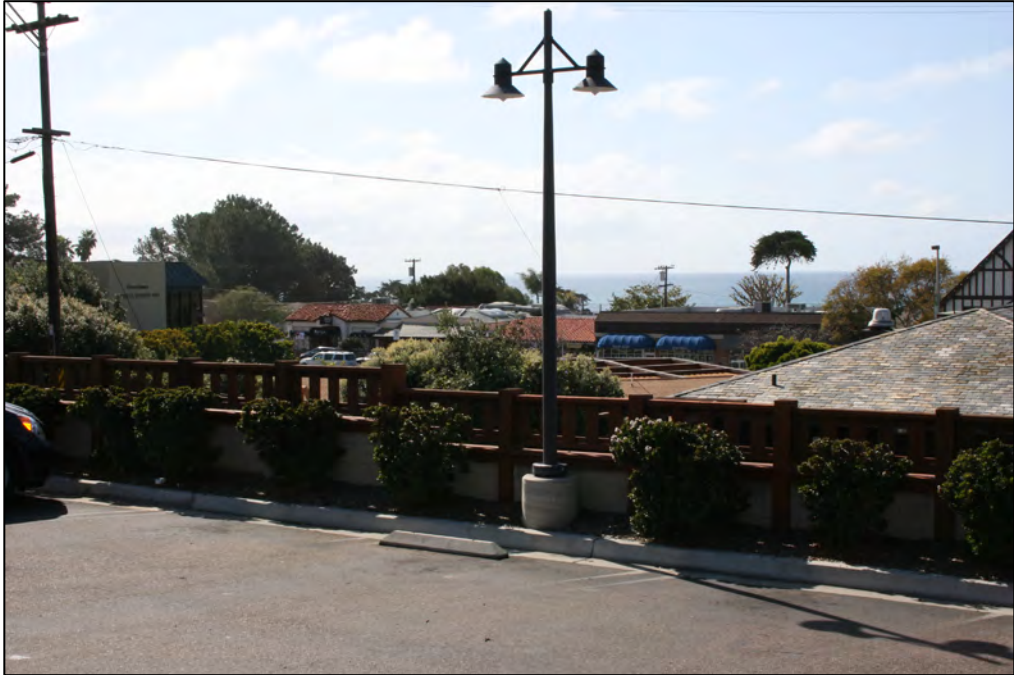
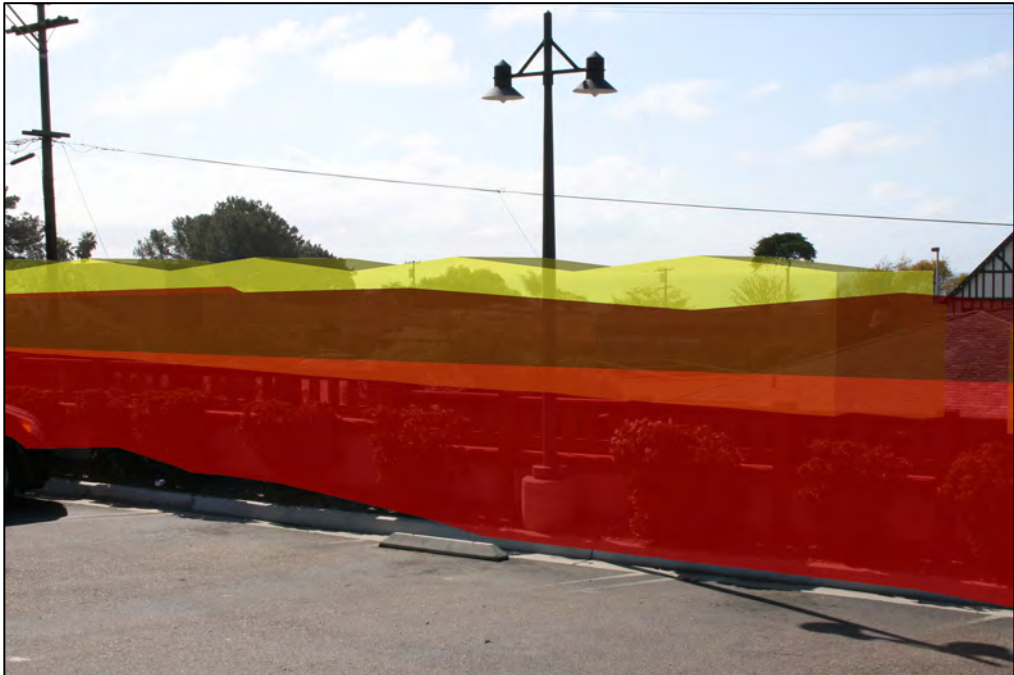
**Candidate Key View #4**

*Candidate Key View #4*

This view looks west from the parking lot east of Maiden between 14<sup>th</sup> Street and Parish. This view is not recommended for simulation since current regulations would block view.

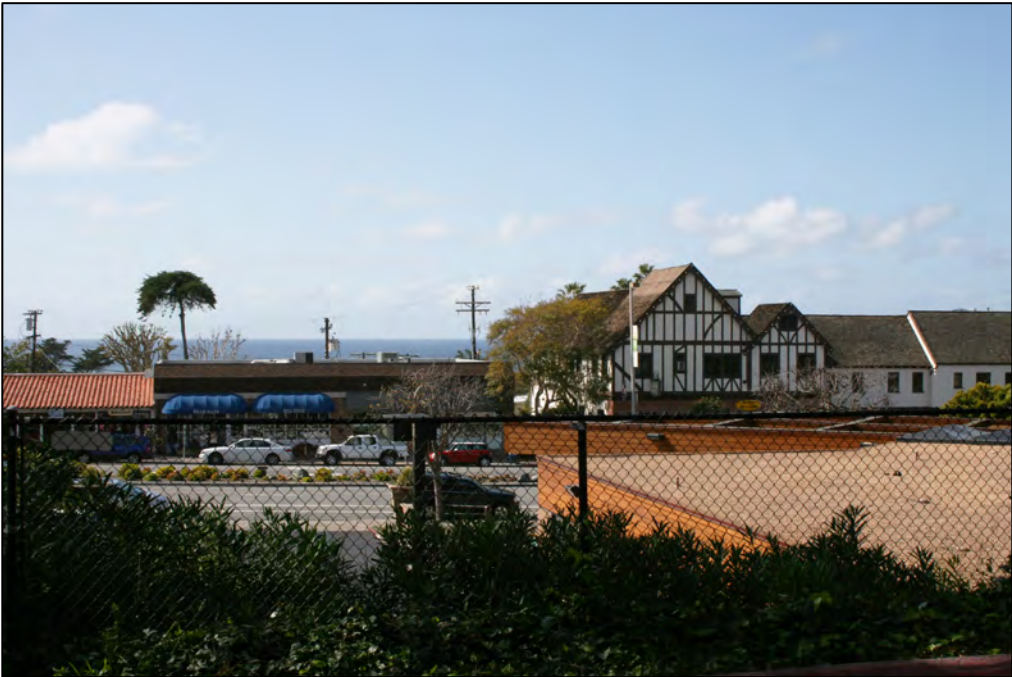
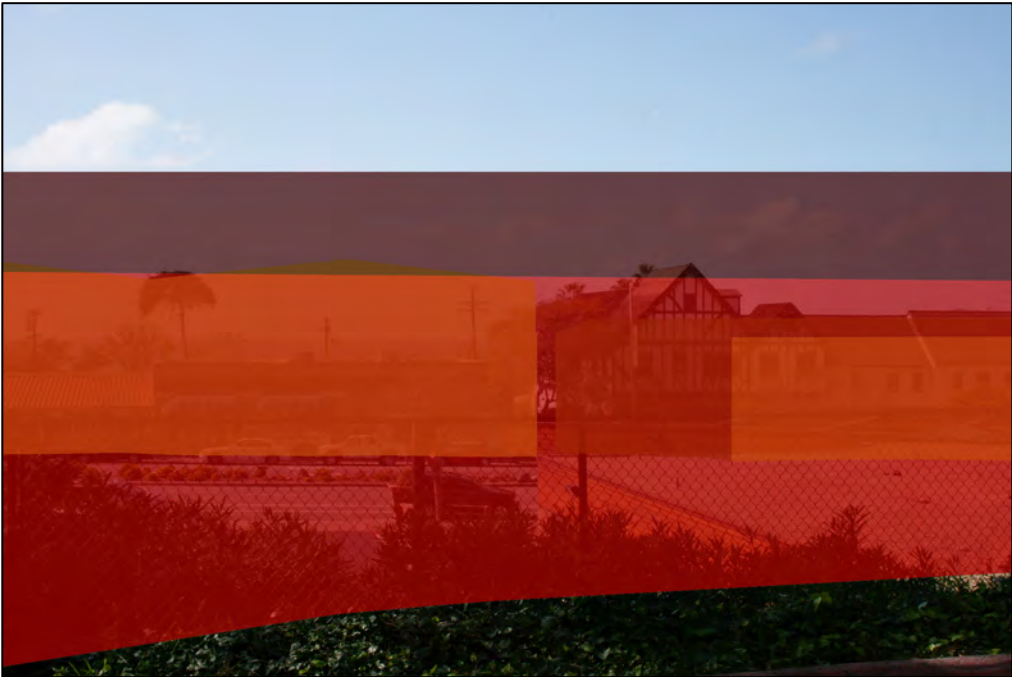
**Candidate Key View #5**

*Candidate Key View #5*

This view looks west from the east side of Maiden between 14<sup>th</sup> and 15<sup>th</sup> Street. This view is not recommended for simulation since it would be blocked by current regulations.

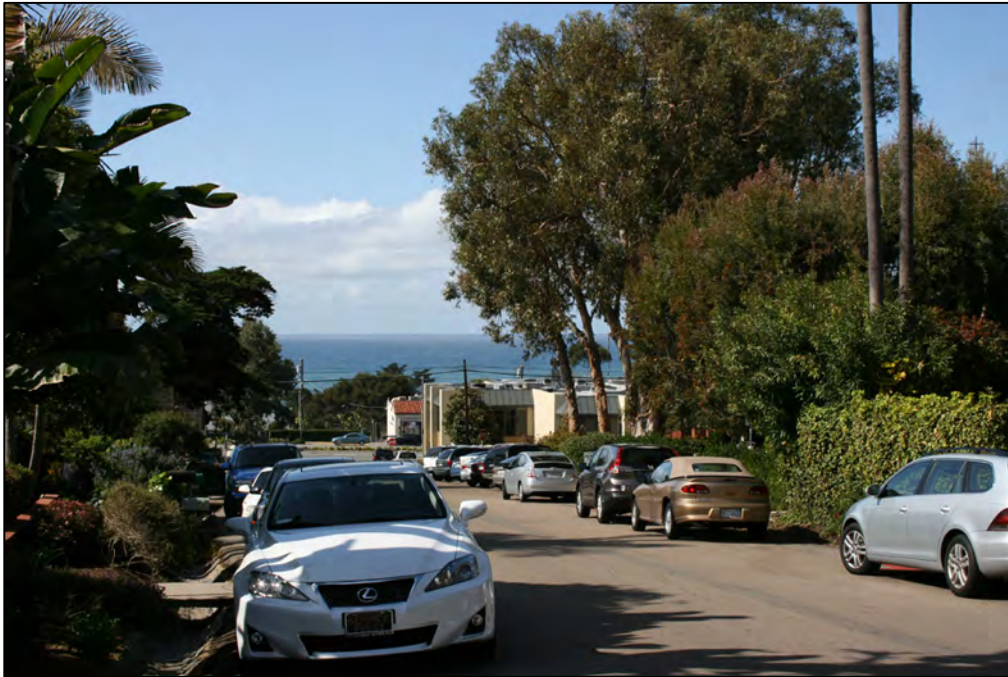
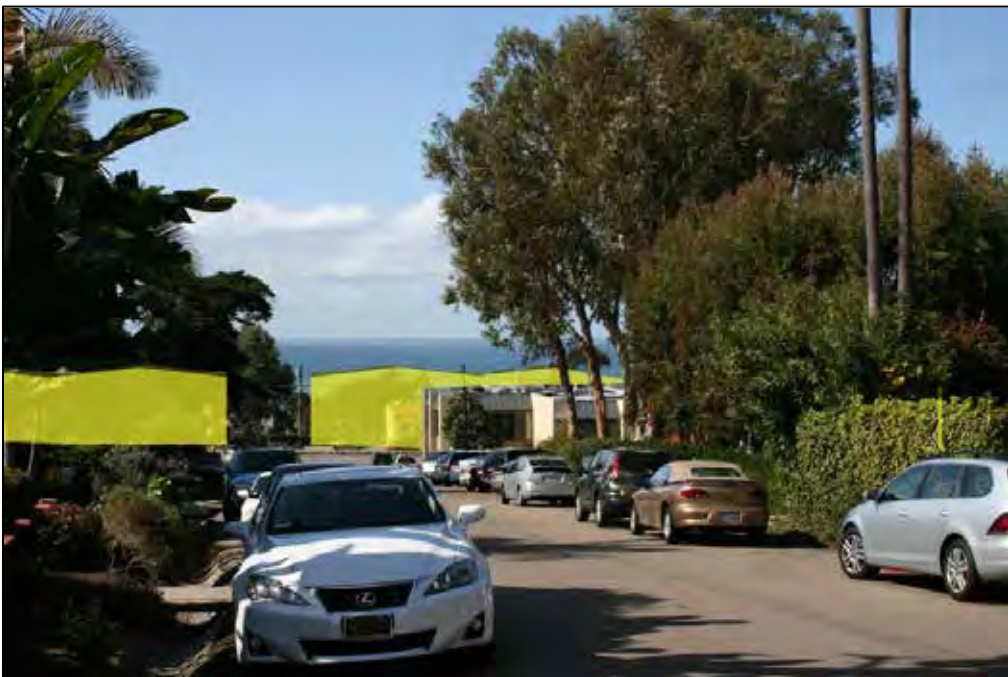
**Candidate Key View #6**

*Candidate Key View #6*

This view looks west from the south side of 14<sup>th</sup> street at 349 14<sup>th</sup>. This view is not recommended for simulation because the existing foreground vegetation blocks the proposed changes.
