Village Specific Plan  
Visual Impact Assessment

**KTU+A Planning and Landscape Architecture**  
3916 Normal Street  
San Diego, CA 92103

March 13, 2012  
Revised July 5, 2012

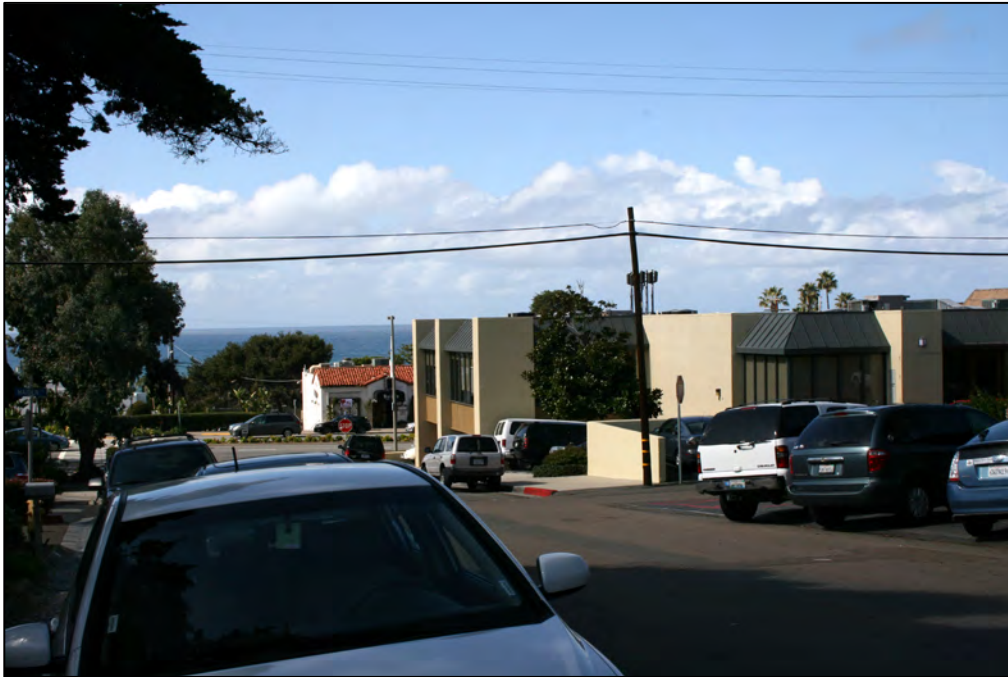
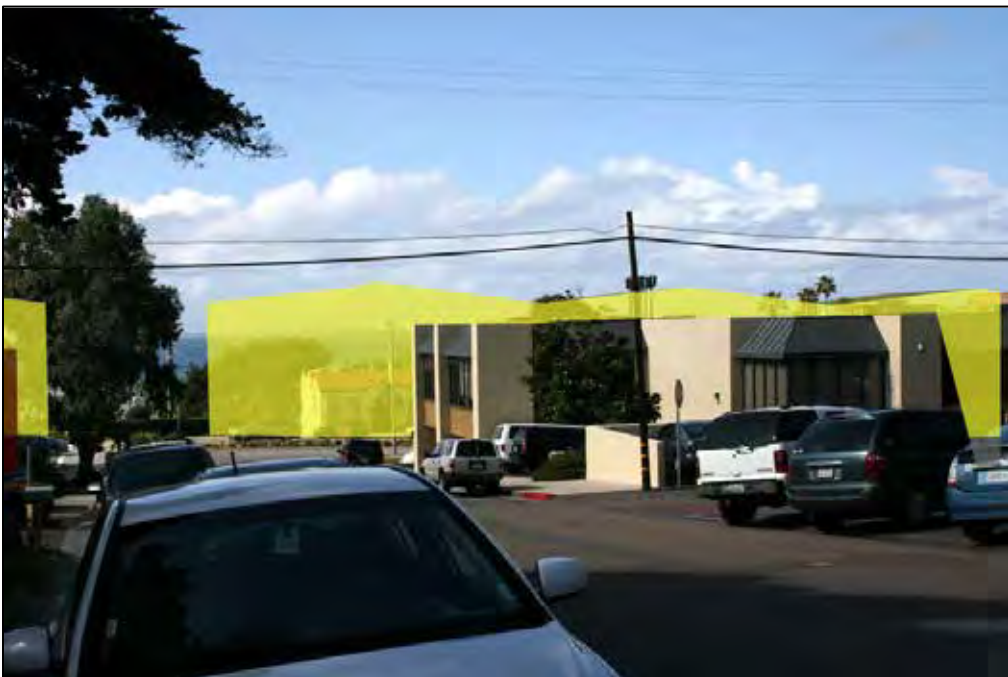
**Candidate Key View #7**

*Candidate Key View #7*

This view looks west from the south side of 14<sup>th</sup> street at 323 14<sup>th</sup>. This view is not recommended for simulation as a sequence as the building in the foreground will most likely not change.

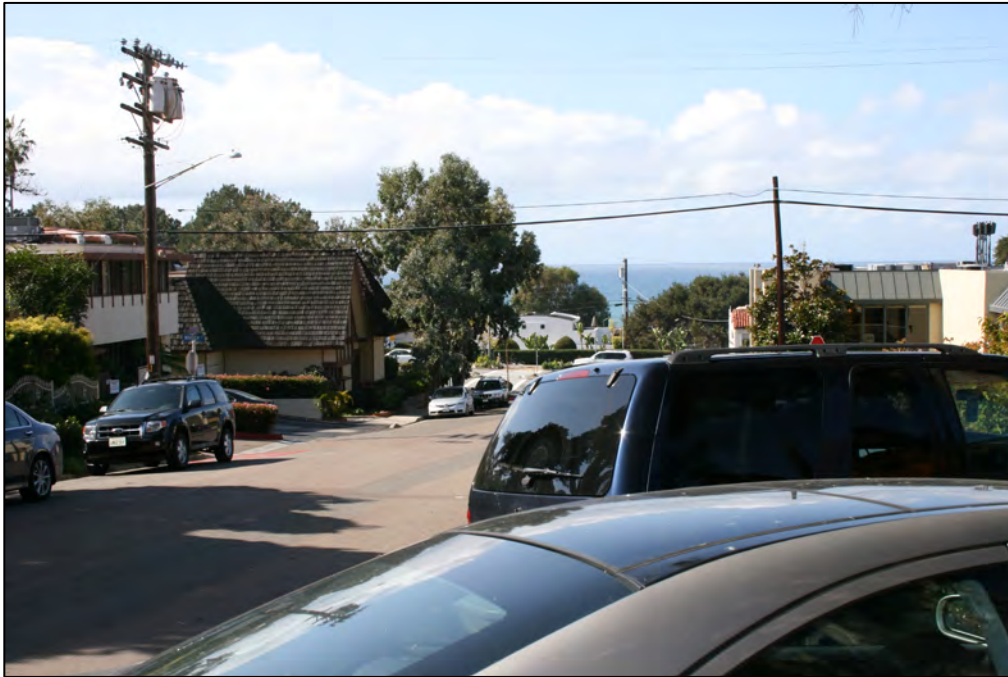
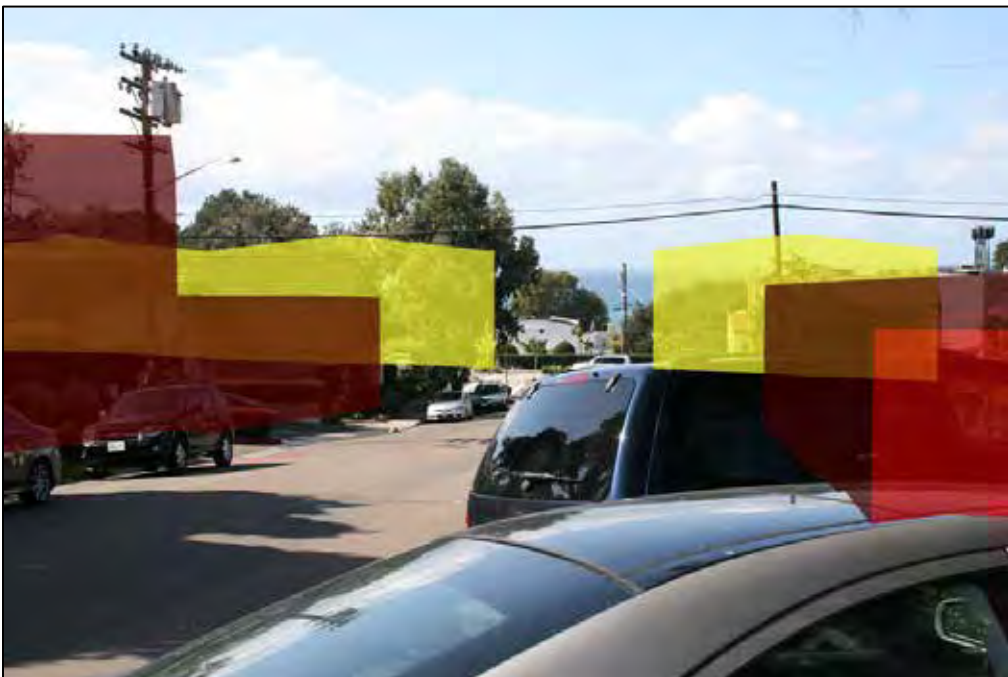
**Candidate Key View #8**

*Candidate Key View #8*

This view looks west from the north side of 14<sup>th</sup> Street at 327 14<sup>th</sup>. This view is not recommended for simulation it be used in a sequence with **Error! Reference source not found.**and **Error! Reference source not found.**

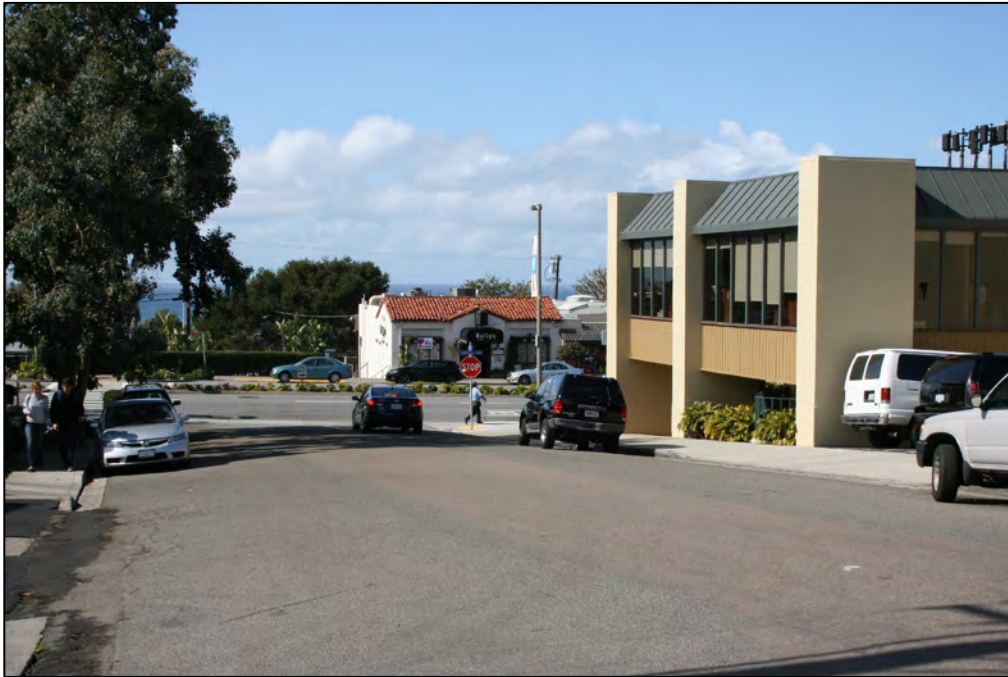
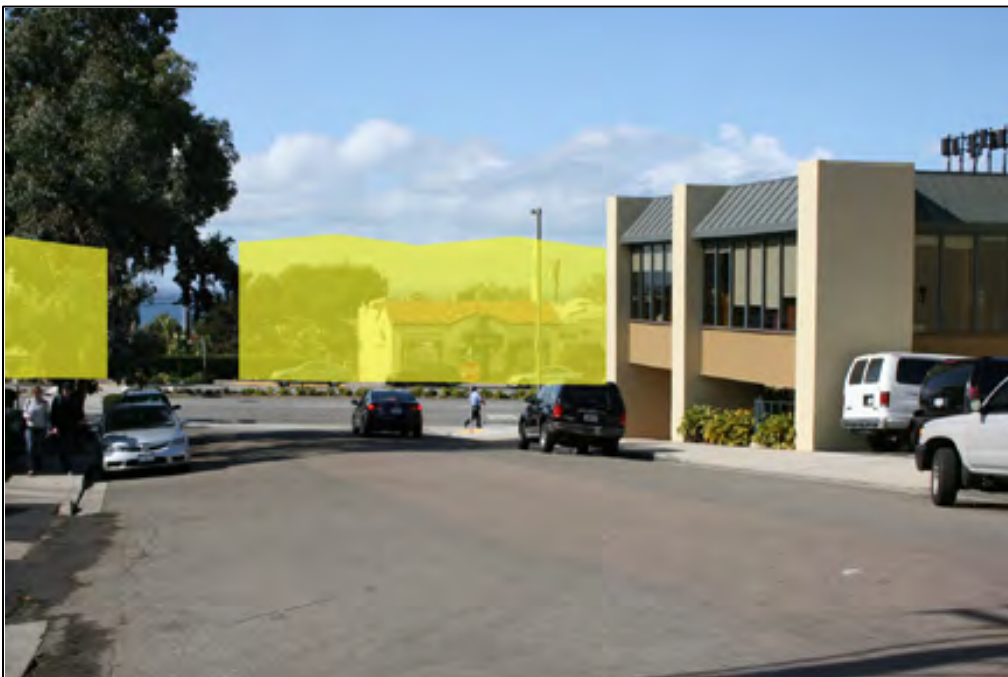
**Candidate Key View #9**

*Candidate Key View #9*

This view looks west from the southeast side of the intersection of 14<sup>th</sup> Street and Maiden. This view is not recommended for simulation as the building in the foreground will most likely not change.

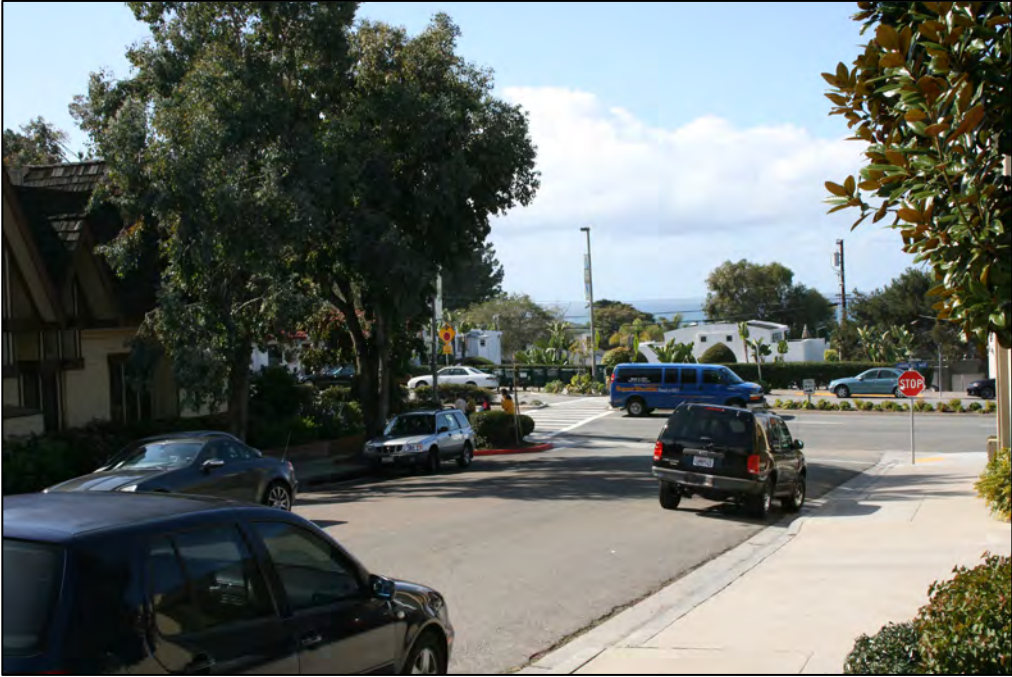
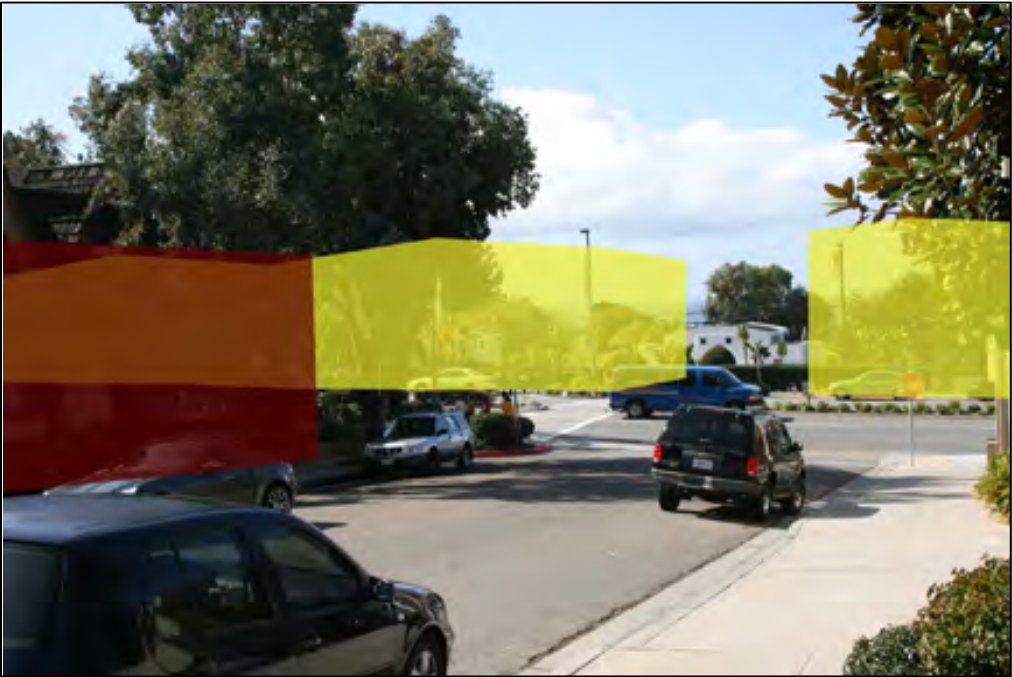
**Candidate Key View #10**

*Candidate Key View #10*

This view looks west from the northwest side of the intersection of 14<sup>th</sup> Street and Maiden. This view is not recommended for simulation, but shows a sequence of views to the horizon line the with **Error! Reference source not found..**

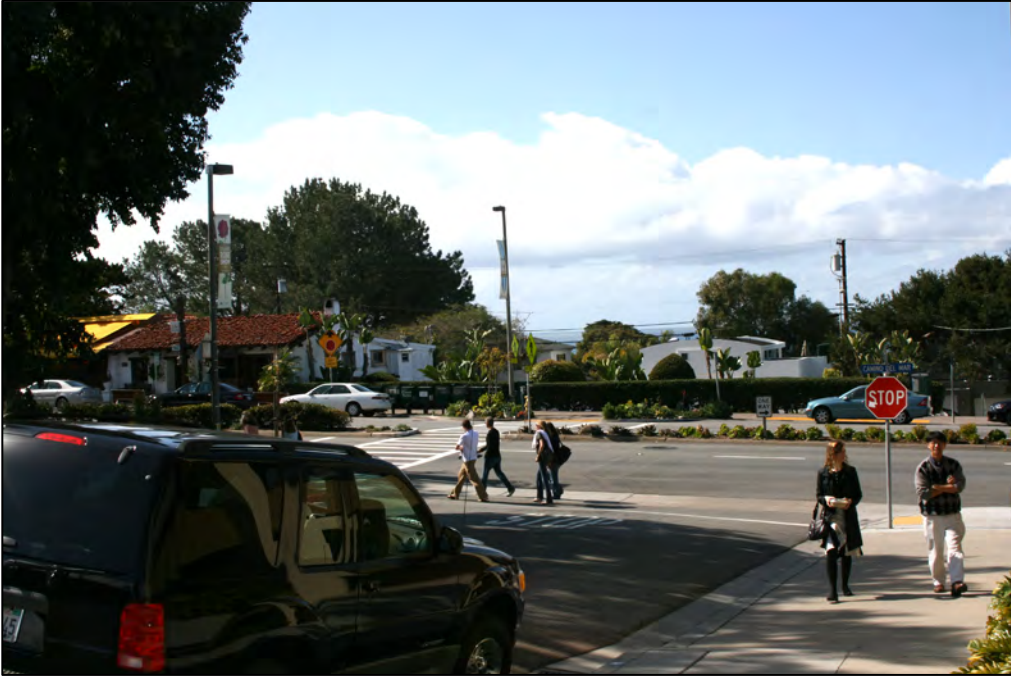
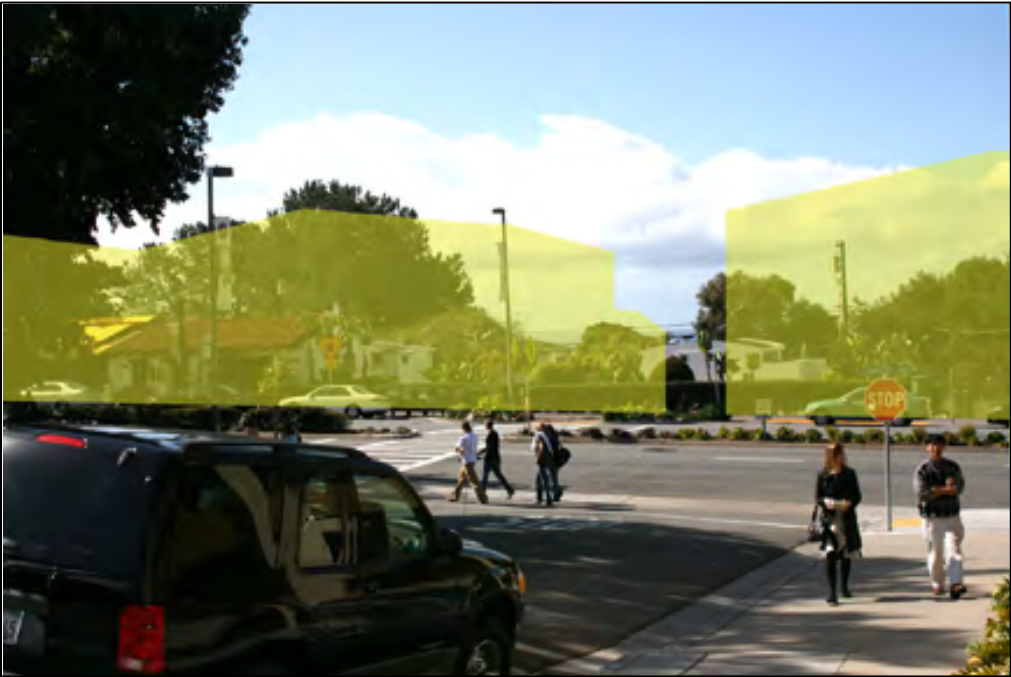
**Candidate Key View #11**

*Candidate Key View #11*

This view looks west from the north side of 14<sup>th</sup> Street at 309 14<sup>th</sup>. This view is not recommended but shows how the view corridor could be kept open if development was not allowed in the street extension.

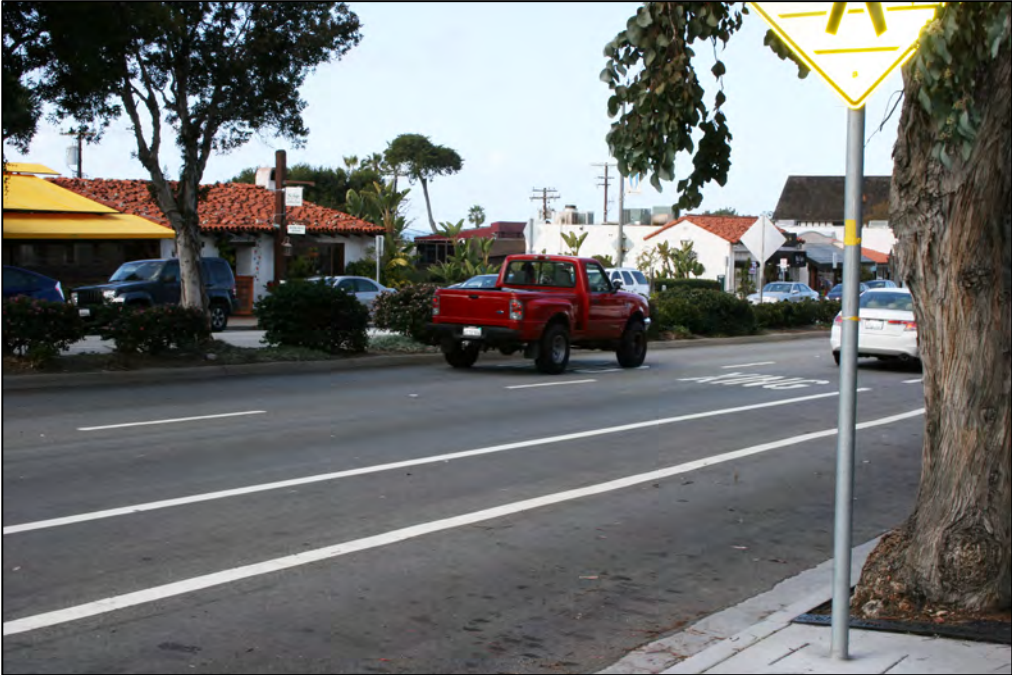
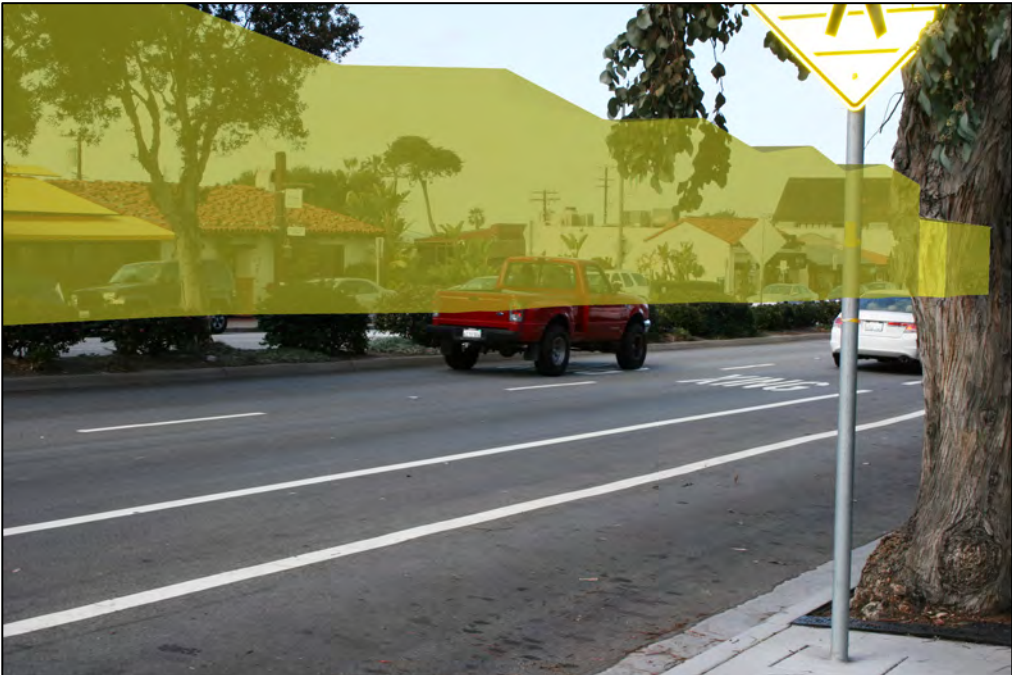
**Candidate Key View #12**

*Candidate Key View #12*

This view looks west from the east side of Camino del Mar between 13<sup>th</sup> Street and 14<sup>th</sup> Street. This view is not recommended for simulation since no ocean view exists.

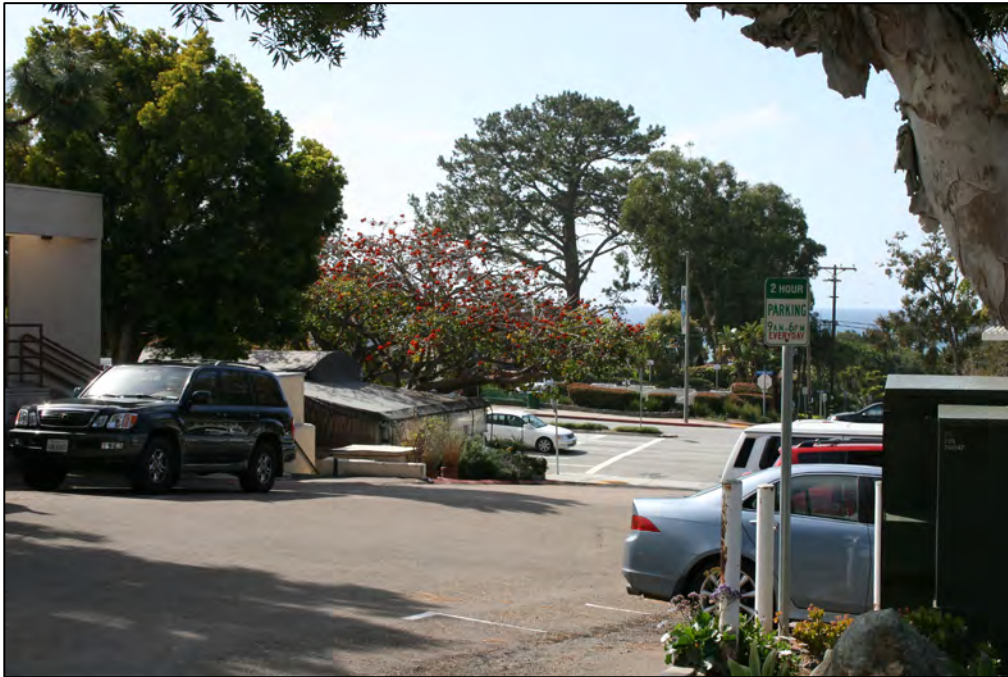
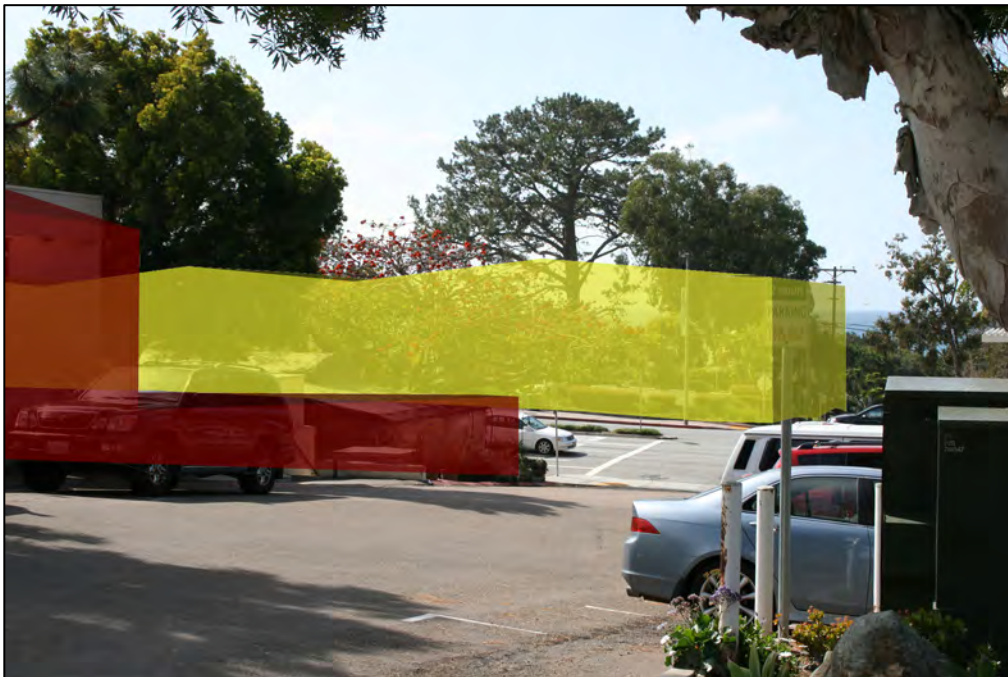
**Candidate Key View #13**

*Candidate Key View #13*

This view looks west from the north side of 13<sup>th</sup> Street at the Del Mar. This view is not recommended for simulation since only a minor view opening exists.

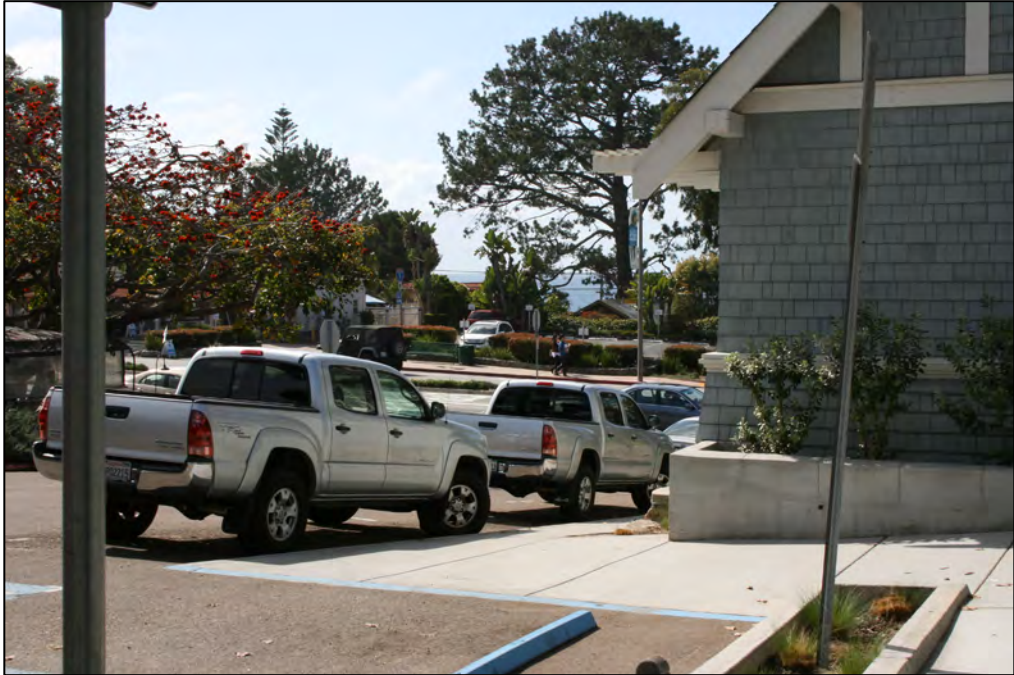
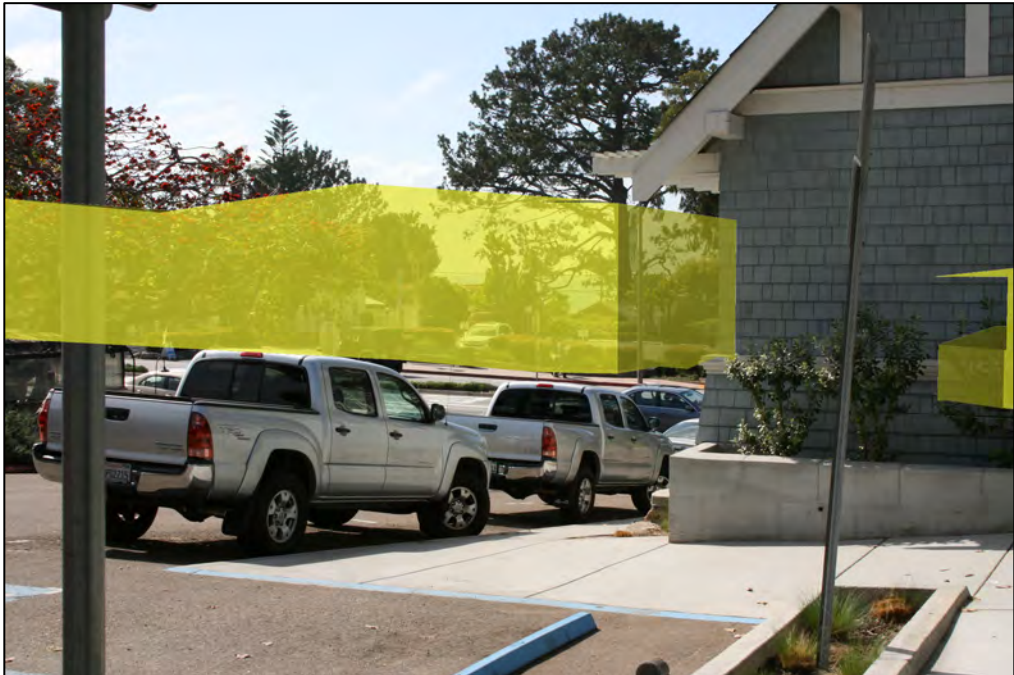
**Candidate Key View #14**

*Candidate Key View #14*

This view looks west from the north side of 13<sup>th</sup> Street at the Del Mar. This view is not recommended for simulation since only a minor view opening exists.

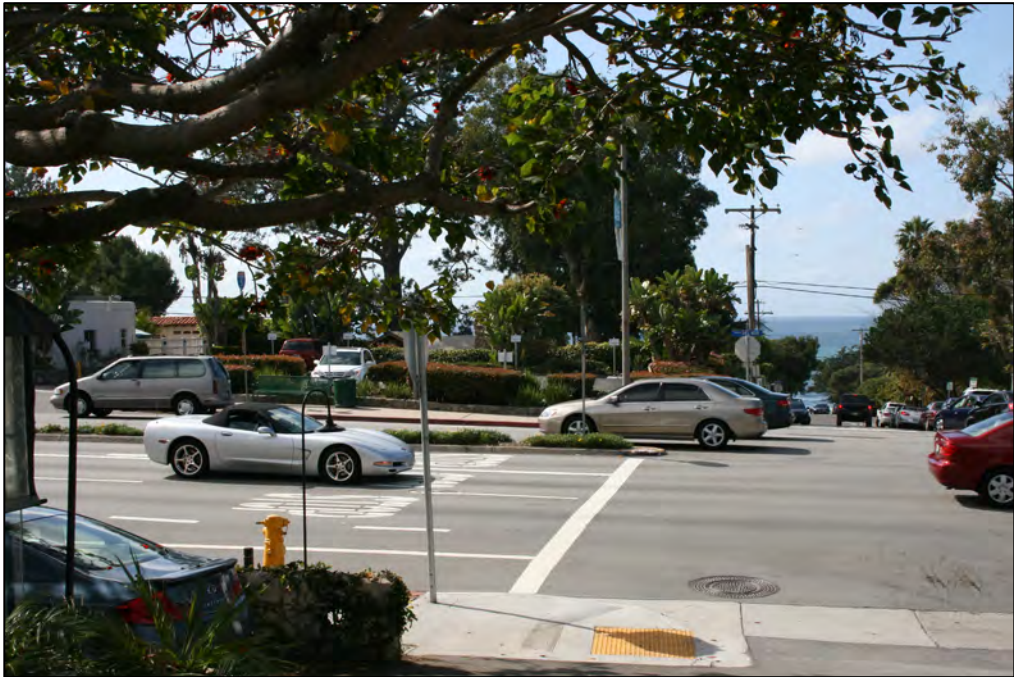
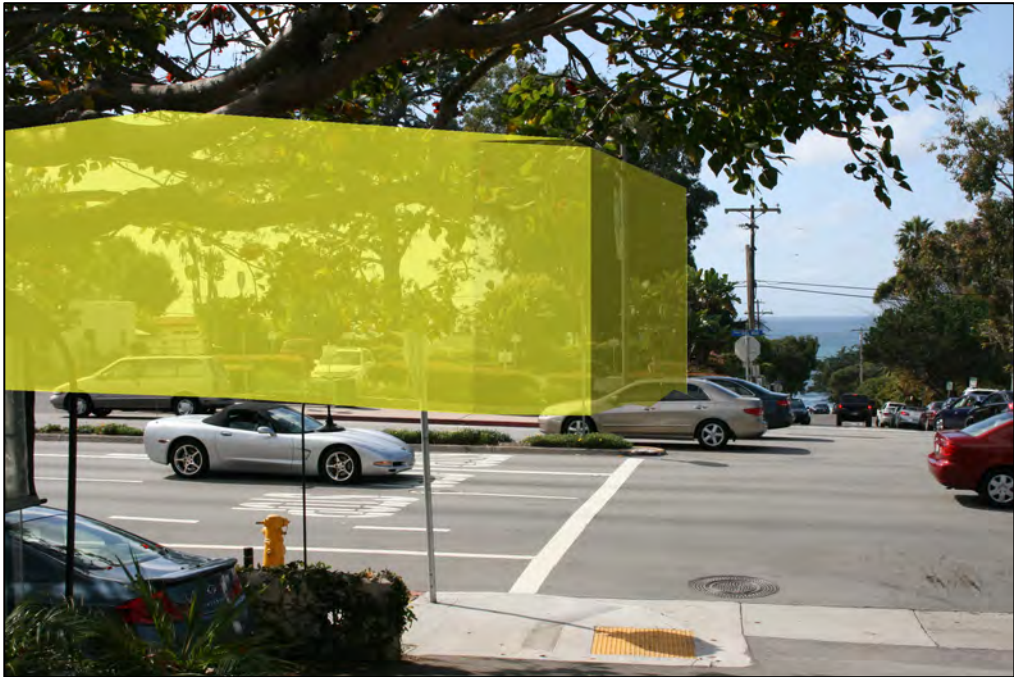
**Candidate Key View #15**

*Candidate Key View #15*

This view looks west from the south side of 13<sup>th</sup> Street at 305. This view is not recommended for simulation since a 14' building would block the view.

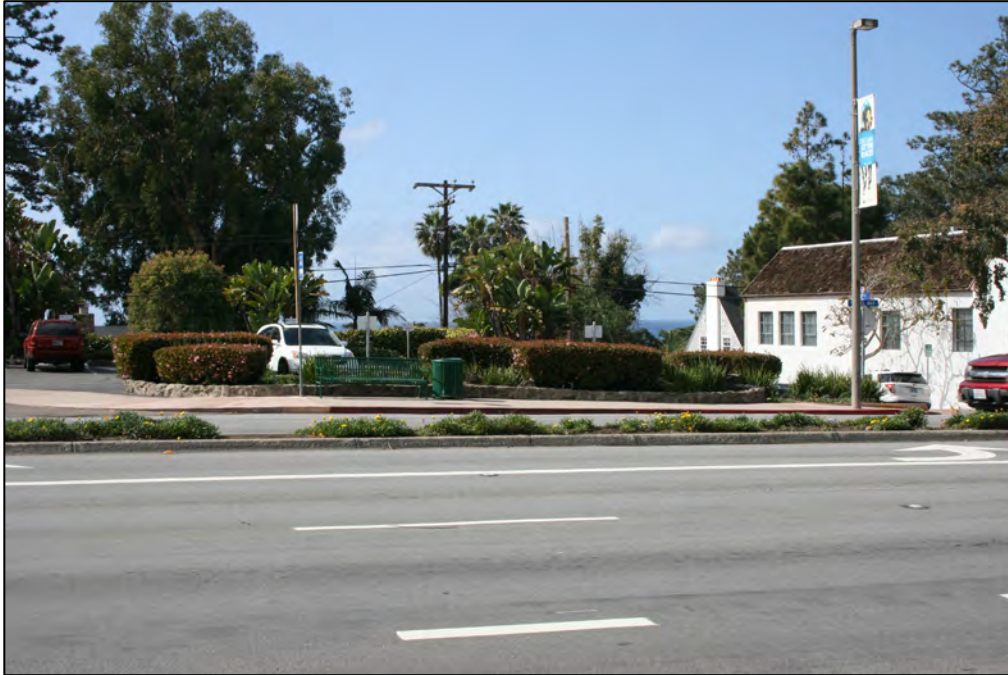
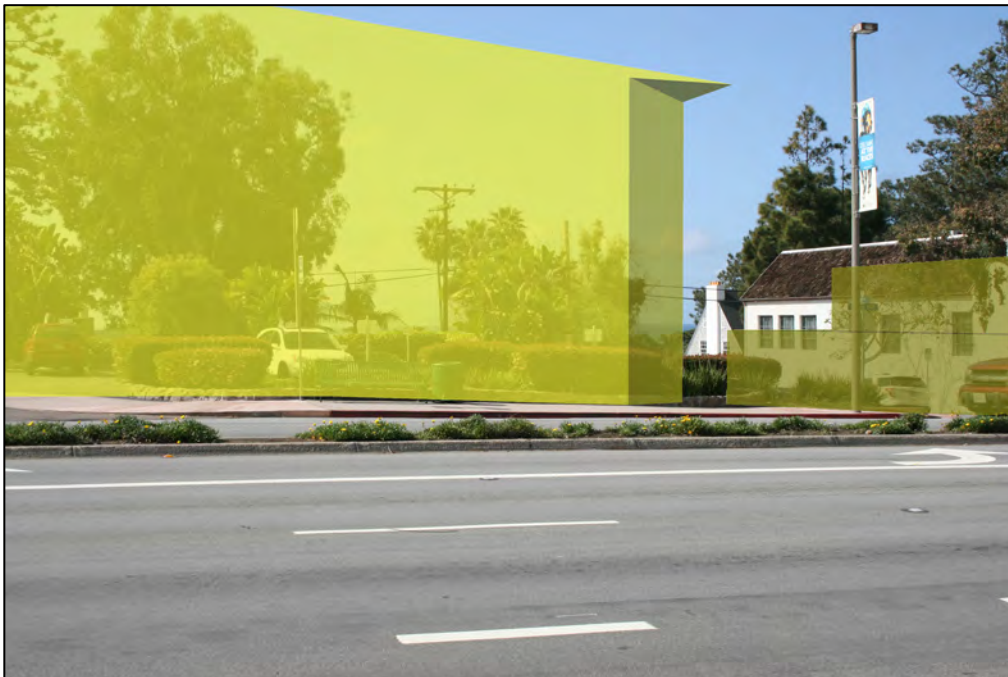
**Candidate Key View #16**

*Candidate Key View #16*

This view looks west from the east side of Camino del Mar at 1247 Camino Del Mar. This view is not recommended for simulation since a 14' building would block the view.

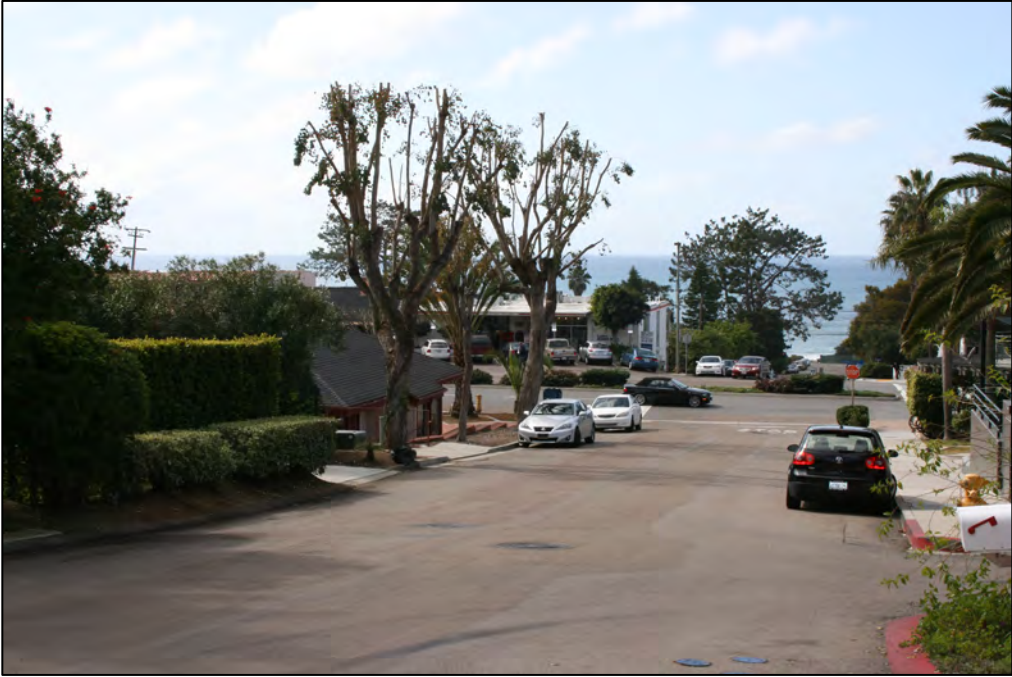
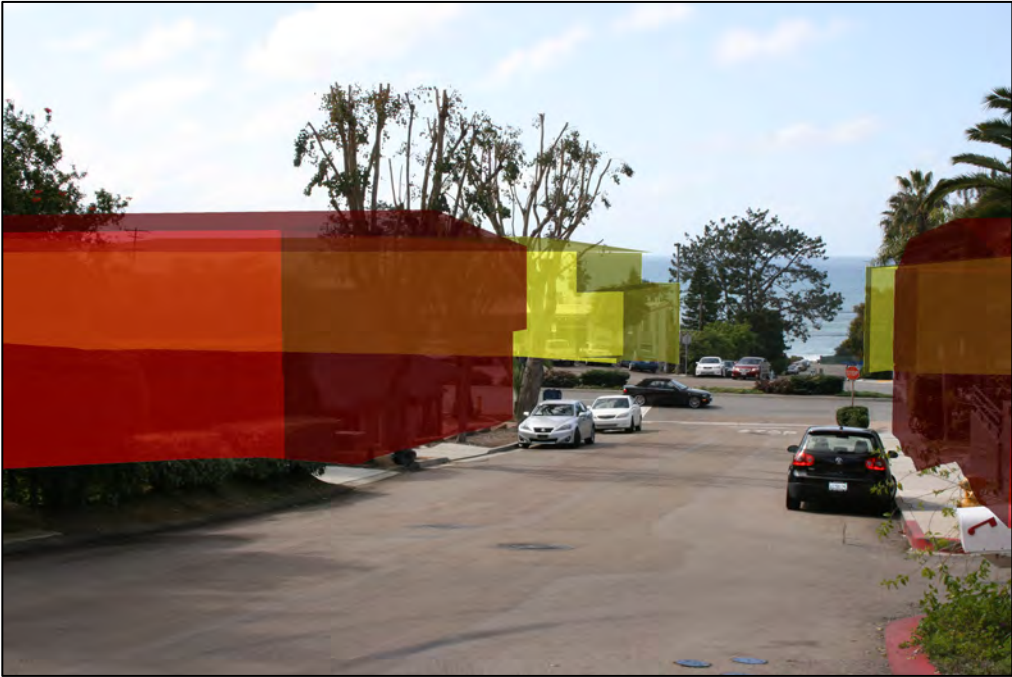
**Candidate Key View #17**

*Candidate Key View #17*

This view looks west from the north side of 12<sup>th</sup> Street at 38112<sup>th</sup>. This view is not recommend for simulation but shows the stepbacks on the side street and the heavy vegetation blocks some views.

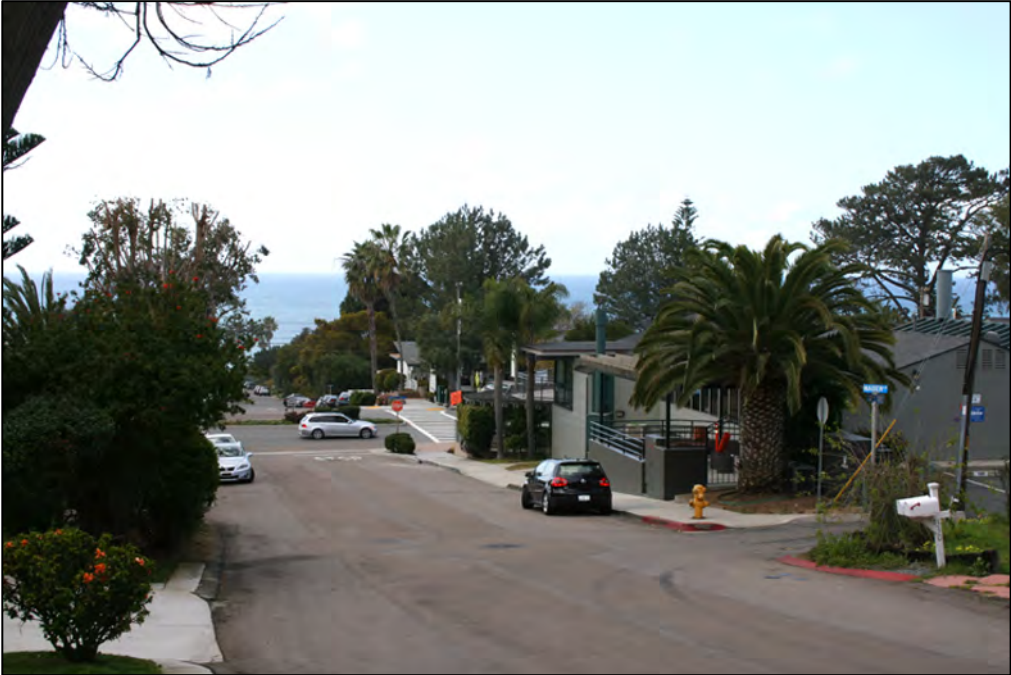
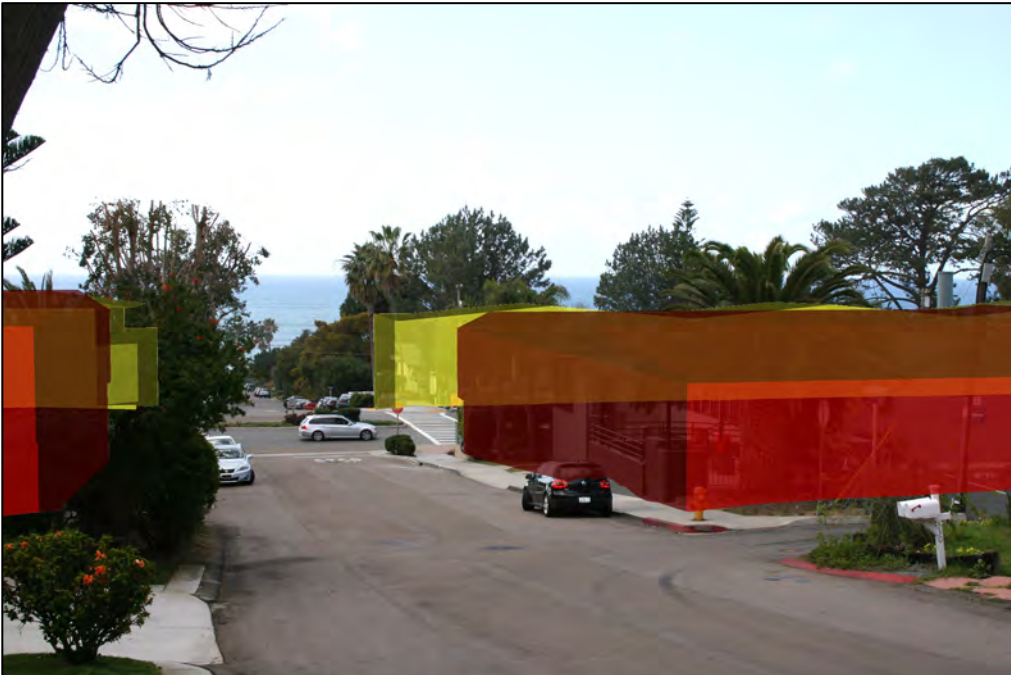
**Candidate Key View #18**

*Candidate Key View #18*

This view looks west from the south side of 12<sup>th</sup> Street at 389 12<sup>th</sup>. This view is not recommended for simulation due to the background vegetation.

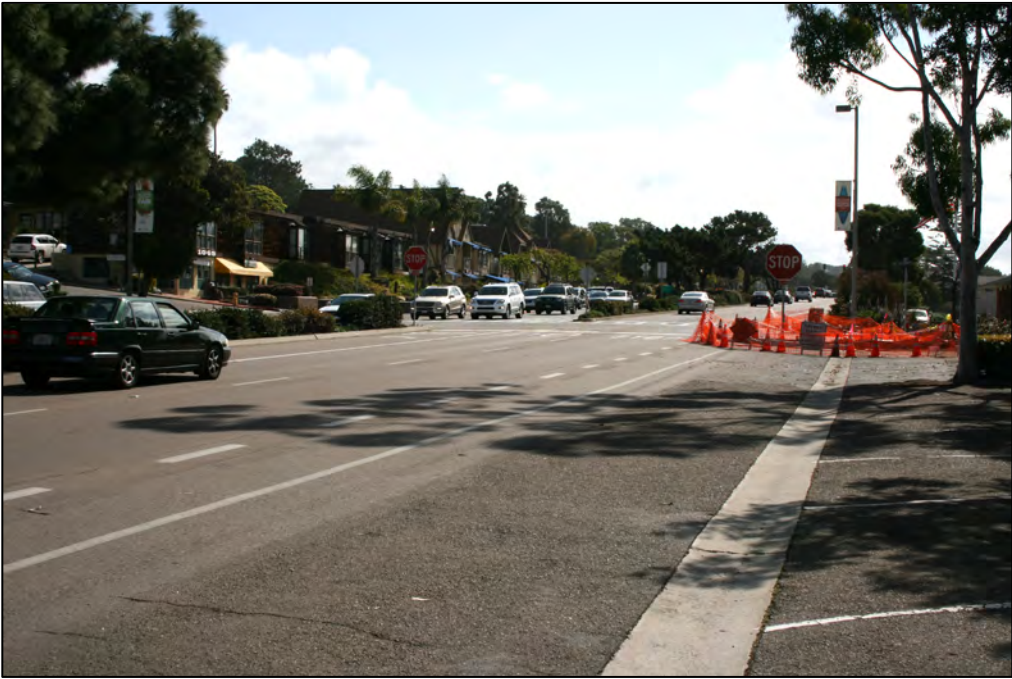
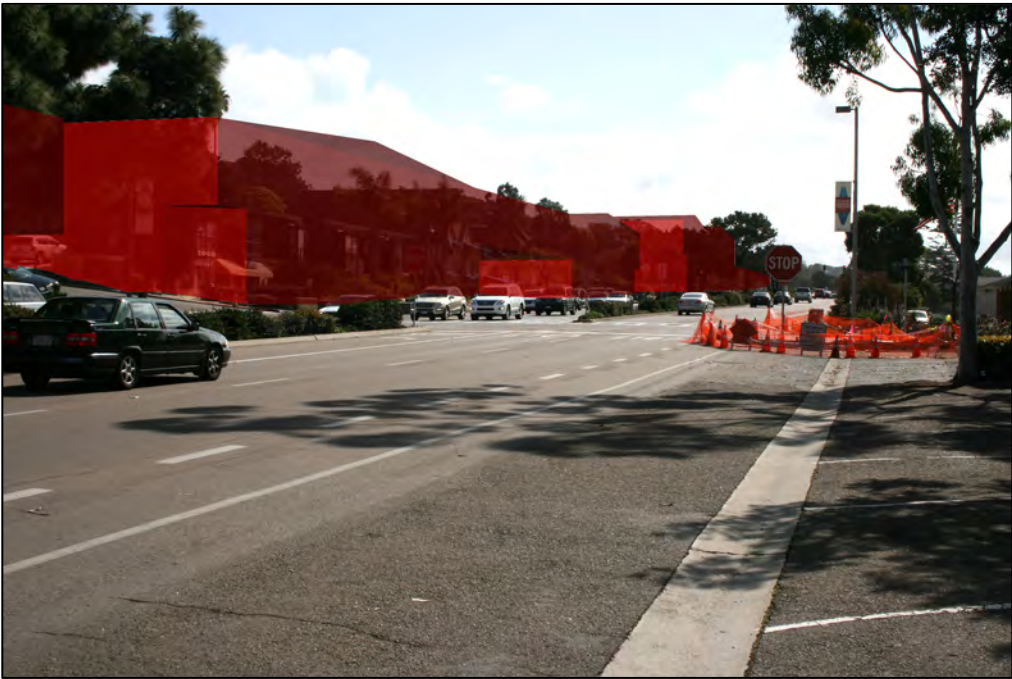
**Candidate Key View #19**

This view looks south at the intersection of 11<sup>th</sup> Street and Camino del Mar. This view is not recommended for simulation since the existing buildings most likely will not change with the proposed heights and FAR's.

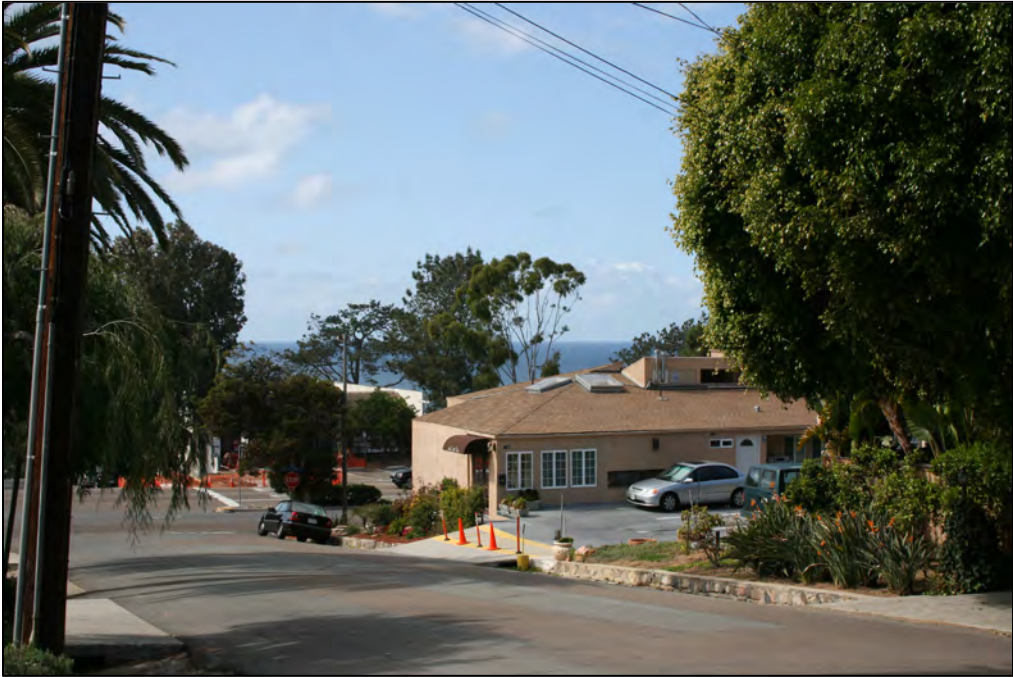
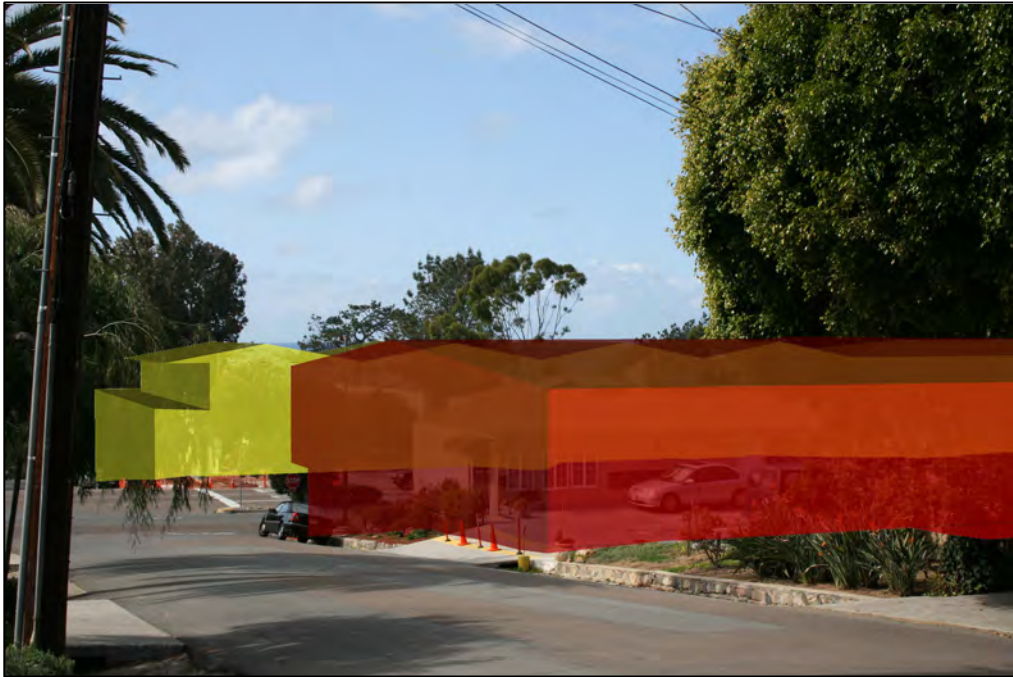
**Candidate Key View #20**

*Candidate Key View #20*

This view looks west from the south side of 11<sup>th</sup> Street at 331 11<sup>th</sup>. This view is not recommended for simulation since too much vegetation blocks the view.

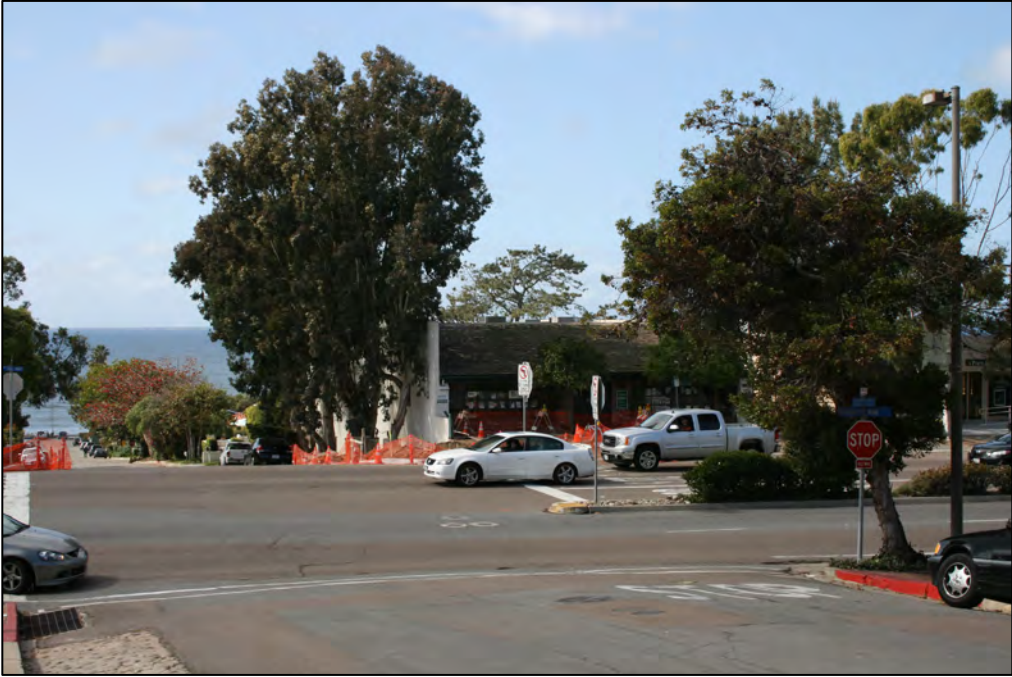
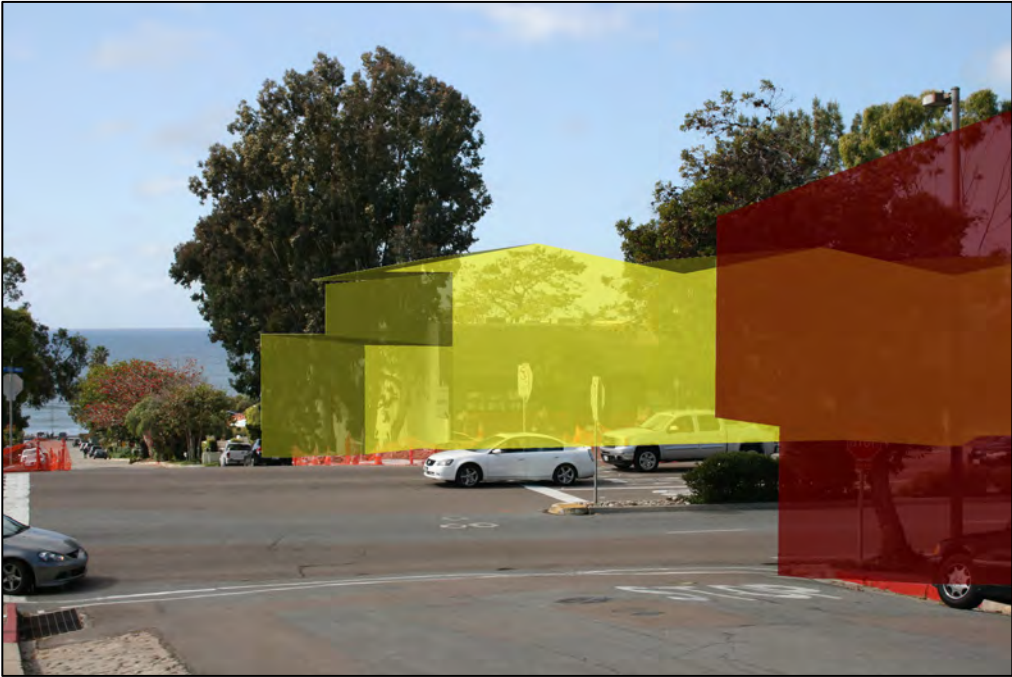
**Candidate Key View #21**

*Candidate Key View #21*

This view looks west from the south side of 11<sup>th</sup> Street at 317 11<sup>th</sup>. This view is not recommended for simulation but shows a corner lot setback and could show a roundabout in the simulation as well.

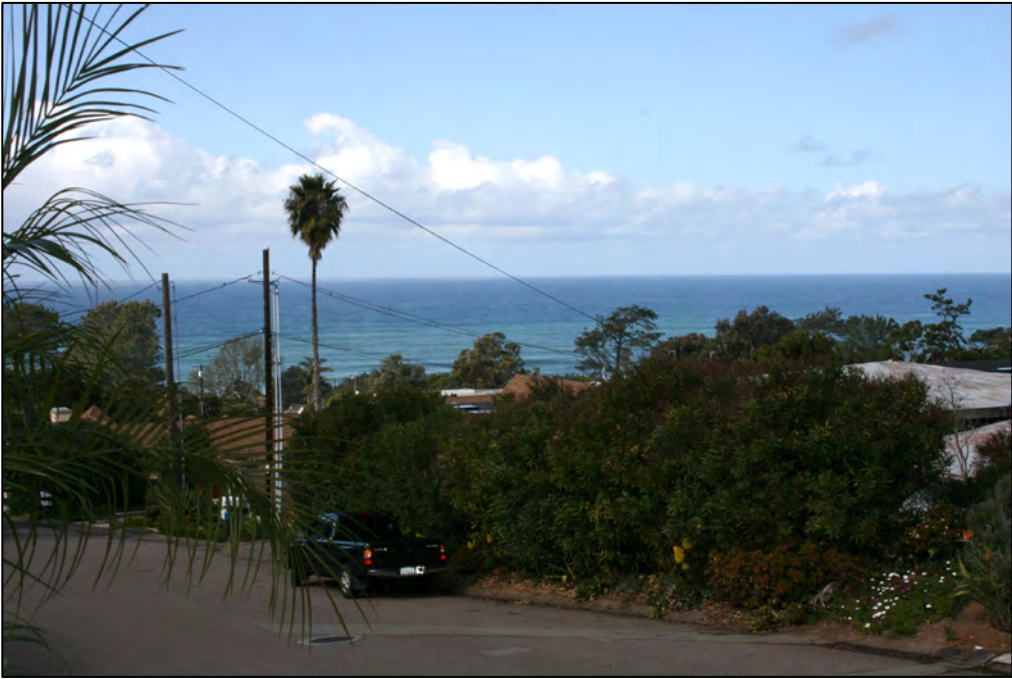
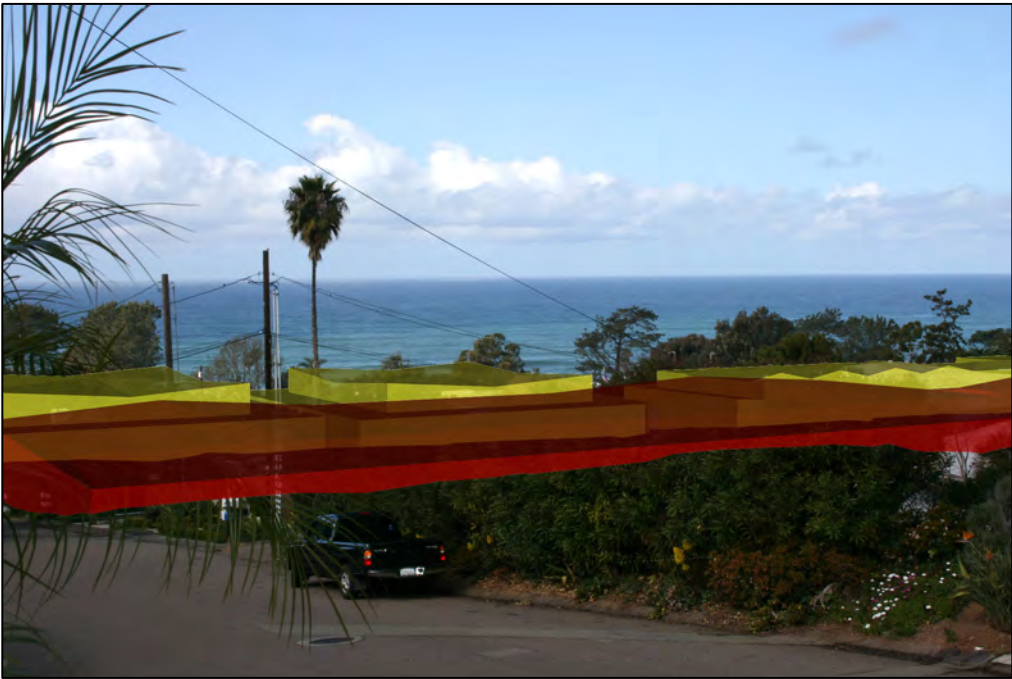
**Candidate Key View #22**

*Candidate Key View #22*

This view looks northwest from the south side of 10<sup>th</sup> Street at 411 10<sup>th</sup>. This view is not recommended for simulation, but shows the proposed building are less of an impact moving up the hill.
