Village Specific Plan  
Visual Impact Assessment

**KTU+A Planning and Landscape Architecture**  
3916 Normal Street  
San Diego, CA 92103

March 13, 2012  
Revised July 5, 2012

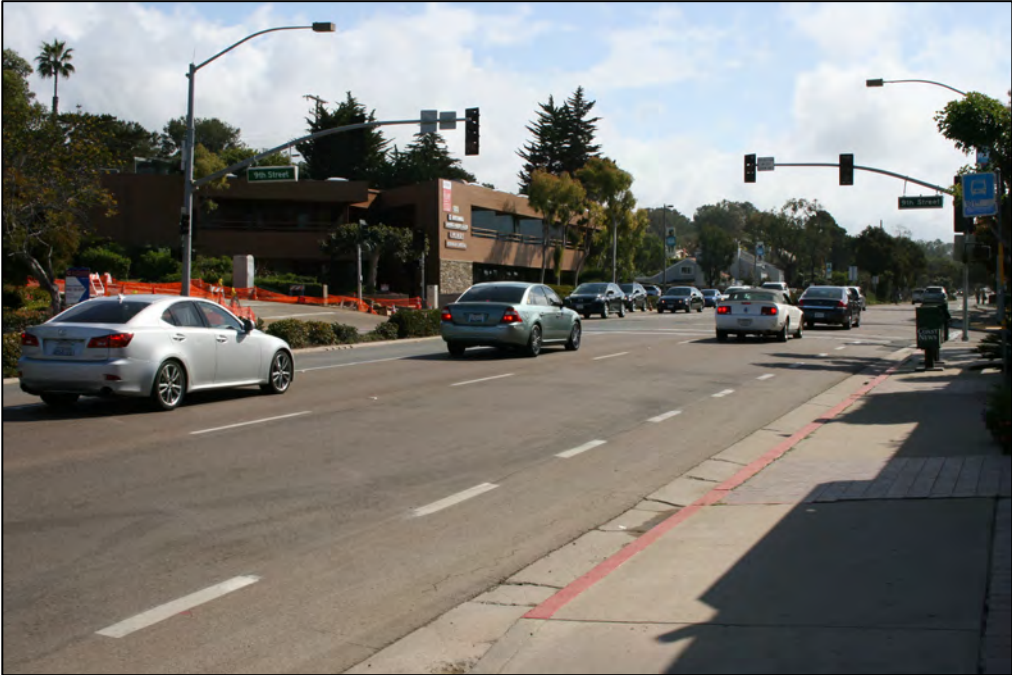
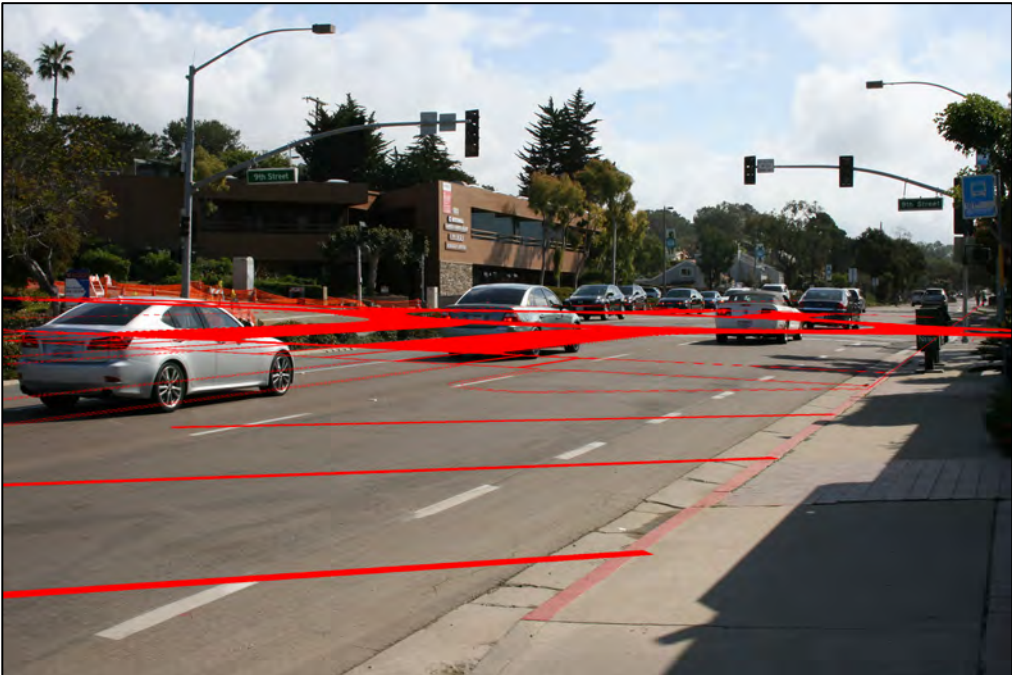
**Candidate Key View #23**

*Candidate Key View #23*

This view looks south at the intersection of 9<sup>th</sup> Street and Camino del. This view is not recommended for simulation of the roundabout.
